(device,0,0,-1,-1,2,2) Characteristics

• Cell Size: 10um

• Last Measurement: 2022/February/28 at 05:01PM

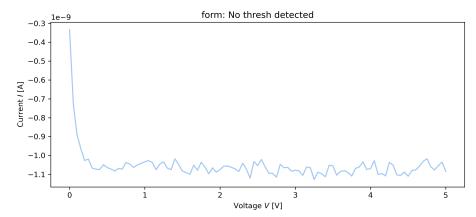
• **Cycle:** 1

• Error: Set failed

Failure to form. Bad probe to pad contact. A: Copper, B: Platinum.

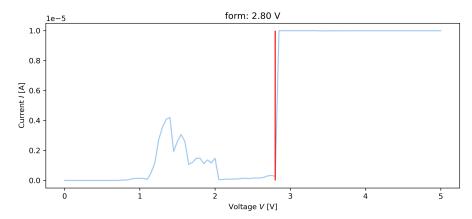
• Cycle: 1

Success, but strange curve in the beginning. A: Copper, B: Platinum.

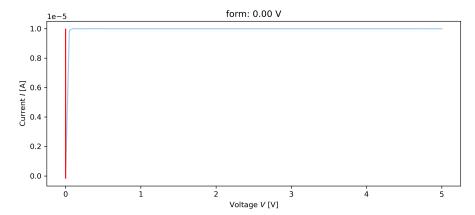
• Cycle: 1

• Error: Set failed

Intention was just to observe, form success confirmed. A: Copper, B: Platinum.

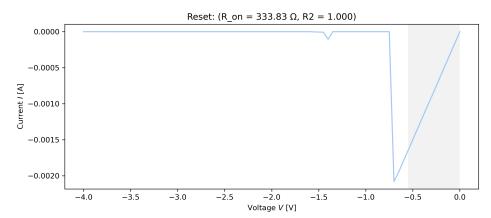
• **Cycle:** 1

Resistance: 333.83 Ω
Linear Fit R2: 1.000

Success. AV column missing, copied from run 2202281620. This run was a near perfect reset. A: Copper, B: Platinum.

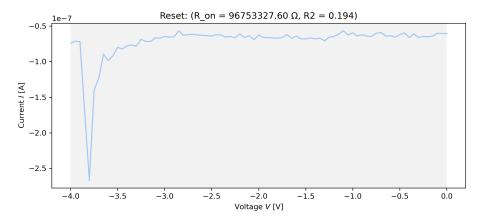
• **Cycle:** 2

• Resistance: 96753327.60 Ω

• Linear Fit R2: 0.194

Retry and observation from run 2202281619 due to missing AV column. A: Copper, B: Platinum.

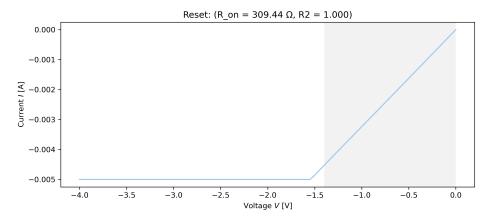
• **Cycle:** 3

Resistance: 309.44 Ω
Linear Fit R2: 1.000

Failure to reset. A: Copper, B: Platinum.

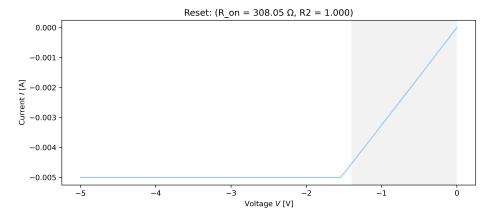
• Cycle: 4

Resistance: 308.05 Ω
Linear Fit R2: 1.000

Reset failure. A: Copper, B: Platinum

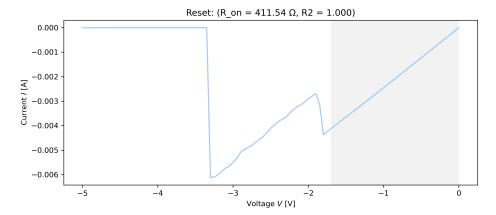
• Cycle: 7

Resistance: 411.54 Ω
Linear Fit R2: 1.000

Reset success. But not smooth. A: Copper, B: Platinum.

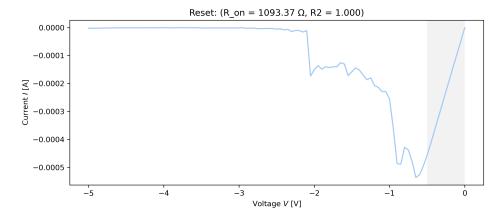
• **Cycle:** 10

Resistance: 1093.37 Ω
Linear Fit R2: 1.000

Successful reset, but very janky. A: Copper, B: Platinum.

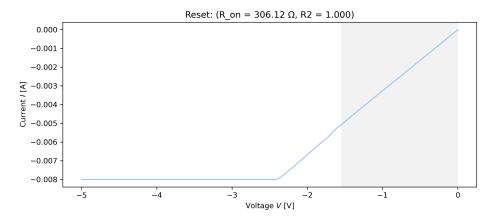
• Cycle: 11

Resistance: 306.12 Ω
Linear Fit R2: 1.000

Reset failed. A: Copper, B: Platinum

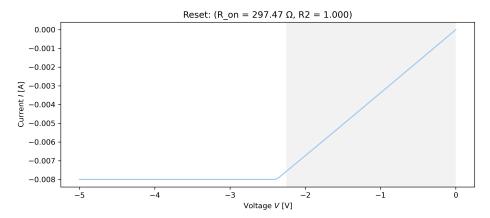
• **Cycle:** 12

Resistance: 297.47 Ω
Linear Fit R2: 1.000

Reset failed. A: Copper, B: Platinum.

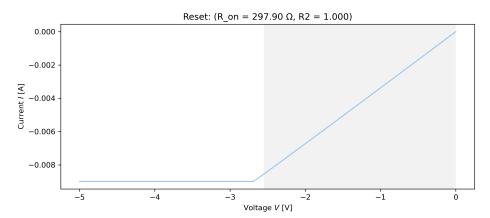
• **Cycle:** 13

Resistance: 297.90 Ω
Linear Fit R2: 1.000

Reset failed. Something wrong, cell is possibly burnt out (i.e. too strong of a filament. A: Copper, B: Platinum.

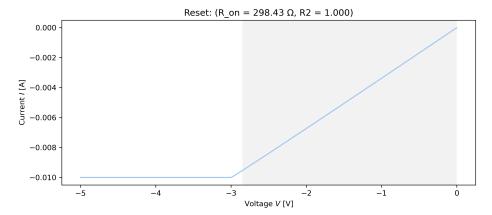
• Cycle: 14

Resistance: 298.43 Ω
Linear Fit R2: 1.000

Reset failed. A: Copper, B: Platinum

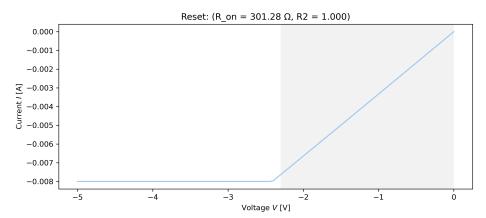
• **Cycle:** 15

Resistance: 301.28 Ω
Linear Fit R2: 1.000

Failed reset again. A: Copper, B: Platinum.
