(device, 0, 0, -1, -1, 2, 2) Plots and Summary

- Cell Size = 10um
- Number of Times Accessed = 27
- Last Stimulated = 2022/February/28 at 05:01PM

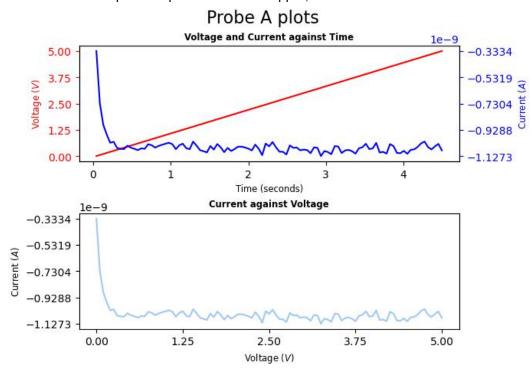
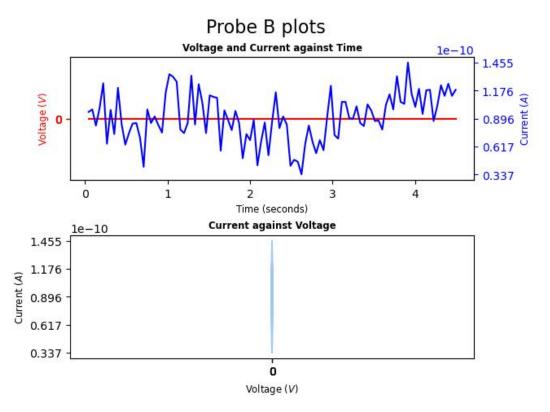
Stimulated at 04:16:09PM on 2022/February/28

Comments = Failure to form. Bad probe to pad contact. A: Copper, B: Platinum.

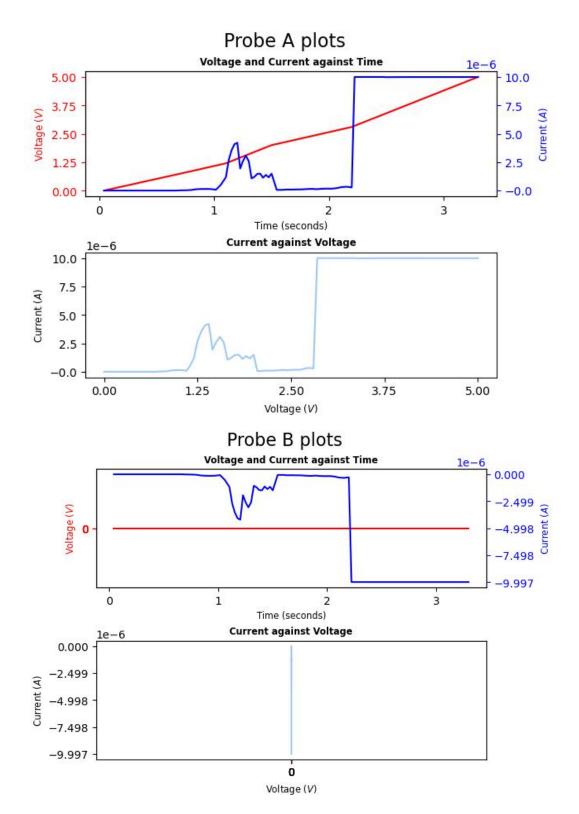
Stimulated at 04:16:59PM on 2022/February/28

Comments = Success, but strange curve in the beginning. A: Copper, B: Platinum.

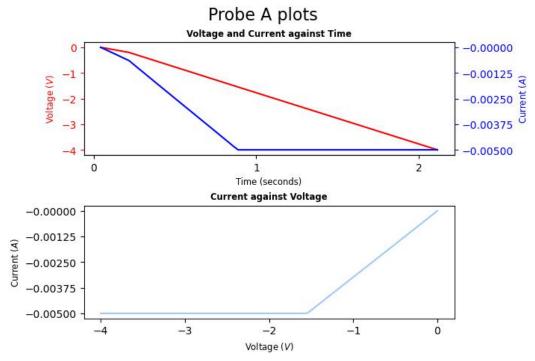
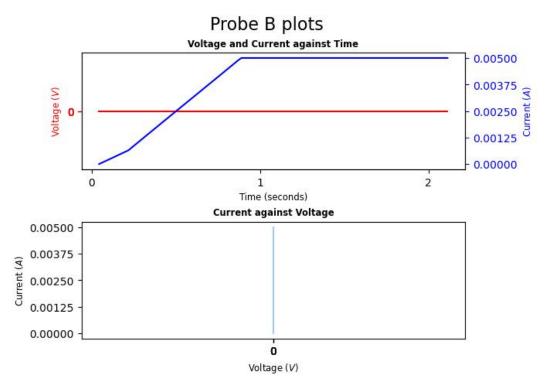
Comments = Failure to reset. A: Copper, B: Platinum.

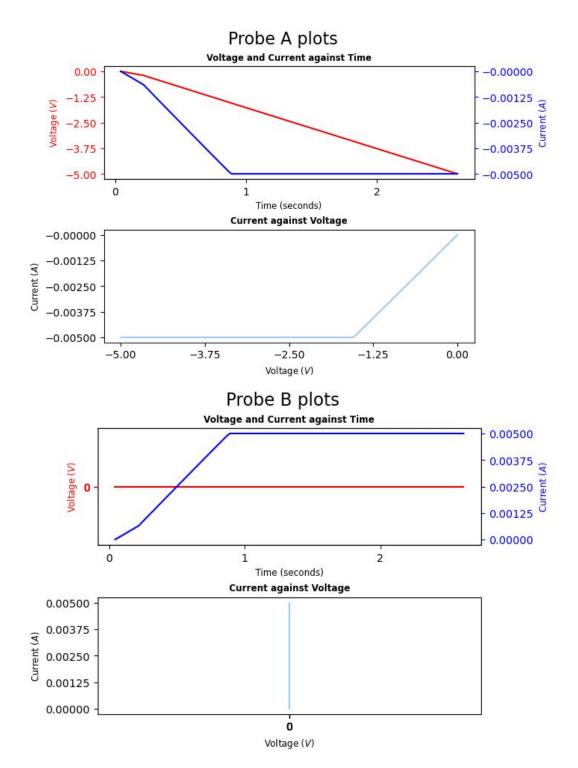
Stimulated at 04:30PM on 2022/February/28

Comments = Reset failure. A: Copper, B: Platinum

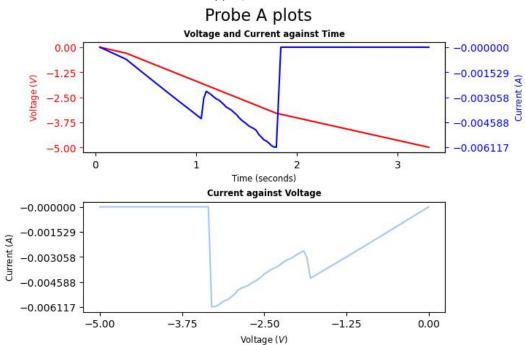
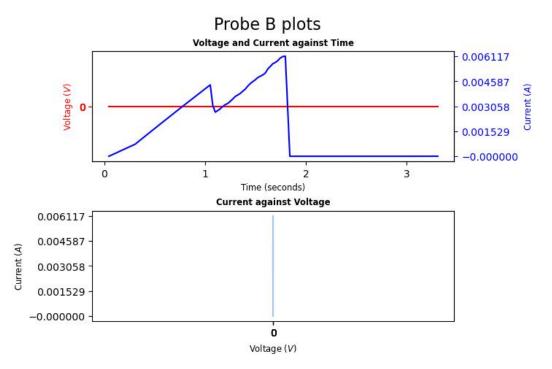
Stimulated at 04:38PM on 2022/February/28

Comments = Reset success. But not smooth. A: Copper, B: Platinum.

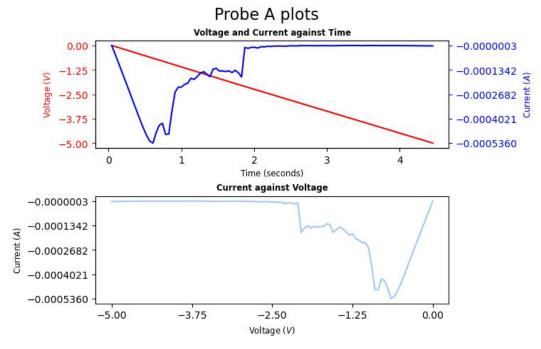
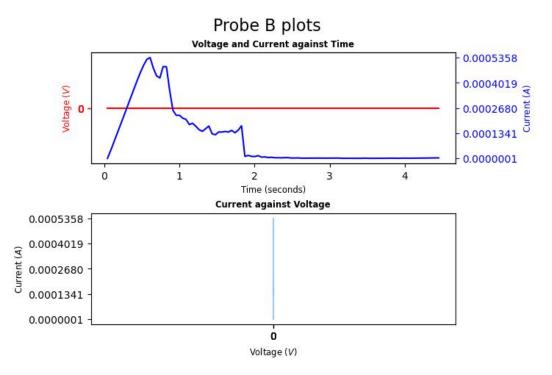
Comments = Successful reset, but very janky. A: Copper, B: Platinum.

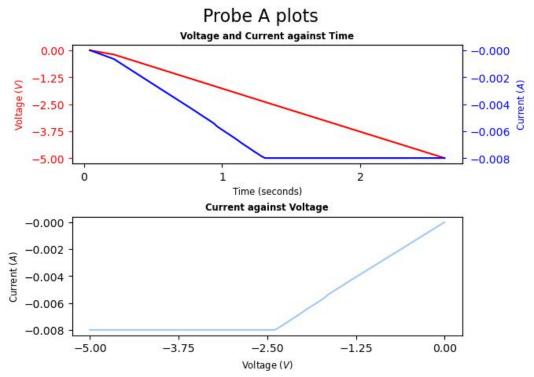
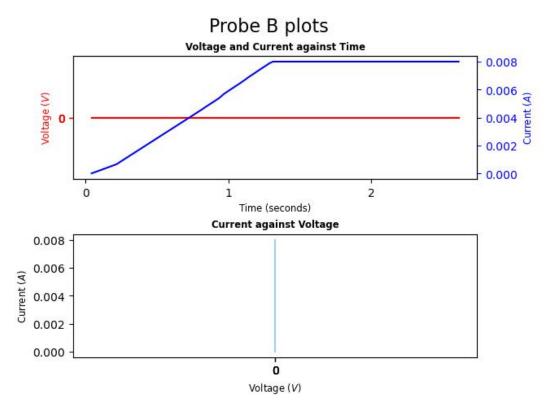
Stimulated at 04:54PM on 2022/February/28

Comments = Reset failed. A: Copper, B: Platinum

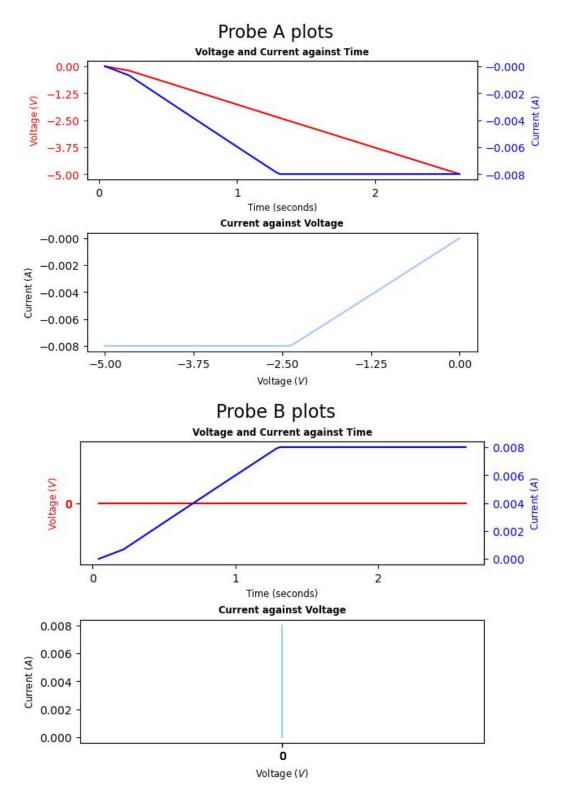
Stimulated at 04:55:04PM on 2022/February/28

Comments = Reset failed. A: Copper, B: Platinum.

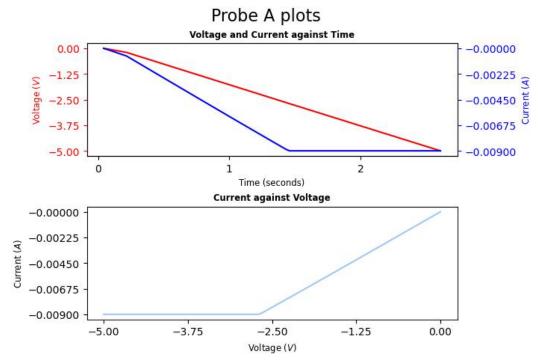
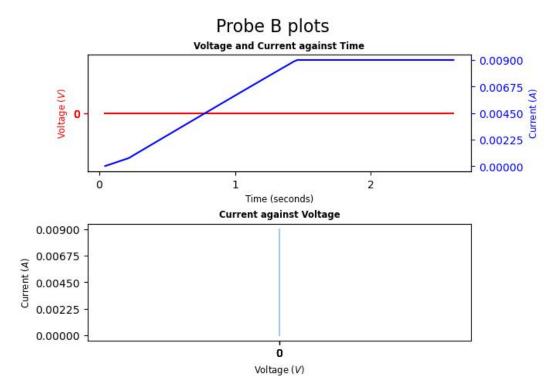
Stimulated at 04:55:32PM on 2022/February/28

Comments = Reset failed. Something wrong, cell is possibly burnt out (i.e. too strong of a filament. A: Copper, B: Platinum.

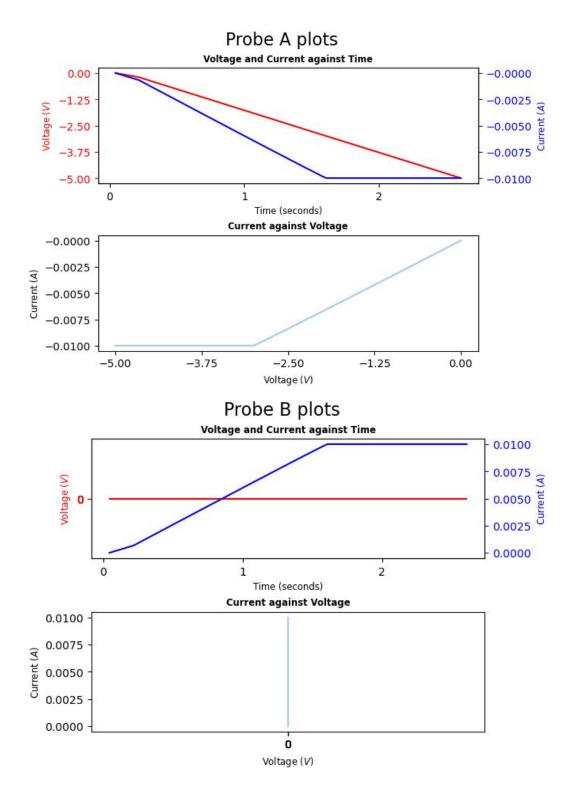
Stimulated at 04:57PM on 2022/February/28

Comments = Reset failed. A: Copper, B: Platinum

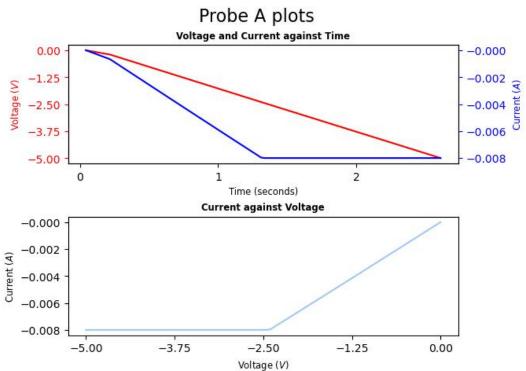
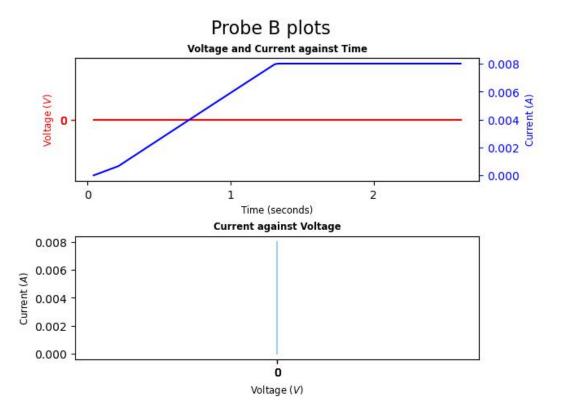
Stimulated at 04:59:04PM on 2022/February/28

Comments = Failed reset again. A: Copper, B: Platinum.

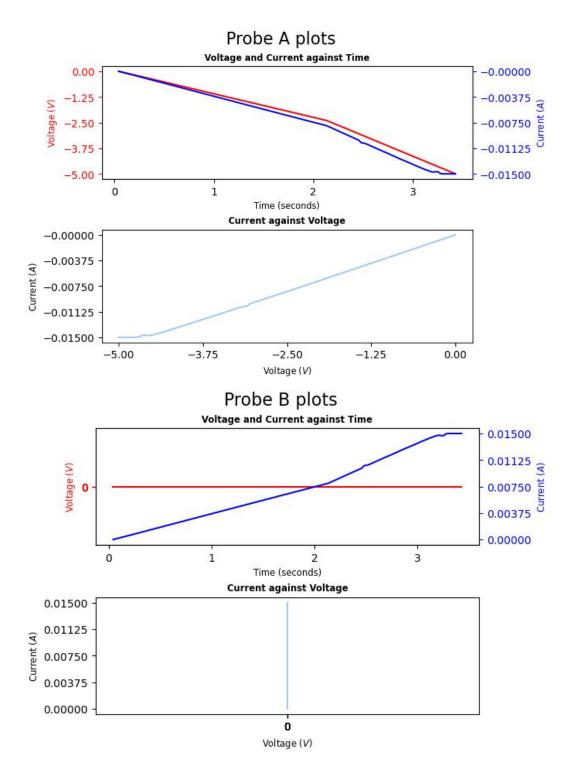
Stimulated at 04:59:43PM on 2022/February/28

Comments = Reset fail. Cell damage confirmed. A: Copper, B: Platinum.

Comments = Cell confirmed stuck in set position. A: Copper, B: Platinum.
