MAGNETOM

Troubleshooting Guide System

RF System

Harmony syngo MR
Symphony syngo MR
Sonata syngo MR
Trio
Upgrades to syngo MR
from Impact/Expert
from Vision

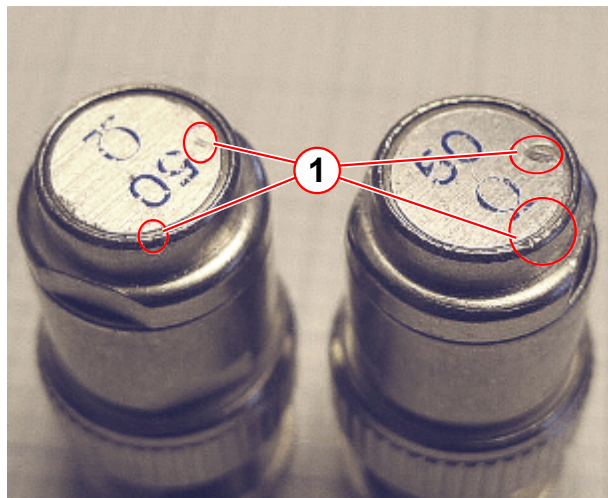
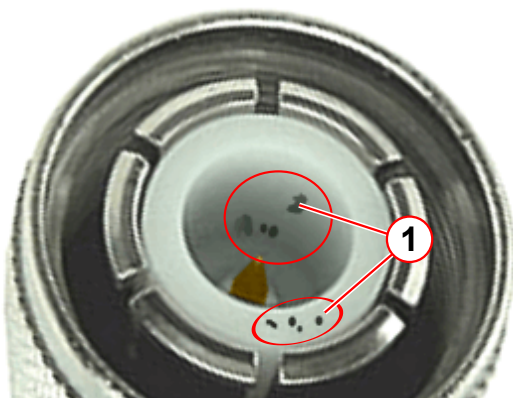
Fig. 27: 50 Ohm BNC Terminators

Examples of defective adapters → replace:

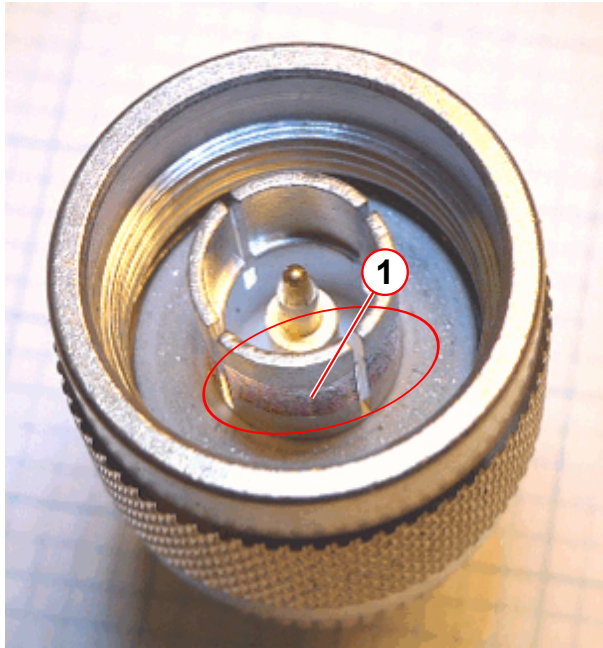
Fig. 28: BNC-HN Adapter

(1) Notches

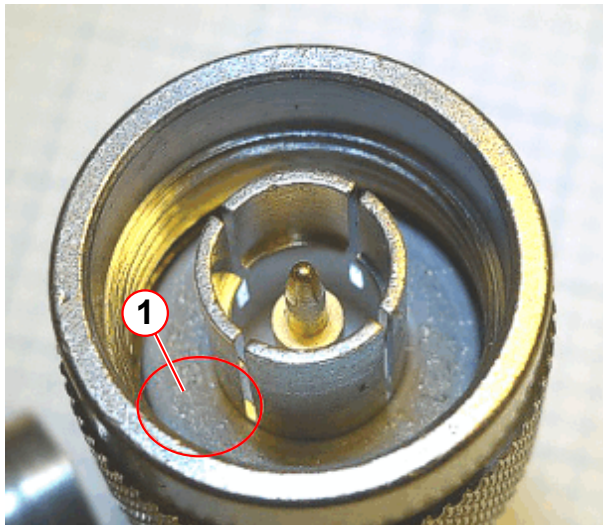
Fig. 30: BNC Adapter

(1) Scratches outer conductor

(1) Metal dust

- Connector metal abrasion, e.g. scratches at outer conductor:
 - » Hold adapters when tightening - avoid turning.

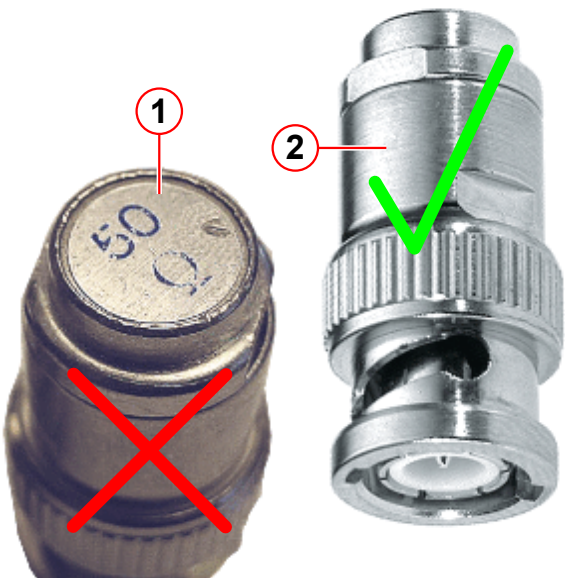
Fig. 31: 50 Ohm BNC Terminator

(1) Oxidized - do NOT use!
(2) Shiny - good condition

Examples of defective adapters -> replace:

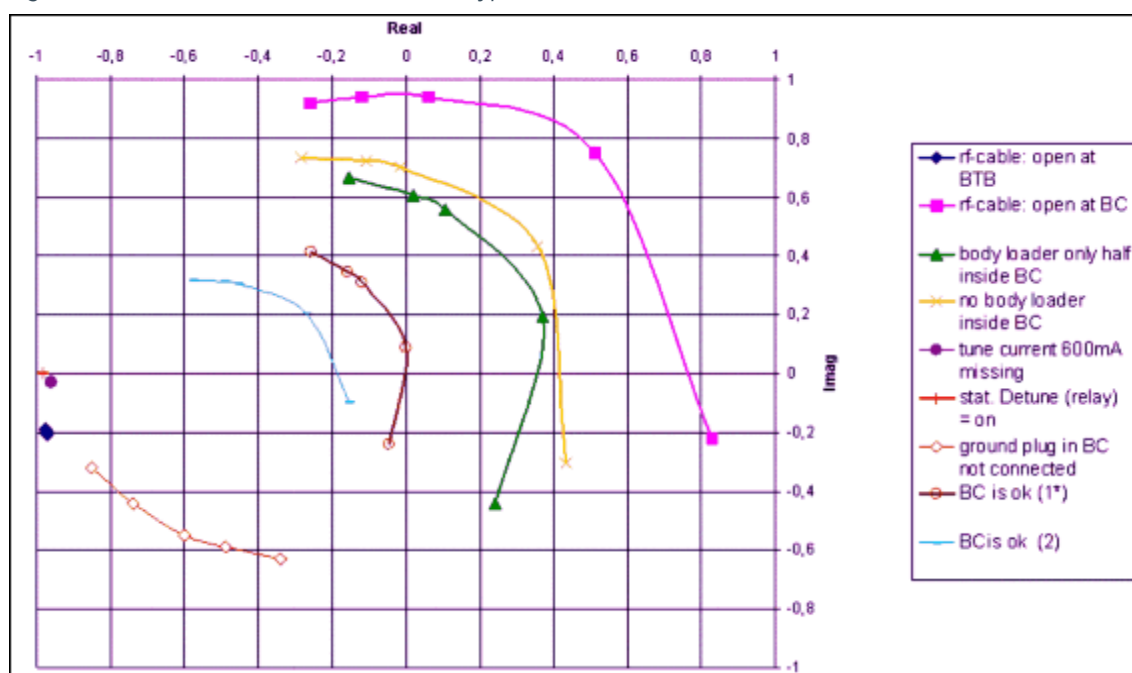
Fig. 42: Measurement results test 9-13 for typical BC errors

The results of measurements 9-13 are displayed graphically in a x-y diagram (real part on x-axis, imaginary part on y-axis). From deviations of the measurement compared with the normal situation shown in the error can be analyzed (→ Fig. 42 Page 82)
