1- SCAN ROOM INTERFACE (SRI) TROUBLESHOOTING

The Scan Room Interface Unit can be a source for intermittent and continuous RF leaks from the frequencies generated by the controllers and Integrated circuits within it. It is necessary to open the cover to look at diagnostic LED and service the SRI. Occasionally, it may be necessary to remove the cover to inspect the inside, or reattach fiber optic cables that may have come loose.

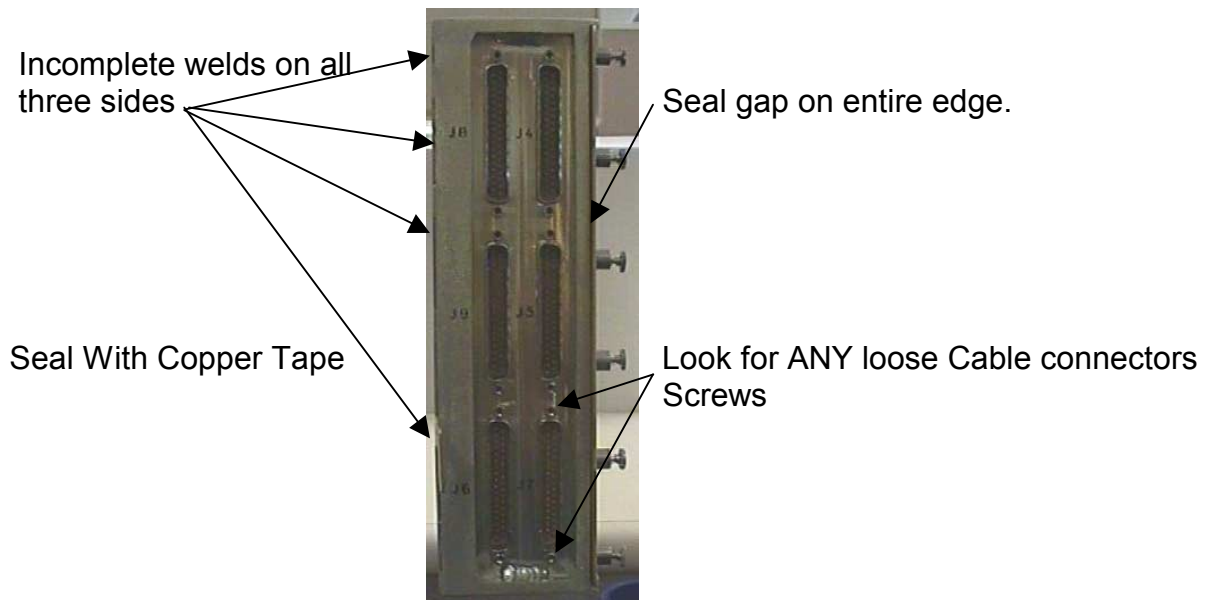
APPLICATION OF COPPER TAPE
ILLUSTRATION 1-4

Watch here for potential leaks, even after copper tape has been applied.

2. Begin applying to entire cover, sealing the gap between the cover and the casing. Work your way around until all gaps are sealed.

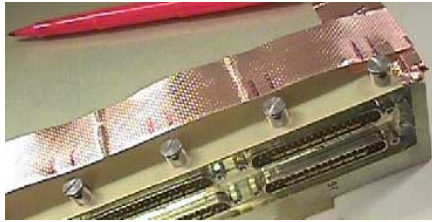
ILLUSTRATION 1-5

3. Inspect the bottom cover and sides of the SRI Unit. Welds may not be seamless and complete. Apply Tape to ANY suspicious leak source on the top bottom and sides of the SRI Unit.

INCOMPLETE WELDS

If you have a doubt about any crack or opening on the SRI seal it with copper tape.

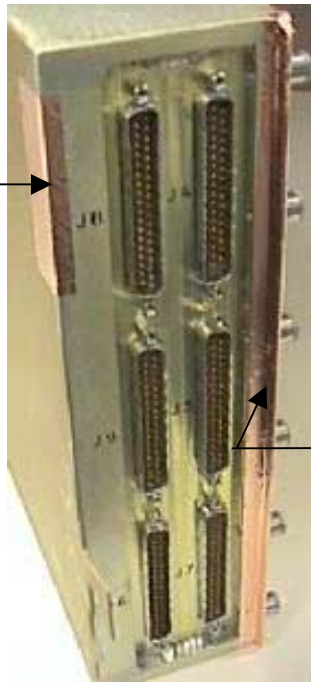
Possible
weld gap
Sealed with
copper tape

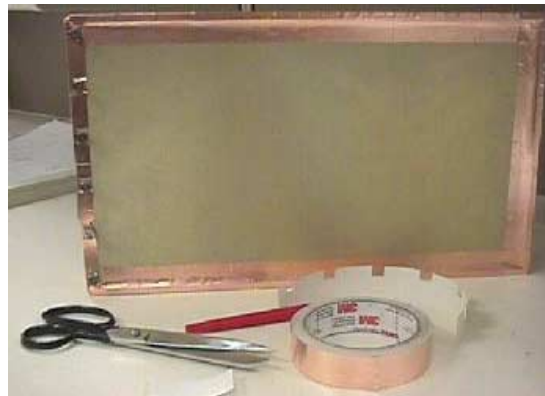
ILLUSTRATION 1-8

Wrinkle

Turned up tape corner

EXAMPLE OF UNACCEPTABLE WRINKLE

4. Insure no wrinkles or tape corners are lifting. Seal wrinkles with additional tape or remove the bad section, clean with alcohol and re-apply tape as necessary.
