MI&CT ESERVICE NOTE SN07072611a

Subject: Rotating Index Lock Inspection prior to Gantry Installation

Effectivity: All Lightspeed Family (including VCT), Brightspeed and Brightspeed Select

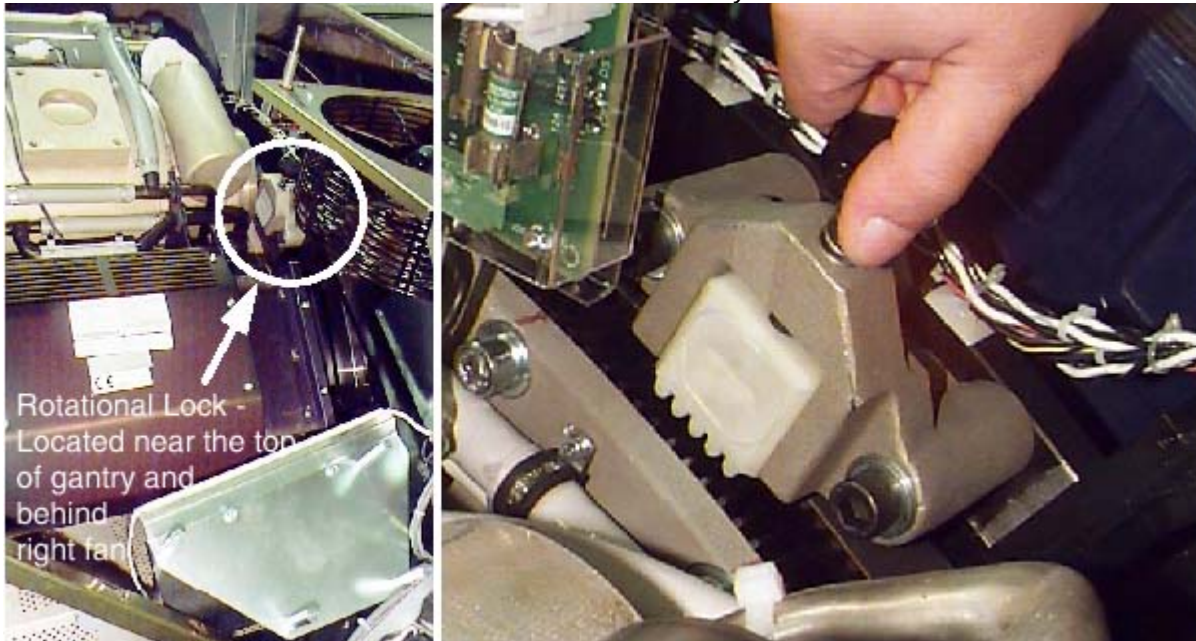
Rotational Lock Assembly

Recently, we've received reports from the field that the rotational locking pin failed on the field during the installation or the first service. Root cause is the pins may got damaged or broken by the vibration and shock during the transportation. This leads the teeth could not be engaged fully. Corrective actions on manufacture procedure and supplier quality have been finished.

The rotational lock is located on the rear side of the gantry, near the top. It is positioned directly across from the teeth in the rotational assembly.

Reminder Notice: All FE's to follow the service manual strictly and verify the lock before any service actions.

To prevent un-commanded motion of the rotating assembly, the rotational locking pin must be engaged anytime the rotating assembly is serviced.
