FMI Completion Certification Report

FMI No.: 25356

FMI Title: 25356 - HP80 (Varian Tube) SmartID Rev.2

The purpose of this document is to upgrade all LightSpeed Pro16 80kW sites with new Rev.2 Smart ID circuit board.

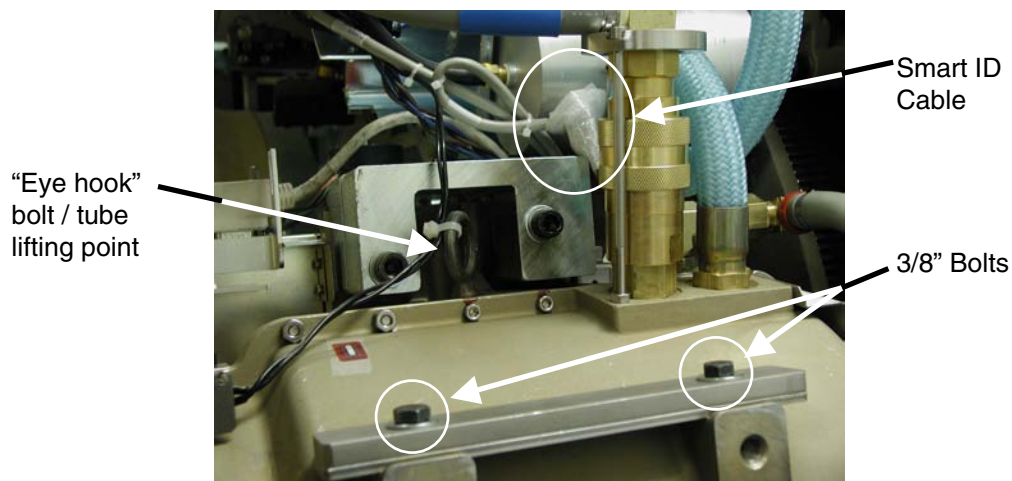
Fig 1 – Performix Pro Config without Smart ID

- 4) Remove the balance weight 3/8" mounting bolts (qty 2) and washers on the topside of the tube casing.
- 5) To compensate for new assembly weight remove quantity one 3/8" thick balance weight or quantity three 2mm thick balance weights. The balance weights vary on each tube.
- 6) Place SmartID board assembly over the remaining tube weights and reinstall the 3/8 bolts and washers using a drop of blue loctite (242) on the bolt.
- 7) Torque the two 3/8" bolts to 47 N-m [35 lb-ft / 420 lb-in / 484 kg-cm].

- 9) Connect Smart ID cable to Smart ID board. You will find this cable coming from the Jedi Inverter, connector J5, which also connects to the heat exchanger power i/f board. The Smart ID cable is the disconnected portion of the Y cable. See figure 1 if necessary.
- 10) Reattach tie-wrap for tube thermal wires to tube lifting hook and reattach any other tie-wraps you may have cut during the procedure.

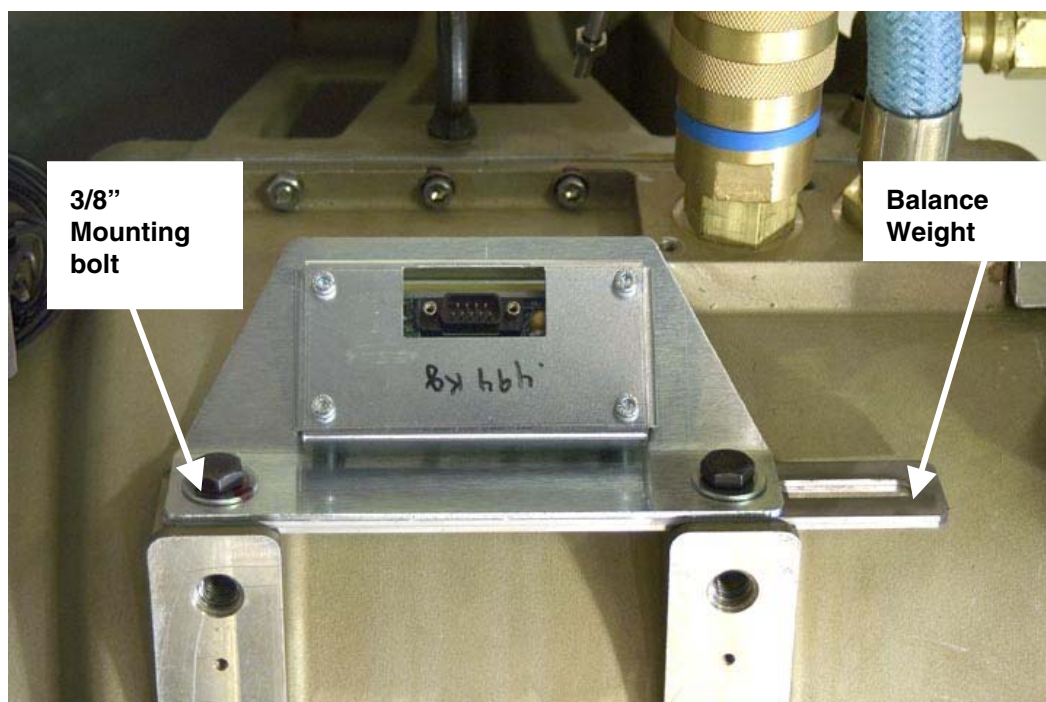
Fig 2 – Mock drawing of Smart ID installation points on Performix Pro tube
