**ADMINISTRATIVE INFORMATION****FMI No: 25363****FMI Title: SmarTube Phase 2 SW Patch for Irix/Pegasus systems**

**Special Instructions:****This FMI is for CT Irix/Pegasus (GOC1) systems only. Do not install in CT/PET.****This replaces F.2 software patch. Software prerequisite:**

The purpose of this FMI is to load Patch G.6 on IRIX/Pegasus (GOC1) systems running LS2002 M5 software. This patch includes all the fixes and enhancements of LS2002 M5 patch F.2 (optional FMI 25353).

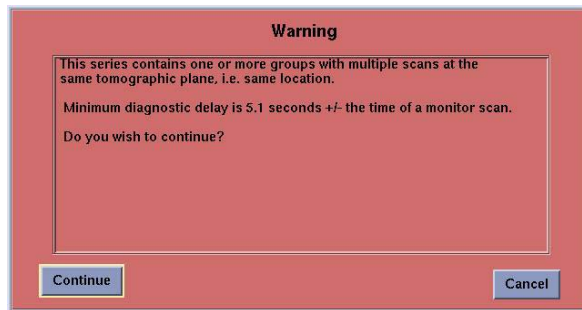
- SmartPrep Diagnostic delay not as expected.

The diagnostic delay is adjusted at Confirm to account for table movement required between the Monitor and Scan phase locations. If the Diagnostic Delay prescribed is less than what the system can do, the expected delay will be posted at Confirm as shown below:

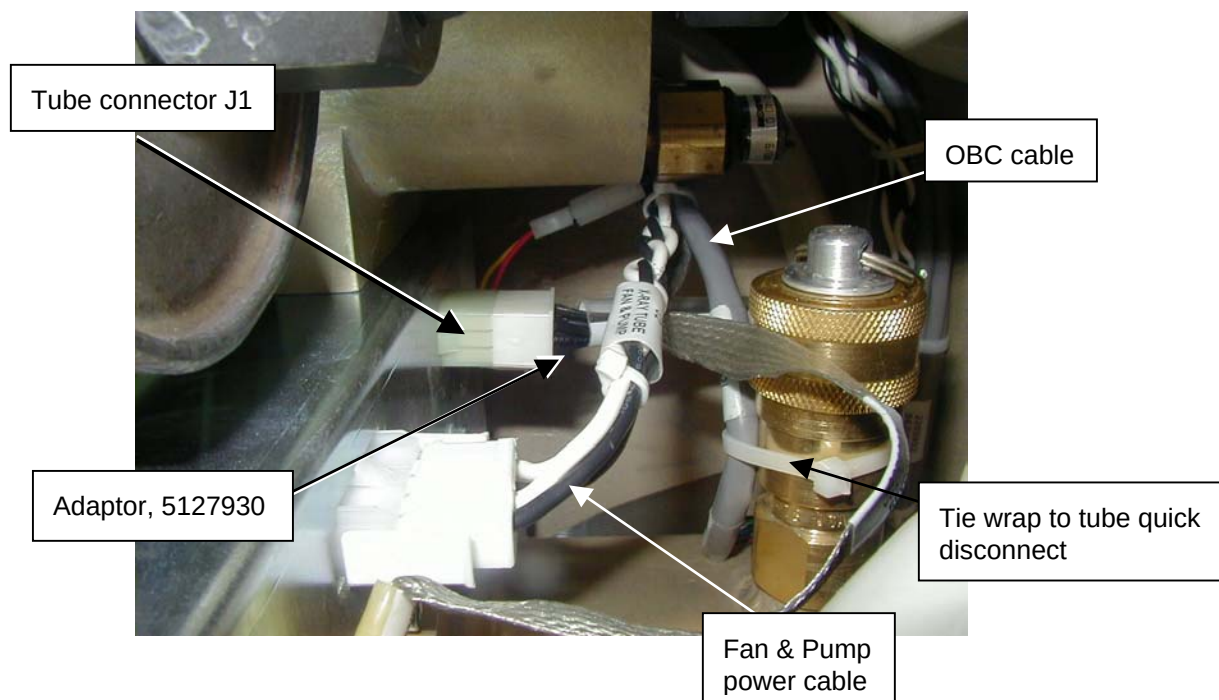
### Removal of Cable Adaptor, 5127930

6. Rotate the gantry with care until the tube is visible.
7. Now, turn off the 120VAC switch in the service panel
8. Shut off power to the console and follow lockout/tag out procedure to make sure that power is off while making the changes to the gantry
9. Locate cable adaptor, 5127930 which is connected to OBC cable, 22445405 at one end and to the Tube ID connector J1 at the other end. It is behind the tube cooling tank power cable.
10. Remove the cable adaptor, 5127930 and discard.
11. Connect cable 2245405 to the tube at connector J1.
12. For easy access to tube connector J1, if you have to disconnect Fan & Pump power cable, **REMEMBER TO RECONNECT AT COMPLETION.**

13. Remove lockout/tag out so that power can be applied to the system. If the site uses UPS, reset UPS.
14. Turn on all three switches (Axial Drive, HVDC and 120VAC) in the gantry
15. Power up console
16. Wait for the console to boot up and the gantry to reset
17. Return to section 2, Installation of Software Patch LS2002 M5 Patch G.6

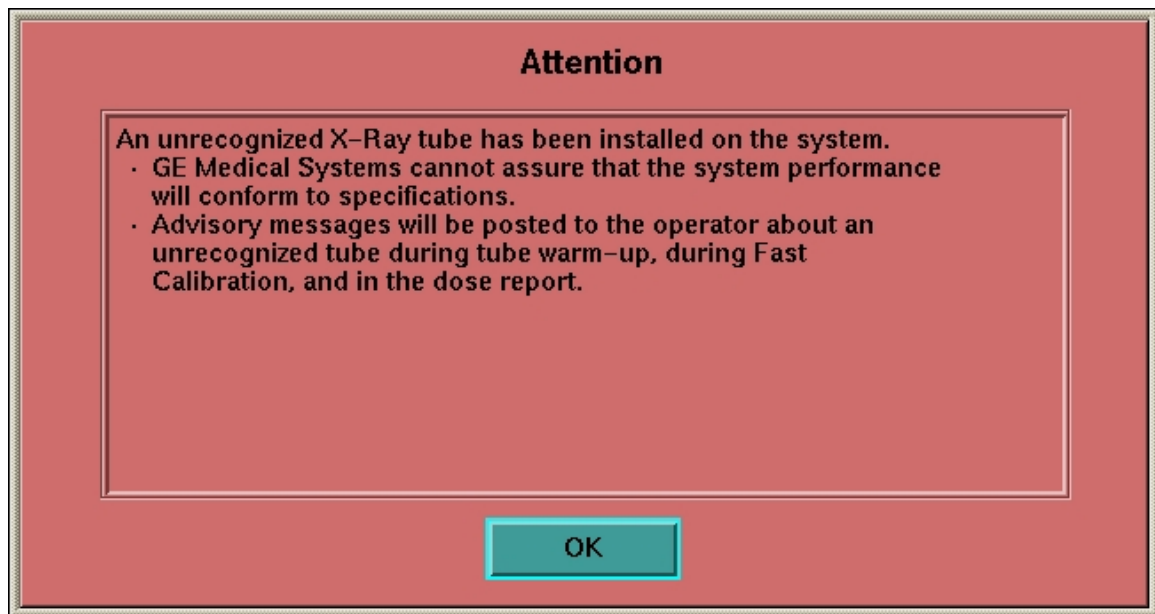
**Message at each boot up when unrecognized X-Ray Tube is installed in System**

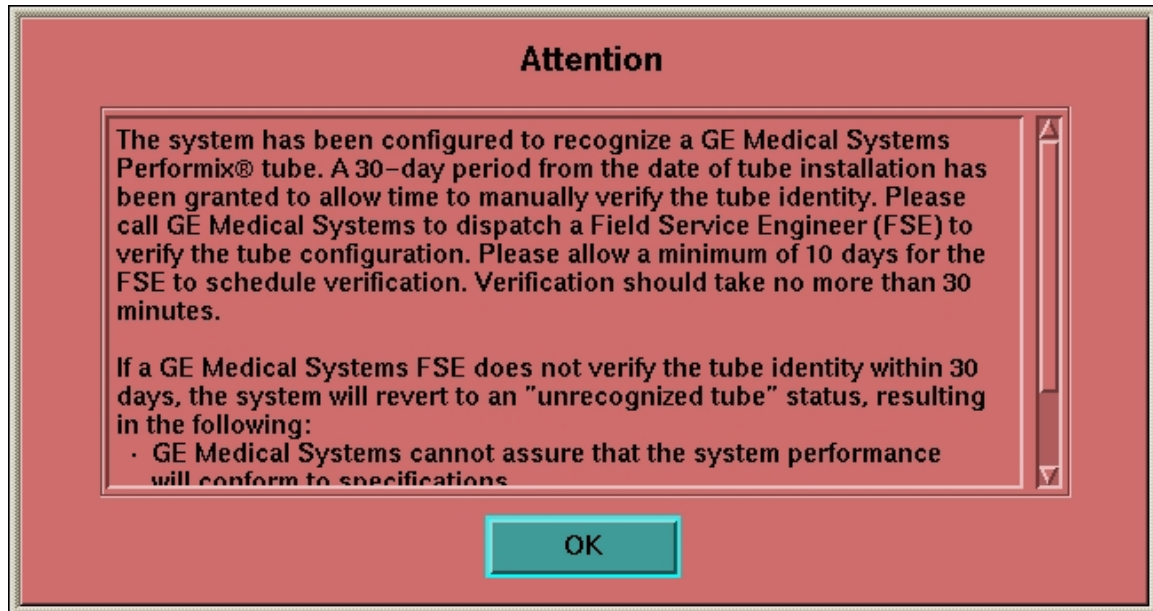
**Message at each boot up when GE Tube is selected but not verified by  
GE Field Engineer**
