**Direction 2249157FMI
Revision 0**

GE Medical Systems FMI 25258 2-Way Video Splitter Replacement

2-Way Video Splitter Replacement

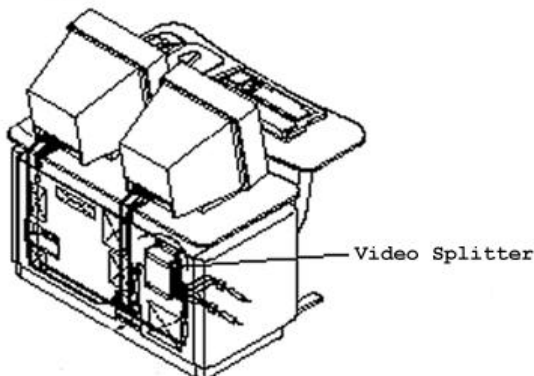
NOTE: This picture depicts only one possible location.

1. Bring down applications and turn console power off.
2. Locate the placement of the 2-way splitter. It should be near the console.
3. Remove console front panel. (If applicable)
4. Unplug the video splitter power source.
5. Locate video splitter on or near the console and unplug all video coax connectors attached to the video splitter. Note which video cables were input and which ones were output.

6. Remove the old video splitter and replace with new video splitter.
7. Reconnect all video cables paying close attention which ones were input and which ones were output.
8. Plug one end of the power cord into the back of the splitter and the other end into the console. (If applicable, because the video splitter could be plugged in elsewhere.)
9. Replace front cover of the console and power back up.
