**ADMINISTRATIVE INFORMATION****FMI No: 25372****FMI Title: VCT M3A (05MW31.6) Software update**

The purpose of this FMI is to update the VCT installed base with the current version of software and documentation.

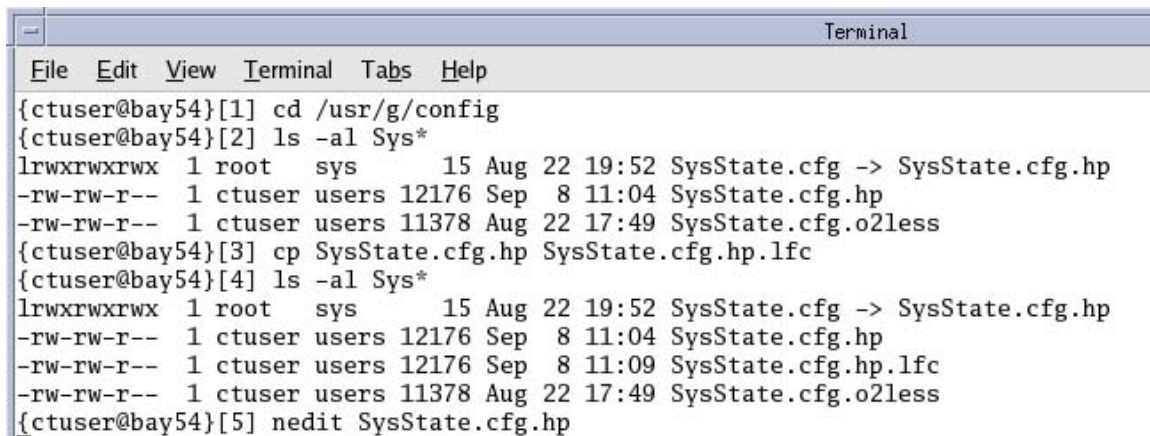
ISSUE: Save System State does not save the necessary detector configuration files for 05MW31.6.V40_H_V64_G_GTL software release. This is a known software bug, which will be fixed in the M4 software release. Failure to perform the defined corrective action will cause FRDM Wizard Tool failures when replacing detector modules.

```
{ctuser@hostname} [2] ls -al Sys*
```

See Figure 1 for output

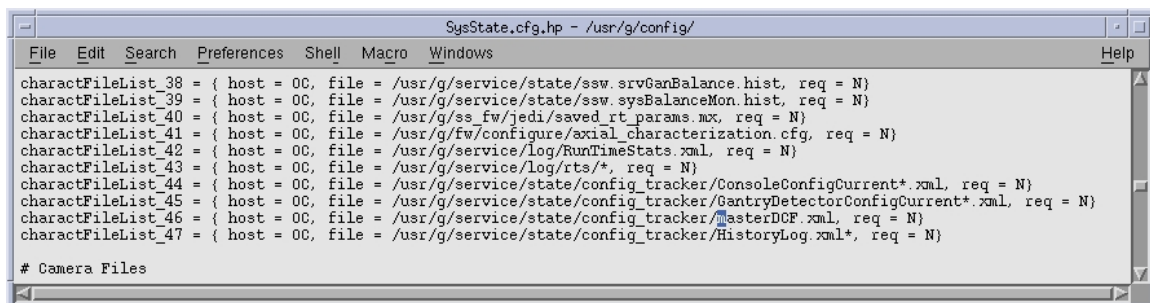
Figure 2

```
charactFileList_46 = { host = OC, file = /usr/g/service/state/config_tracker/masterDCF.xml, req = N}
```

Using the cursor, **left click** and highlight the first lower case "m" in "masterDCF.xml" only. See figure 2.

With this letter highlighted type a capital M on the keyboard: **Shift + M**

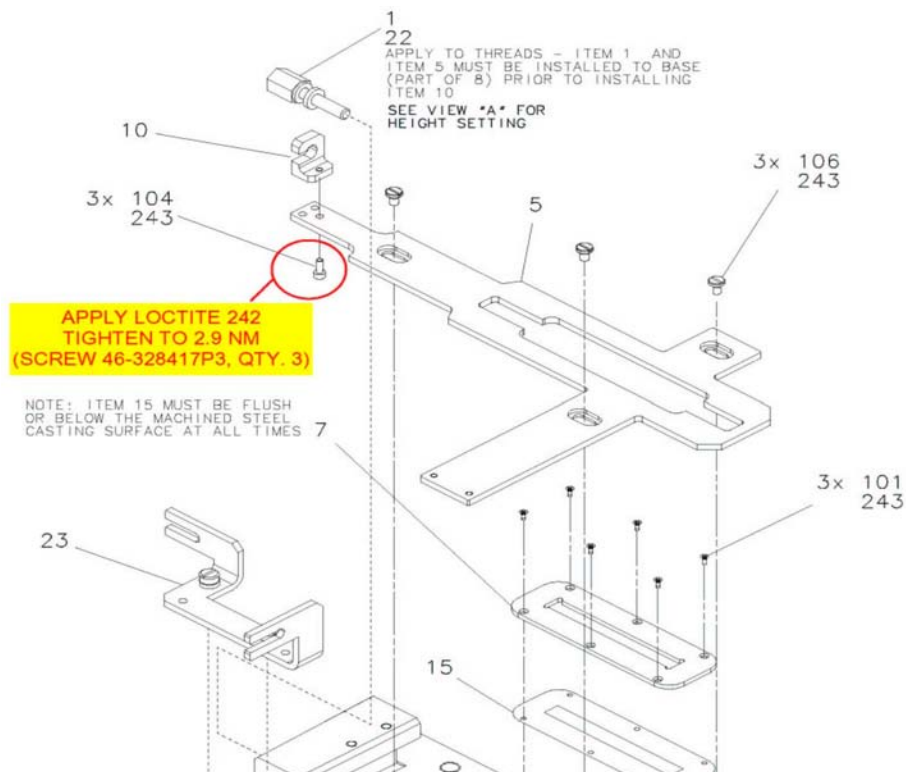
6. Collimator ISO adjuster screws

Screws attaching the ISO adjuster block to the collimator interposer plate may be missing Loctite, which could cause the screws to loosen or fall out.

- Remove the screws attaching the adjuster block to the interposer plate, one screw at a time.
- Apply Loctite 242 (blue) and reinstall screws. Torque to 2.9 NM. See figure.
