**ADMINISTRATIVE INFORMATION****FMI No: 25374****FMI Title: VCT Failsafe Collimator Upgrade**

FMI Title: **VCT Failsafe Collimator Upgrade**

The purpose of this FMI is to inspect the VCT system and determine if the existing collimator is of FAILSAFE type or not. If not, the existing collimator must be replaced with the FAILSAFE version included in the FMI kit.

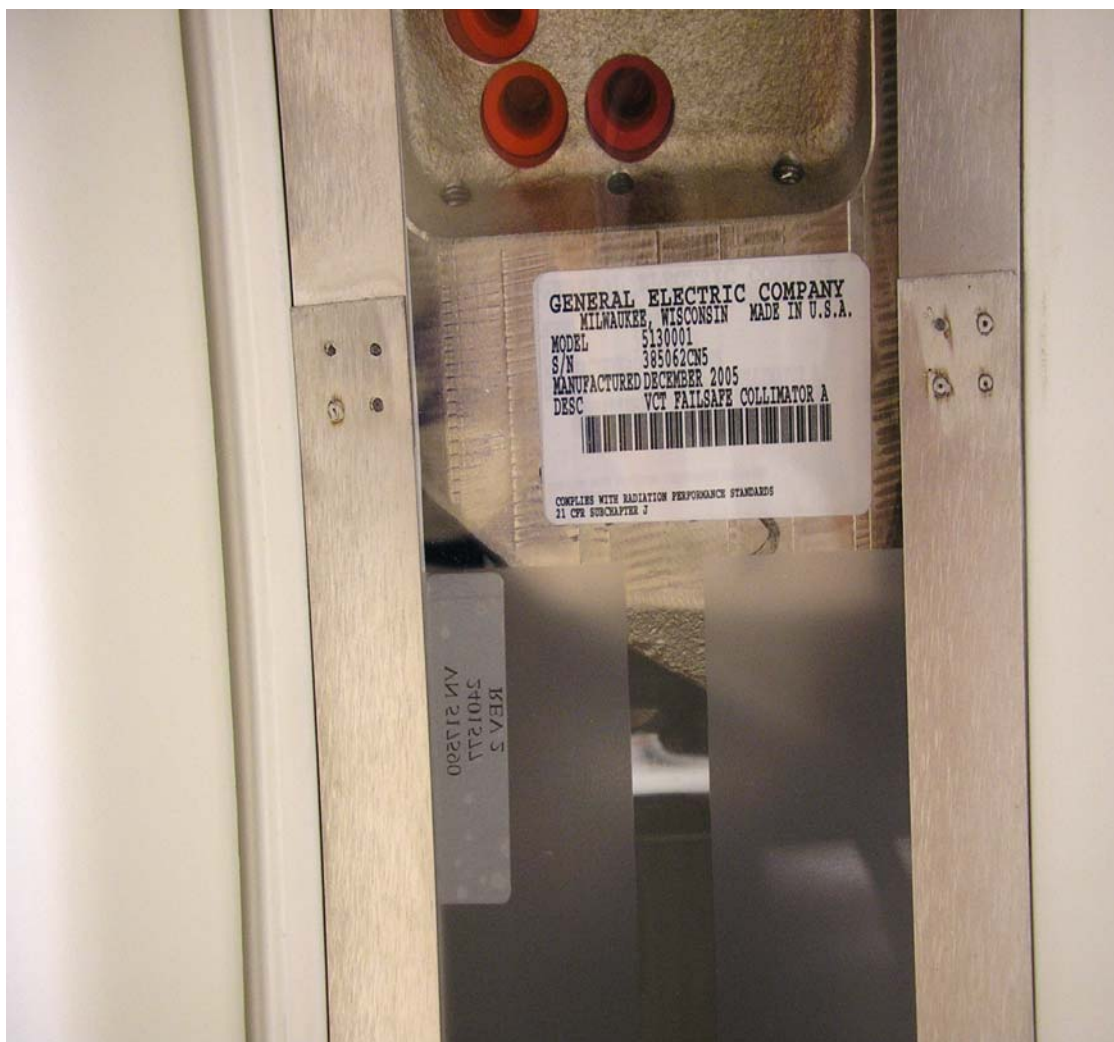
1. Verify that the existing collimator in the system is the FAILSAFE version by looking through the Mylar window. Part number will be (5130001).

View through the Mylar window.

View when looking from right side, tube @ 2:00.

2. If the existing collimator in the system is NOT FAILSAFE replace the collimator with the FAILSAFE version included in the FMI kit. Go to the "**Collimator Replacement**" section on page 5.
3. If the existing collimator in the system is FAILSAFE stop here. The FMI does not need to be performed. Return unused FMI kit to:
