**ADMINISTRATIVE INFORMATION****FMI No: 25375****FMI Title: CT H1 Gantry Helios Collimator Filler Bar Front Cover Interference Kit**

Purpose

This FMI kit provides the parts and instruction to eliminate a mechanical interference condition between the CT H1 gantry front cover laser alignment windows and the Helios collimator filler bar deployed by FMI 25360 for 2214768-3 and 2214768-4 collimators.

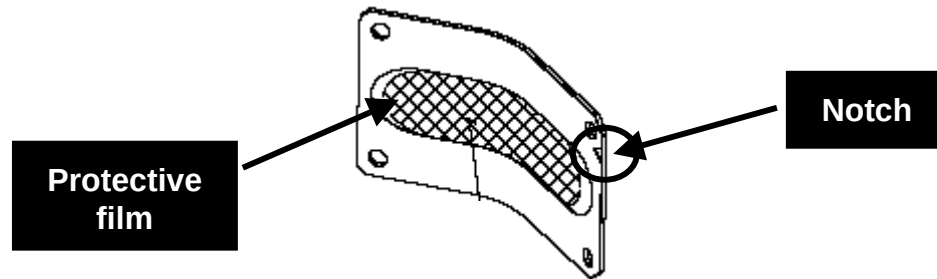
Picture 2, Mounting Tabs to Remove – Qty 2 per Laser Window

NOTE: Removing these mounting tabs creates a mechanical clearance to prevent the collimator filler bar installed by FMI 25360 (Helios Collimator Xray Scatter Filler Bar) from interfering with the front cover on H1 gantries.

7. Remove the mounting tabs from the front gantry cover.
Refer to Picture 2 for an illustration of mounting tabs to be removed.
- Use pliers to grab / twist / remove the tabs from the fiberglass.
Three tabs exist per bracket. Only remove two tabs, located at 6 & 12 o'clock positions.
 - Remove the fiberglass material that held the mounting tabs.
Use needle nose pliers to grab/twist/remove the fiberglass (or flat blade screwdriver).
