**ADMINISTRATIVE INFORMATION****FMI No: 25385****FMI Title: CT Gantry Control Touch Panel Replacement**

Unit Tracked: Refer to Effectivity list on page 3.**FMI Instructions Part No.: 5198284-100, Rev 2****Do NOT leave unsecured on site**

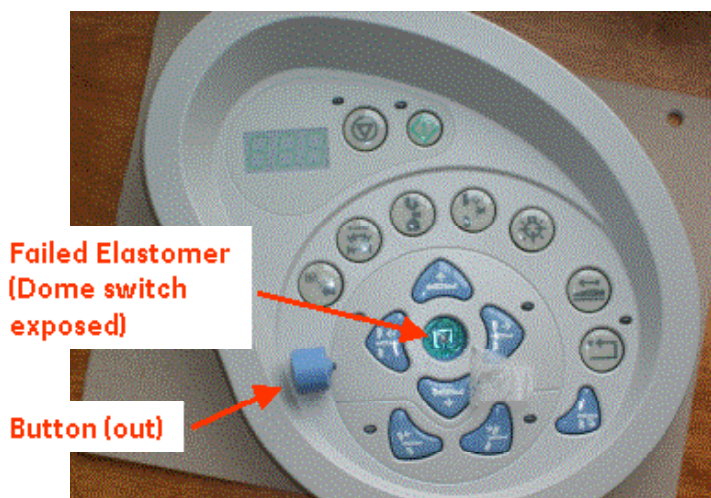
Purpose

2. Problem: Control Panel Buttons Stop Functioning and Fall Out

- a. Type of material used on elastomer holding keypads was too brittle and fails between 100-200K cycles. Depending on use of the CT system this could be as early as 1 year.
- b. Stainless Steel dome switch (located under buttons, contact to circuit board) also lost contact effectiveness between 100-200K cycles (switch activations).

This FMI supplies only two (2) replacement panels, one left and one right. The system actually has four (4) control panels, one left and one right and on both front and back of gantry. The person performing this FMI will need to decide which panels to replace. It is recommended that the most used/accessed panels be replaced, typically the two panels on the front of the gantry.
