Vibration Analysis Report

BHILAI STEEL PLANT

SP-3 Area E1062 CONVEYOR Report
11-03-23

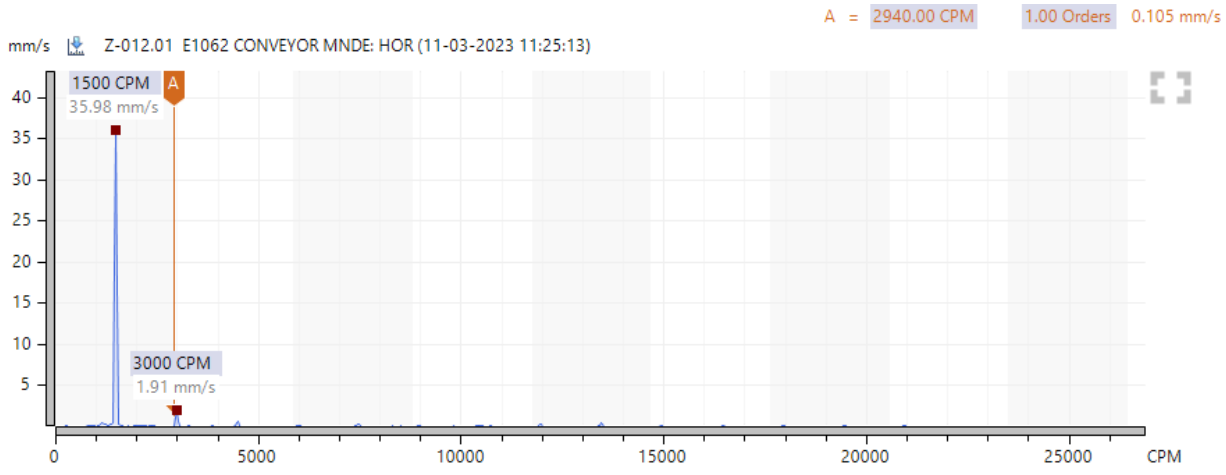
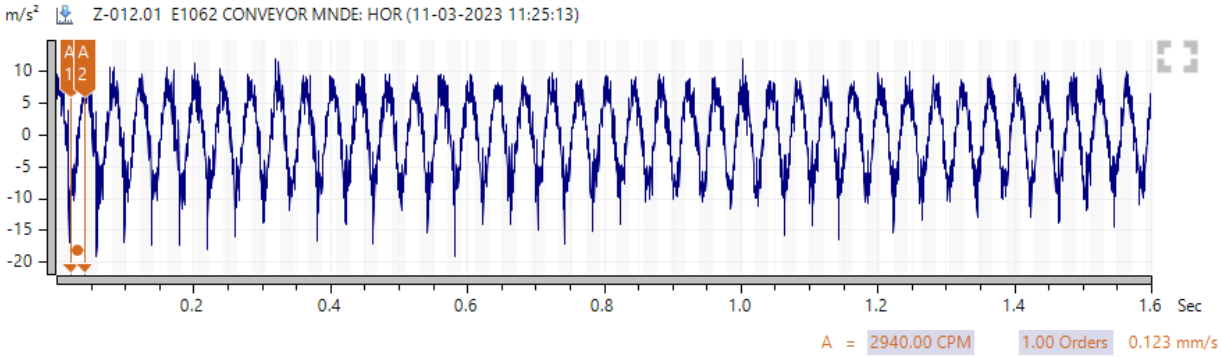
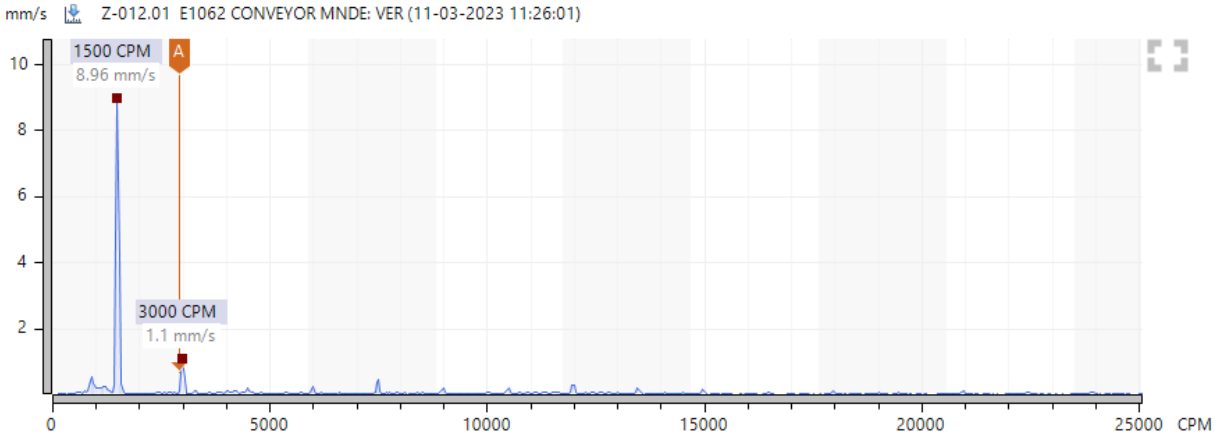
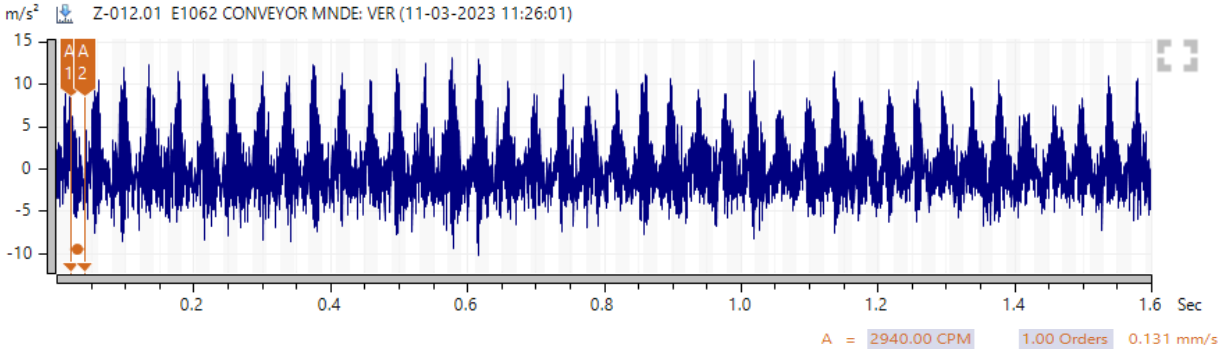
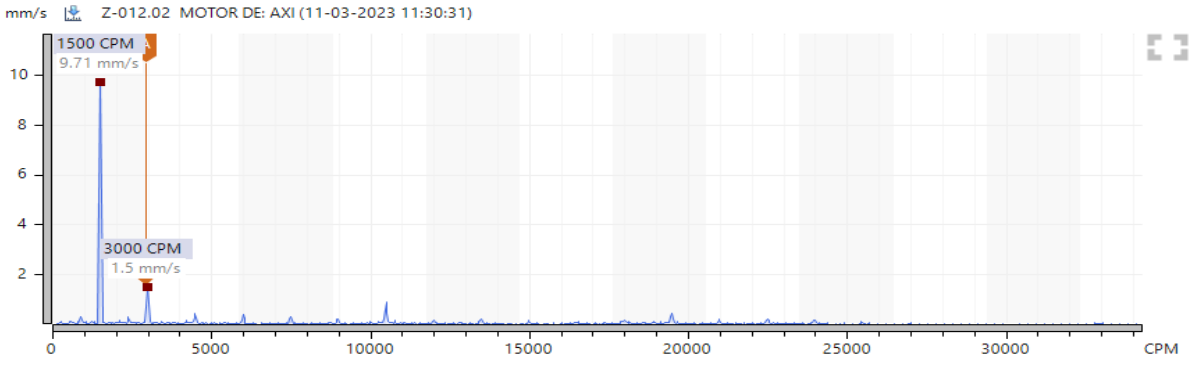
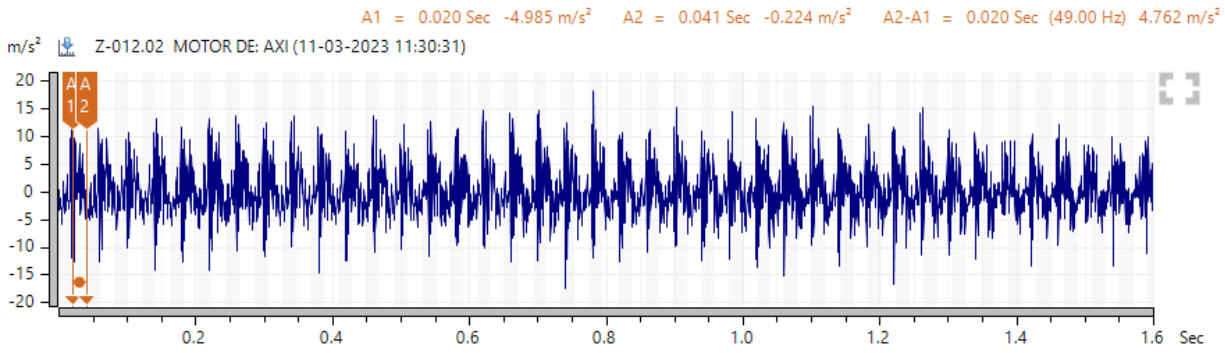
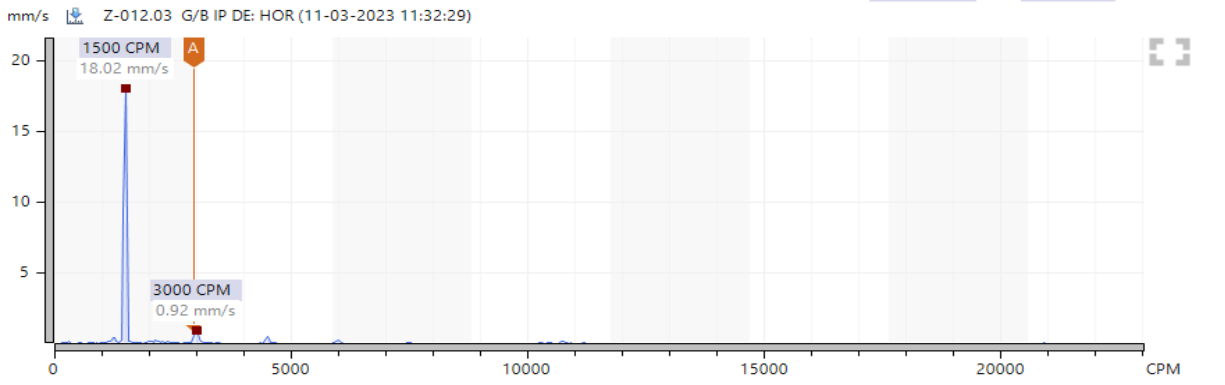
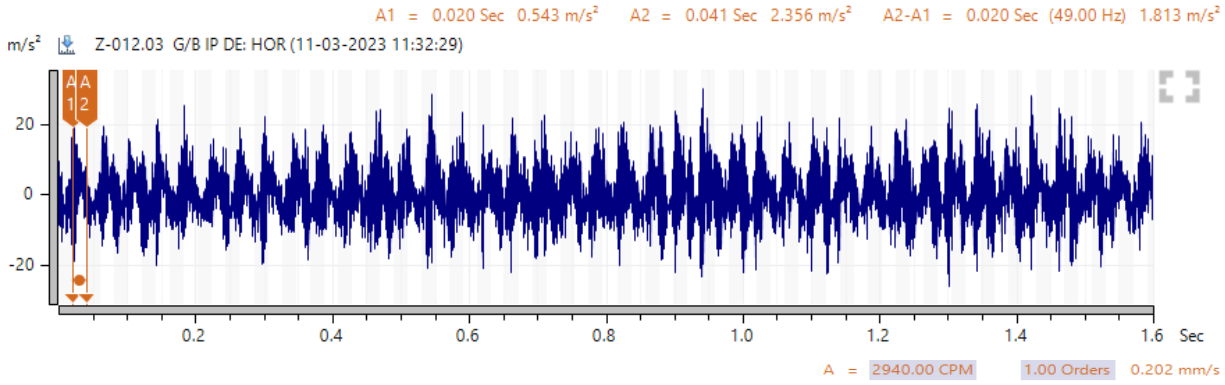
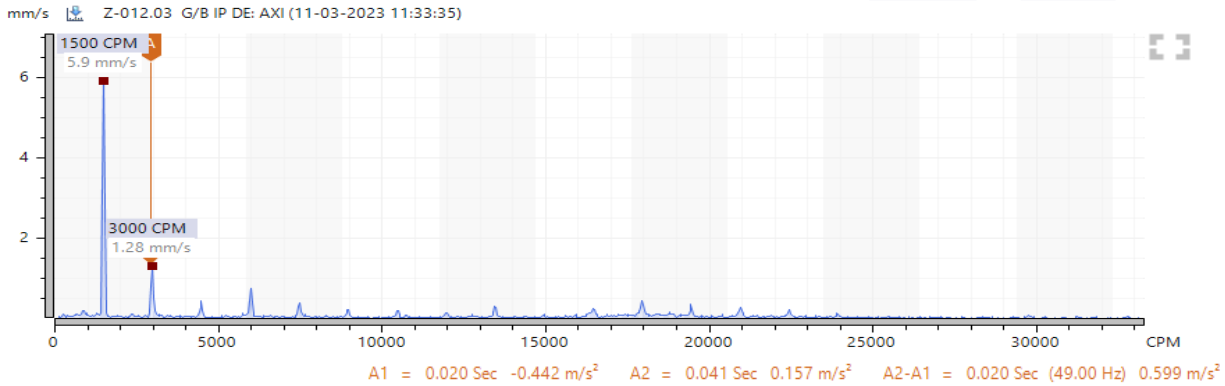
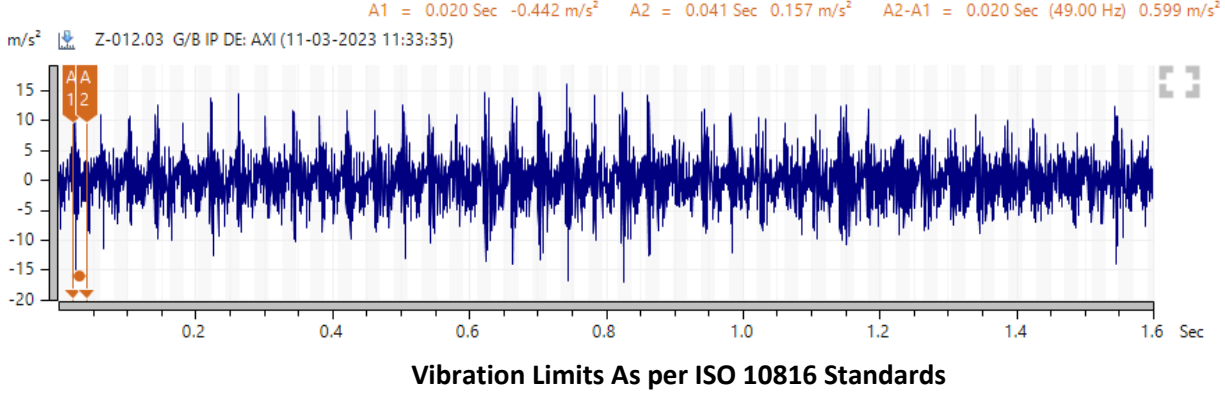
Analysis: The vibration spectrum generating dominating 1X (1500 CPM) and minor 2X, peak which indicates Symptoms of misalignment/ Fluid coupling unbalance.

1. Review the alignment between motor to gearbox. If vibration is not reduce then
2. Check the fluid coupling for any unbalance/abnormalities.
