REFLEX - GYRO QUALITY CHECK REPORT

Project ID: fd

Borehole ID: fds

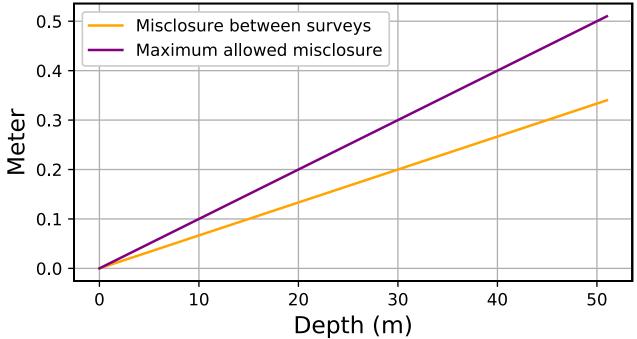
Depth	Misclosure	Misclosure %	Quality
51	0.34	0.67	Passed
