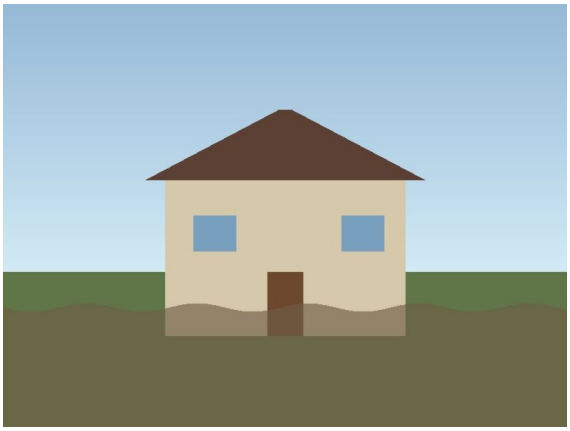
123 River Street

75.0%

Substantially Damaged

Date of Assessment	09/21/2026	Date of Damage	09/14/2026
Inspector Name	Inspector A	Cause of Damage	Flood
Inspector Phone	(555) 555-0100	Duration of Flood	2 Days
Residence Information	Brick ranch, attached one-car garage.	Est. Depth of Flood Above Lowest Floor	4.25

Replacement Cost	$170,434.38	Computed Damages	$96,900.46
Depreciation %	24.2%	Percent of Existing Improvements and Repairs Pre-Disaster	
Computed Actual Cash Value*	$129,189.26	Repair/Reconstruction %	75.0%
Other Depreciation Explanation

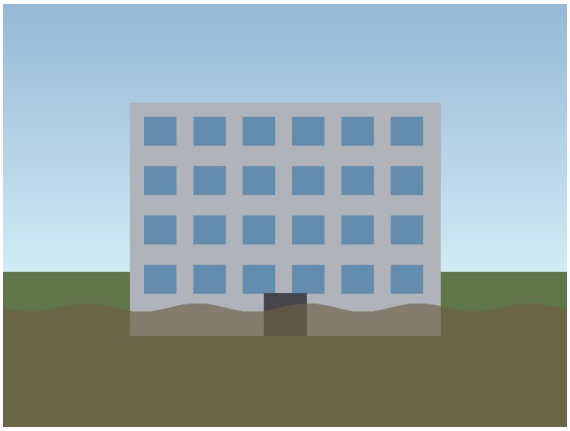
400 Front Street

51.6%

Substantially Damaged

Date of Assessment	09/22/2026	Date of Damage	09/14/2026
Inspector Name	R. Inspector	Cause of Damage	Flood
Inspector Phone		Duration of Flood	3 Days
Structure Information	Three-story steel frame office.	Est. Depth of Flood Above Lowest Floor	2.50

Replacement Cost	$1,851,400.00	Computed Damages	$656,876.72
Depreciation %	31.3%	Percent of Existing Improvements and Repairs Pre-Disaster	
Computed Actual Cash Value*	$1,271,911.80	Repair/Reconstruction %	51.6%
Other Depreciation Explanation
