## Assessment of Salt weathering in Siwa Oasis (The Western Desert of Egypt)

# Azza Abdallah

Bull. De la soc. De Geog. De Egypt, 2007

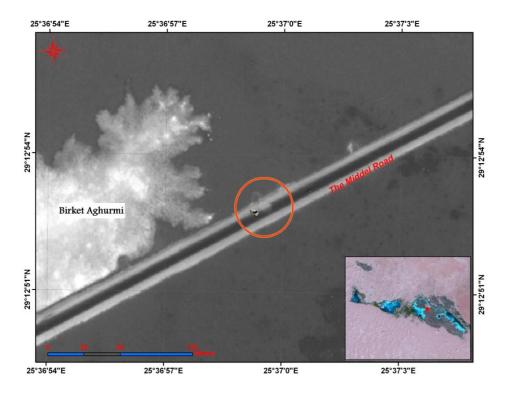
Surfaced roads in Siwa oasis show signs of damage as falling downs in terms of cracking, potholing, scabbing, stripping, crumbling and disintegration. This damage is apparent because saline ground water is near the surface, some roads crossing the saline lakes (Fig.5 and Plate 9) Such as the middle road crossing Lake Aghurmi, lake El Zeitun, and abundant soluble salts occur on the ground surface and in the soil. (Plate 10).

Figure (5): Location of middle road crosses Lake Aghurmi

The deterioration in the roads in Siwa Oasis is due to the use of poor coarse or fine aggregate, lack of quality control and poor workmanship. Also, break-up in roads may also be due to thermal cracking (Obika et. al., 1992).

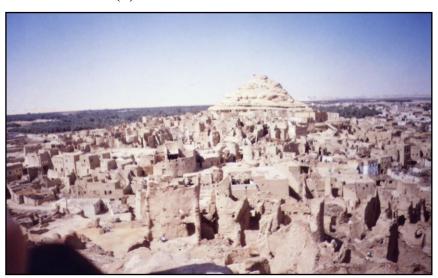
Plate (2): G. El Kosha

Plate (6): Efflorences, Granular disintegration, Tafoni and Flaking in old Shalley City

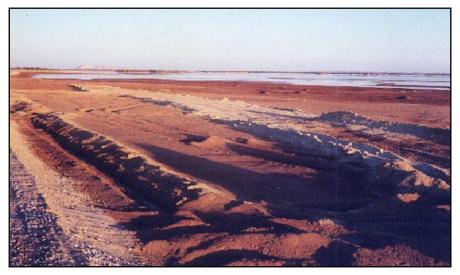
These may simply represent an early stage in the development of a black gypsum crust. Some experiments have shown that these thinner crusts can form as a relatively dense surface covering the contrasts the surface with subsequent black crusts that tend to have an open structure of interlocking. (Plate 7) (Ibid, 2005).

Plate (7): Black and grey crust near Birket Zeitun

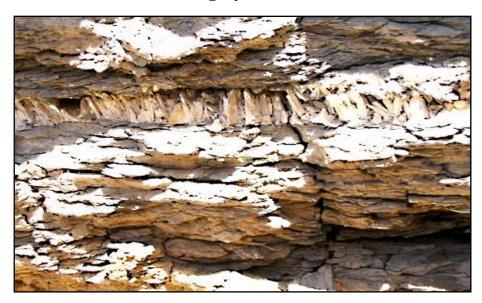
The most remarkable landscapes features in the Oasis represented in the saline lakes surrounded by marshes then by salinas and at the outer margins by sabkhas occupying the lowest parts formulating the probable source for "Korshf" which is the local building material. However, during rainy storms, this crust becomes very weak since salt is dissolved by rain water. (Embabi,2004). By this action and by salt weathering activities houses were destroyed several times during the long history of Siwa (Plate 8).

Plate (8): Salt weathering action in' Korshf"
