Alert

Unit ID: **4RK1** Asset ID: **51081631**

Description: **Kiln 2 Drive pinion gear**

Name: **Greer Lime**

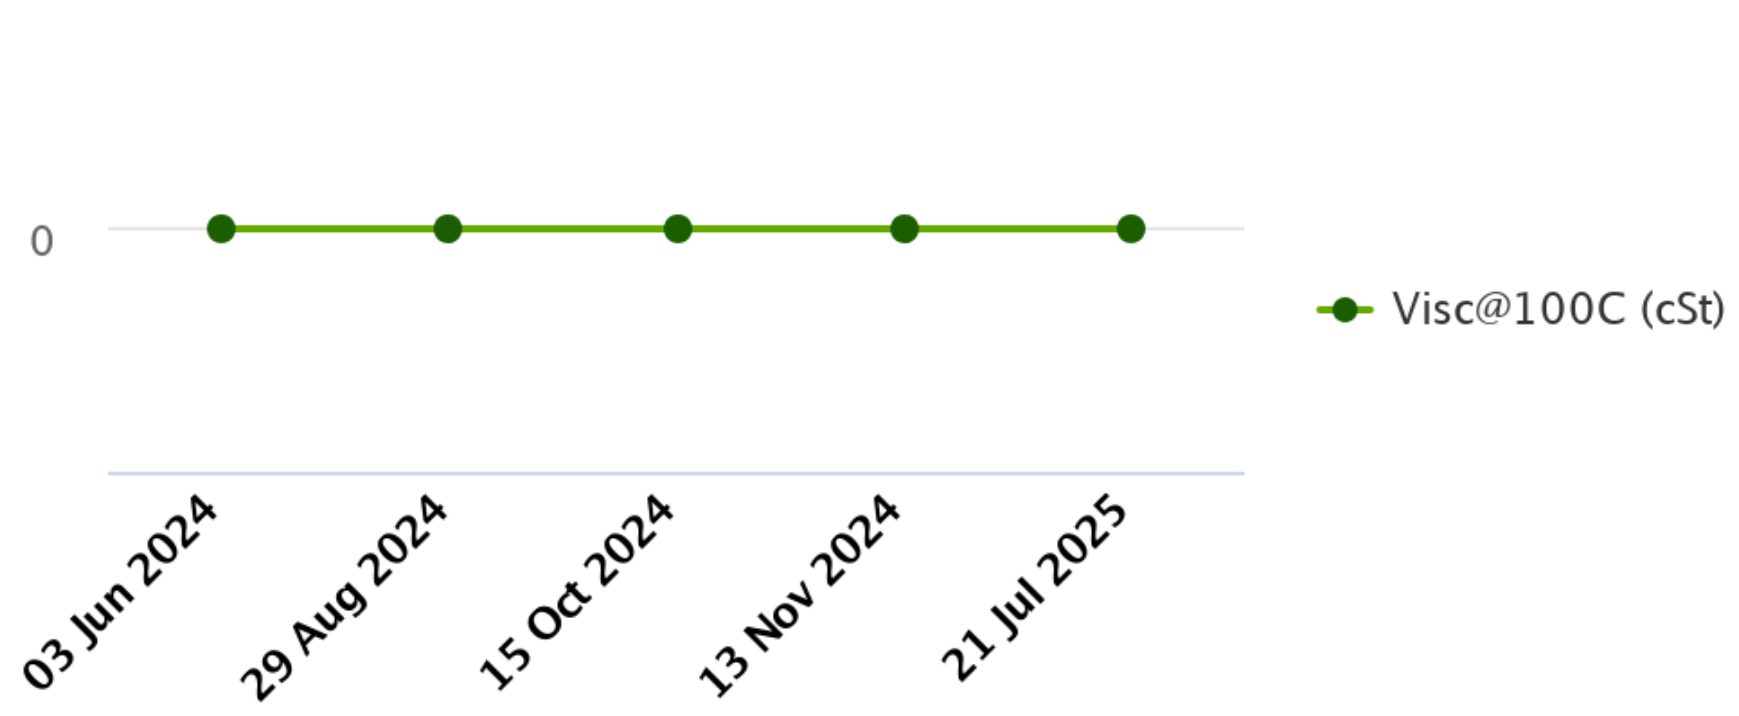
Viscosity

ACTION REQUIRED – EXCESSIVE CONTAMINATION. Due to the nature or condition of the sample, viscosity could not be performed. Oil samples that contain significant amounts of contaminants (i.e. water, fuel, coolant) and/or insolubles (i.e. soot, glycol) do not comply with the operating limitations of the laboratory equipment responsible for conducting viscosity tests. Before sending future samples to the laboratory, please ensure that no signs of excessive visible contamination are present. Oil samples should not be collected from the bottoms of a filter unit, tank, or crankcase due to the heavy concentrations of sediment that can deposit in these areas (resulting in a sample that is not representative of the system). Contact your ExxonMobil representative for further assistance.

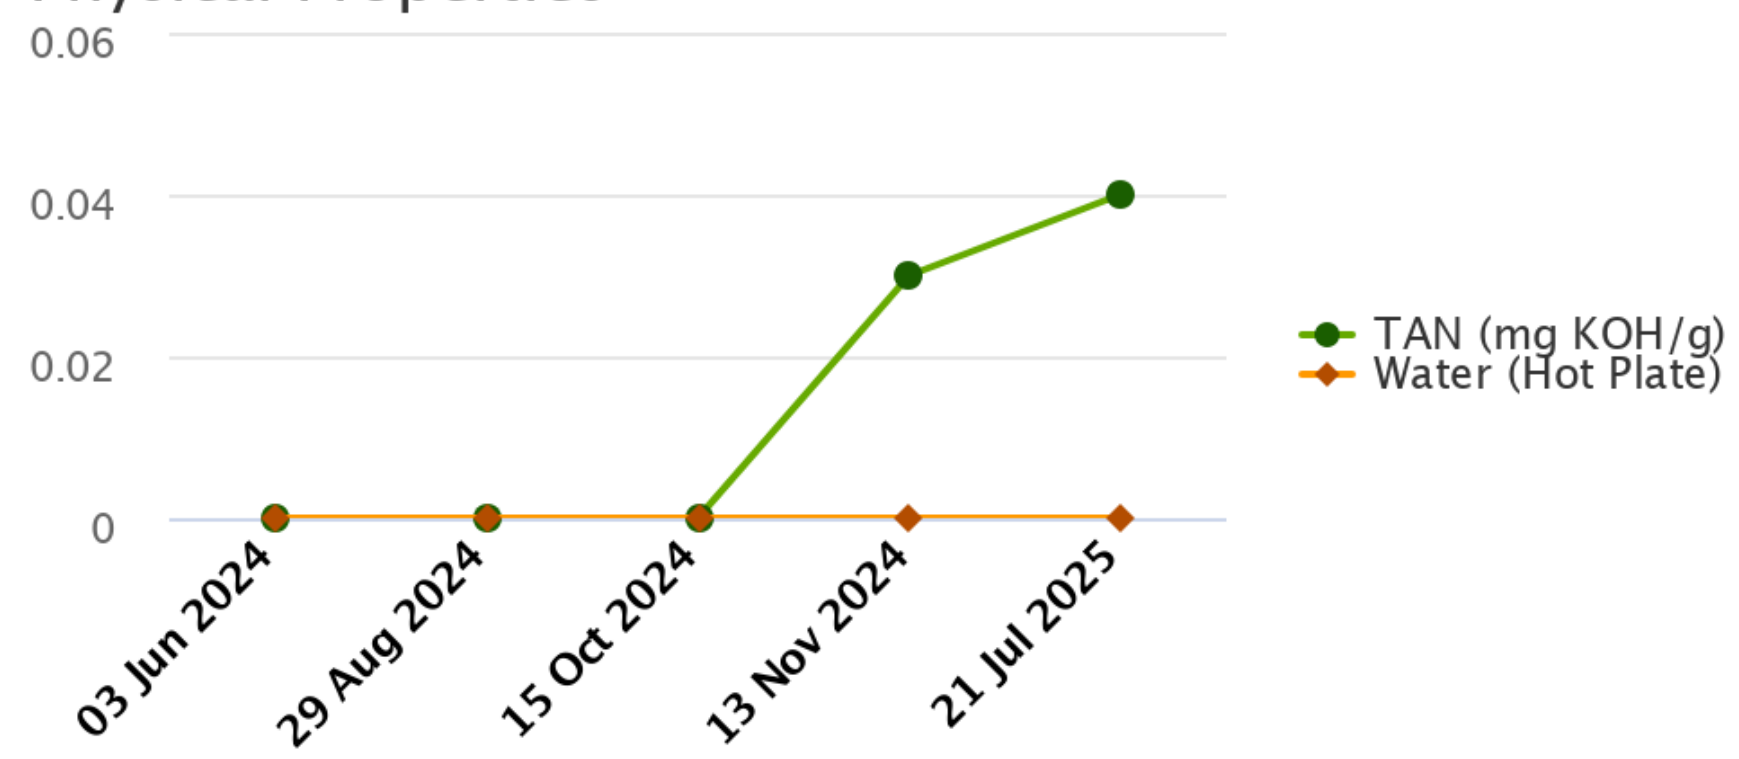
Physical Properties

ACTION REQUIRED - EXCESSIVE WATER CONTAMINATION. Determine source of water and take corrective action. Analyze the oil with an on-site water test if accessible. Possible sources of water include: a. Leaking seals; b. Condensation resulting from low operating temperatures or prolonged shutdowns; c. Compromised oil cooler; d. Direct exposure to atmosphere as a result of compromises to system components (i.e. improperly sealed tank fill access point). Remove water from oil using centrifuges or dehydration units, or drain the oil and recharge the system with new oil. Resample the system after corrective measures have been implemented. Contact your ExxonMobil representative for further
