Alert

Unit ID: **11-BM-1 lube pump** Asset ID: **50074736**

Description: **Fine Grinding Bradley Mill**

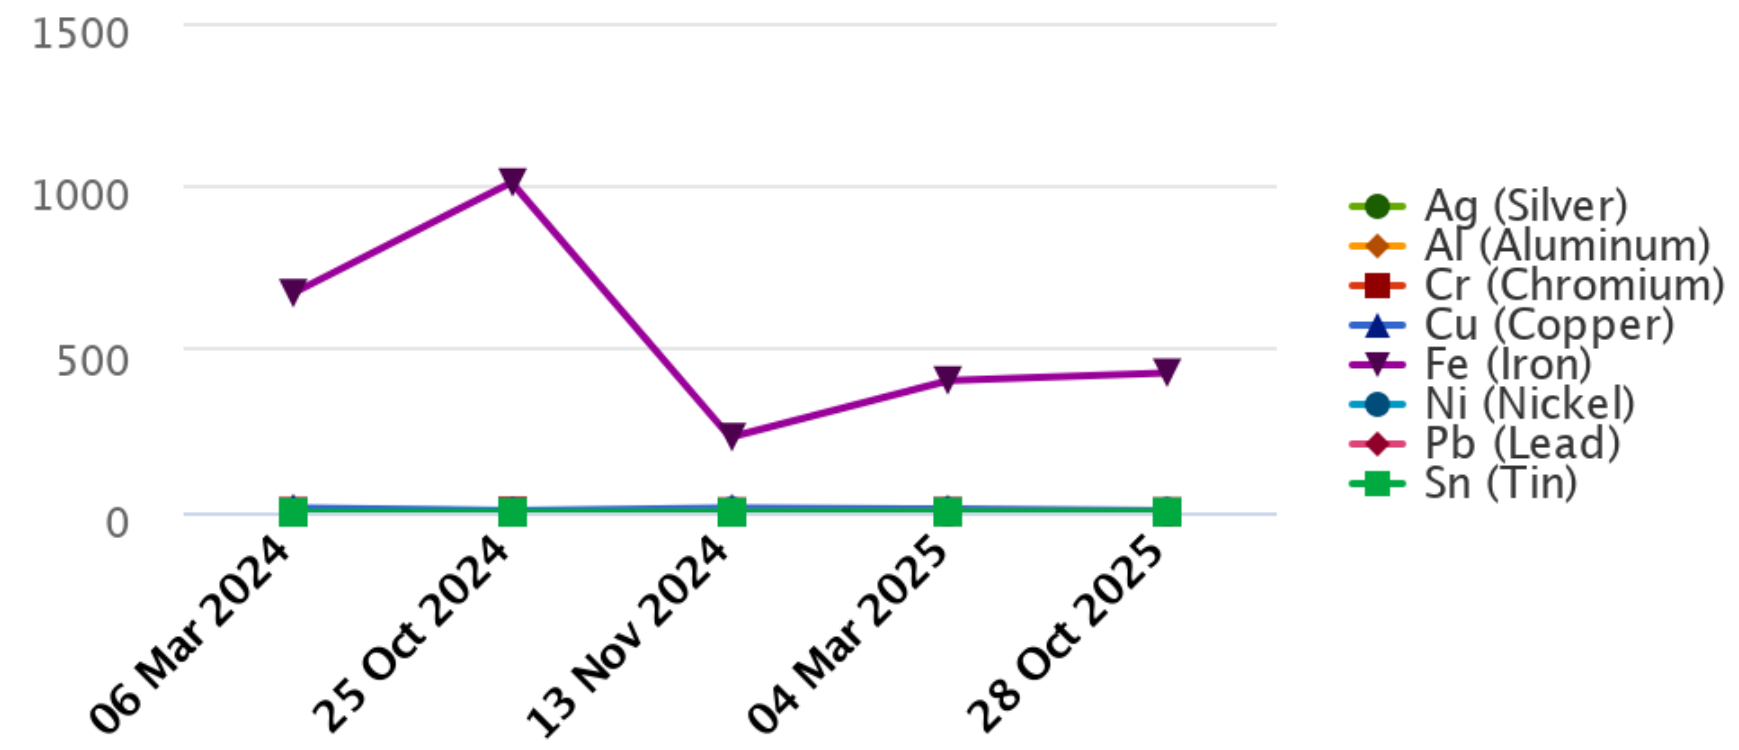
Wear (ppm)	Ag (Silver)	0	0	0	0	0
	Al (Aluminum)	1	1	2	2	1
	Cr (Chromium)	3	4	2	3	2
	Cu (Copper)	14	6	14	11	6
	Fe (Iron)	671	1011	230	404	428
	Mo (Molybdenum)	7	10	2	2	2
	Ni (Nickel)	2	1	4	3	3
	Pb (Lead)	0	0	1	1	1
	Sn (Tin)	0	0	0	1	1
Contaminant (ppm)	K (Potassium)	1	1	1	0	1
	Na (Sodium)	0	1	0	0	3
	Si (Silicon)	4	6	11	21	26
Additive (ppm)	B (Boron)	13	10	16	22	23
	Ba (Barium)	0	0	1	0	0
	Ca (Calcium)	38	44	92	142	81
	Mg (Magnesium)	0	0	4	4	1
	P (Phosphorus)	336	232	294	308	307
	Zn (Zinc)	141	75	20	33	42

ACTION REQUIRED - EXCESSIVE IRON LEVEL. Determine source of Iron (Fe) and take corrective action. If the iron level is excessive for the first time with no history of an increasing trend, then resample immediately to confirm condition. The oil and filter are unfit for continued use. Change the filter immediately and either centrifuge or change the oil. Prolonged usage of oil with excessive iron levels can adversely affect product performance and damage the equipment. Contact your ExxonMobil representative for further assistance if necessary.

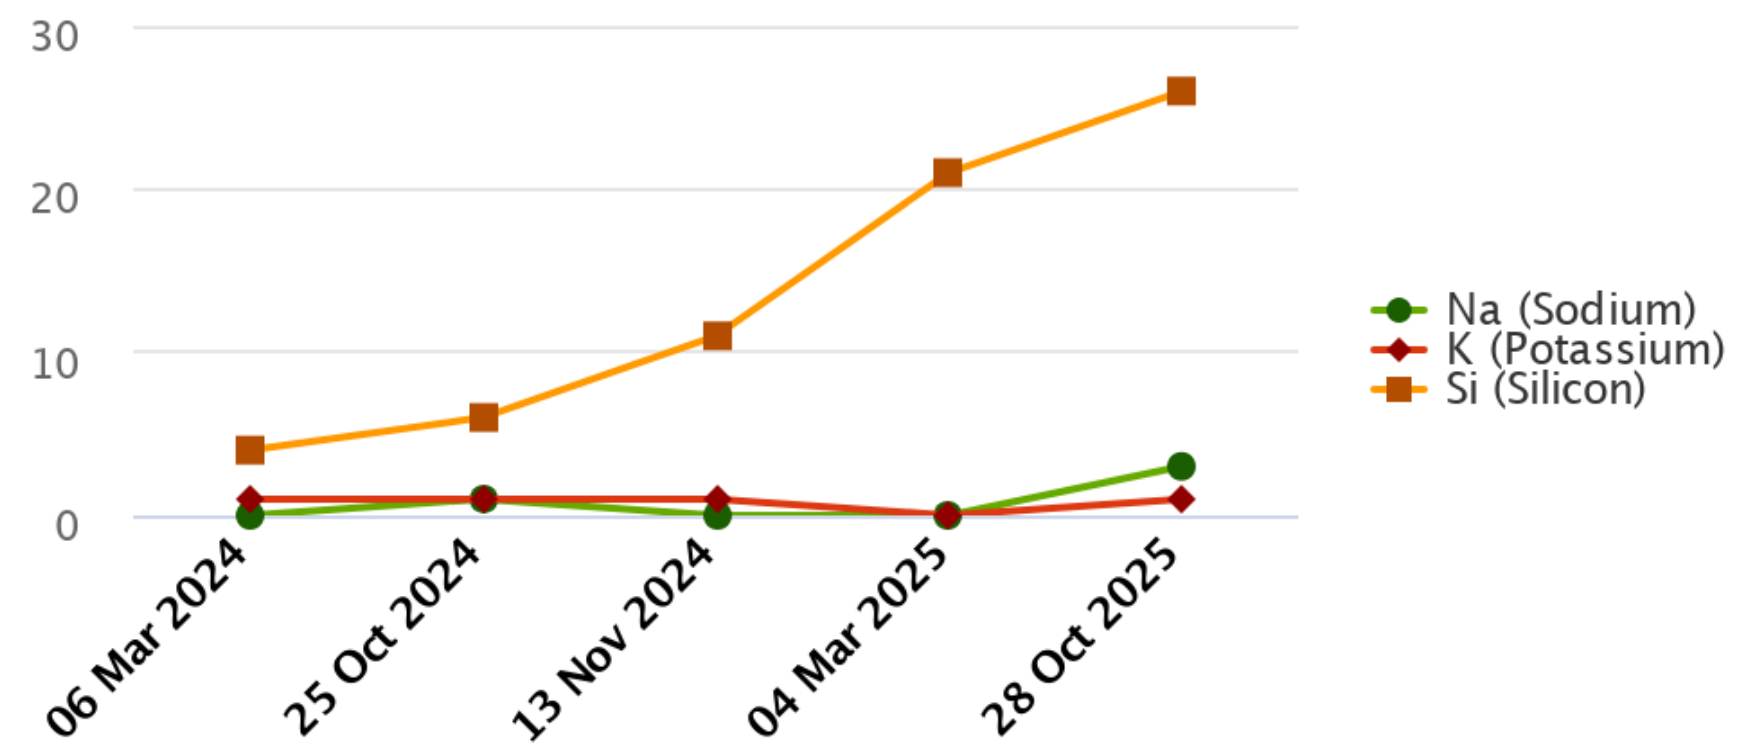
Contaminants

ACTION REQUIRED - ELEVATED SILICON LEVEL. Determine source of Silicon (Si) and take corrective action. If the silicon level is elevated for the first time with no history of an increasing trend, then resample immediately to confirm condition. If the wear metals levels are low, then the silicon likely exists in a non-abrasive form. Possible sources of non-abrasive silicon include: a. Defoamants; b. Sealant compounds. If wear metals levels are elevated, then the silicon likely exists in an abrasive form. Possible sources of abrasive silicon include: a. Abrasive dirt; b. Contamination from environment during an equipment overhaul or shutdown. Other possible sources of silicon include: a. Inefficient or leaking air intake filters; b. Leaking pipes; c. Clogged oil bath air filter; d. Poor oil filtration; e. Dirty sample containers or improper sampling procedures. In landfill gas applications, silicon can enter the engine as a siloxane. This material is a gas and is not normally abrasive; however, siloxanes can easily mask the presence dirt. The oil may be unfit for continued use and should be monitored closely for further condition regressions. Prolonged usage of lubricants with elevated levels of abrasive silicon can cause severe wear and damage to the equipment. Inspect the equipment for signs of excessive wear and change the oil immediately if damage is detected. Contact your ExxonMobil representative for further assistance if necessary.
