Alert	
Unit ID: **2-VS-1 Upper**	Asset ID: **50254146**
Description: **2-VS-1 upper**

ID: **402009**
Name: **Greer Lime**
Address: **1088 Germany Valley Limestone Road, Riverton, WV 26814-0000 US**
Parent Account: **MATTHEWS LUBRICANTS, INC.**

Sample ID: **25069376060**
Service Level: **Essential**
Bottle ID: **a003617376**
Tested Lubricant: **MOBIL SHC 629**

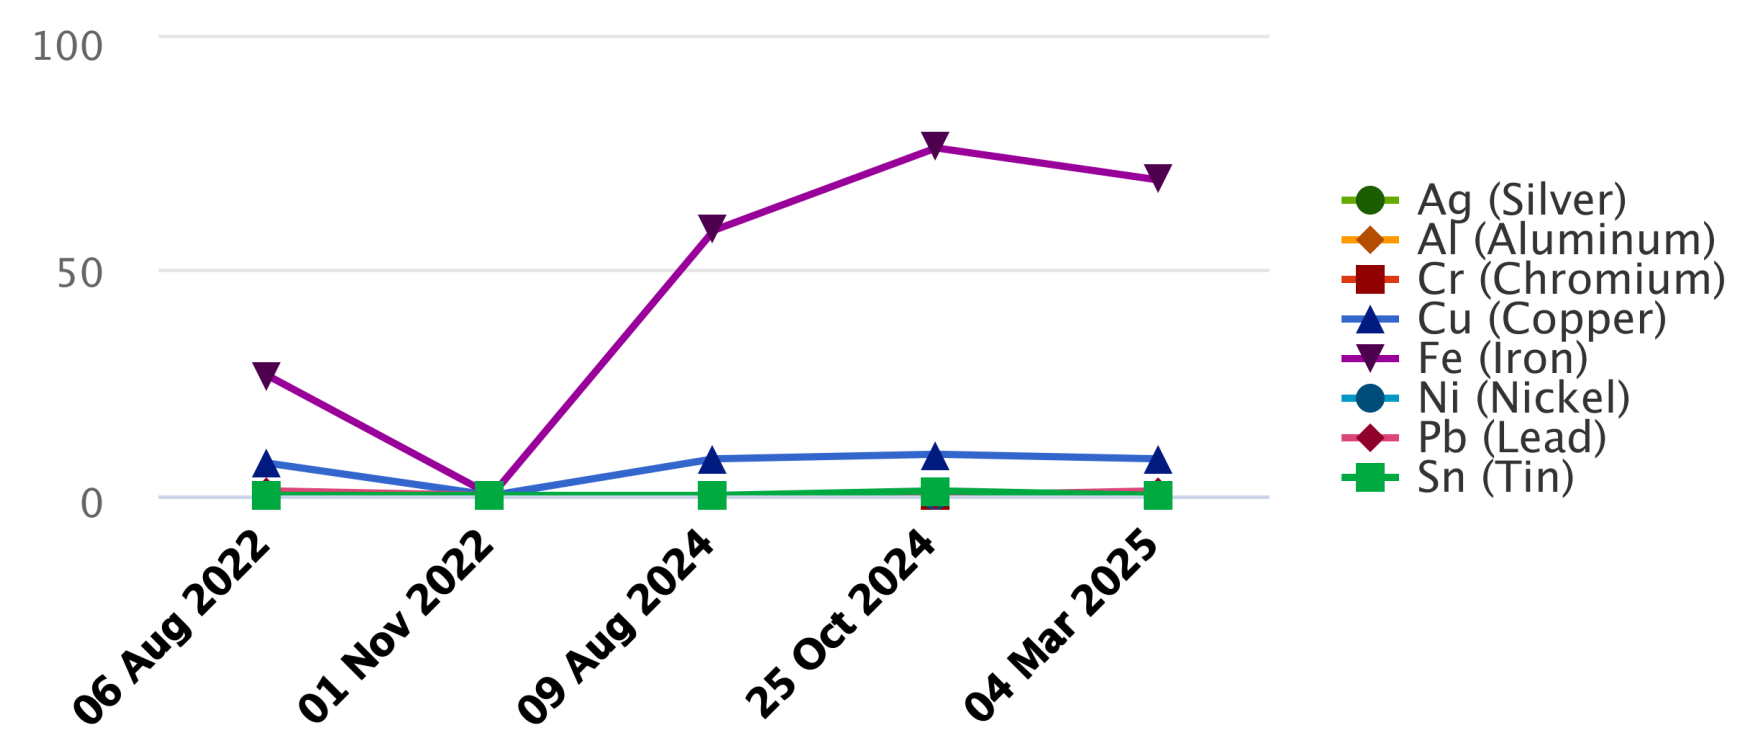
Wear

ACTION REQUIRED - ELEVATED IRON LEVEL. Determine source of Iron (Fe) and take corrective action. If the iron level is elevated for the first time with no history of an increasing trend, then resample immediately to confirm condition. Possible sources of iron include: a. Machinery component wear; b. Metal-to-metal contact; c. Corrosion; d. Abrasive dirt contamination. The oil may be unfit for continued use and should be closely monitored for further condition regressions. Inspect the equipment for signs of damage. Change the oil after corrective measures have been implemented. Contact your ExxonMobil representative for further assistance if necessary.

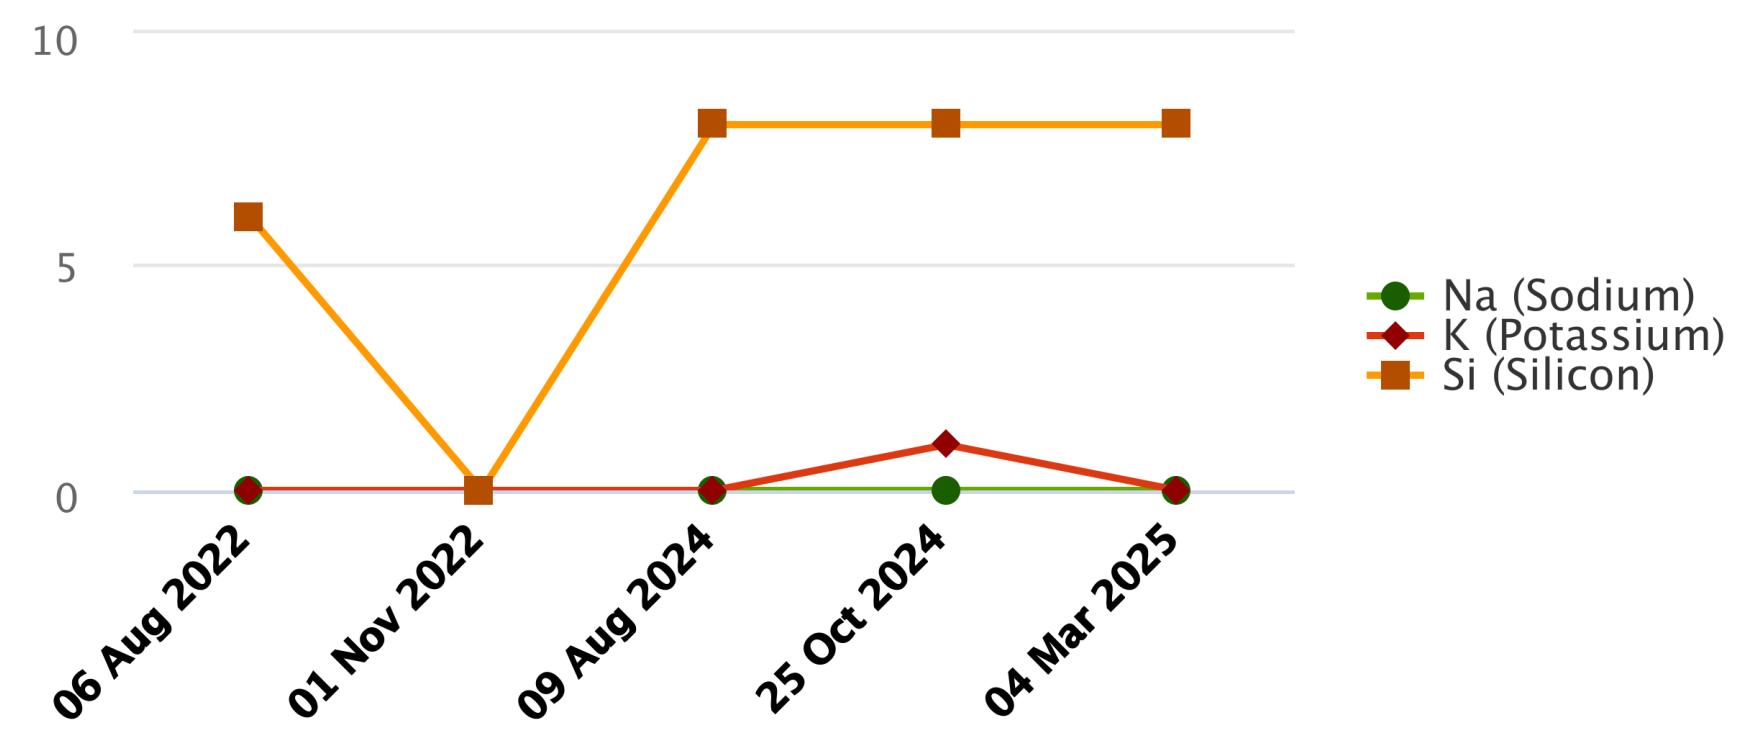
Contaminants

ACTION REQUIRED - EXCESSIVE WATER CONTAMINATION. Determine source of water and take corrective action. Analyze the oil with an on-site water test if accessible. Possible sources of water include: a. Leaking seals; b. Condensation resulting from low operating temperatures or prolonged shutdowns; c. Compromised oil cooler; d. Direct exposure to atmosphere as a result of compromises to system components (i.e. improperly sealed tank fill access point). Remove water from oil using centrifuges or dehydration units, or drain the oil and recharge the system with new oil. Resample the system after corrective measures have been implemented. Contact your ExxonMobil representative for further assistance if necessary.
