Mobil™

Unit ID: **1212**

Asset ID: **51414376**

Description: **front diff**

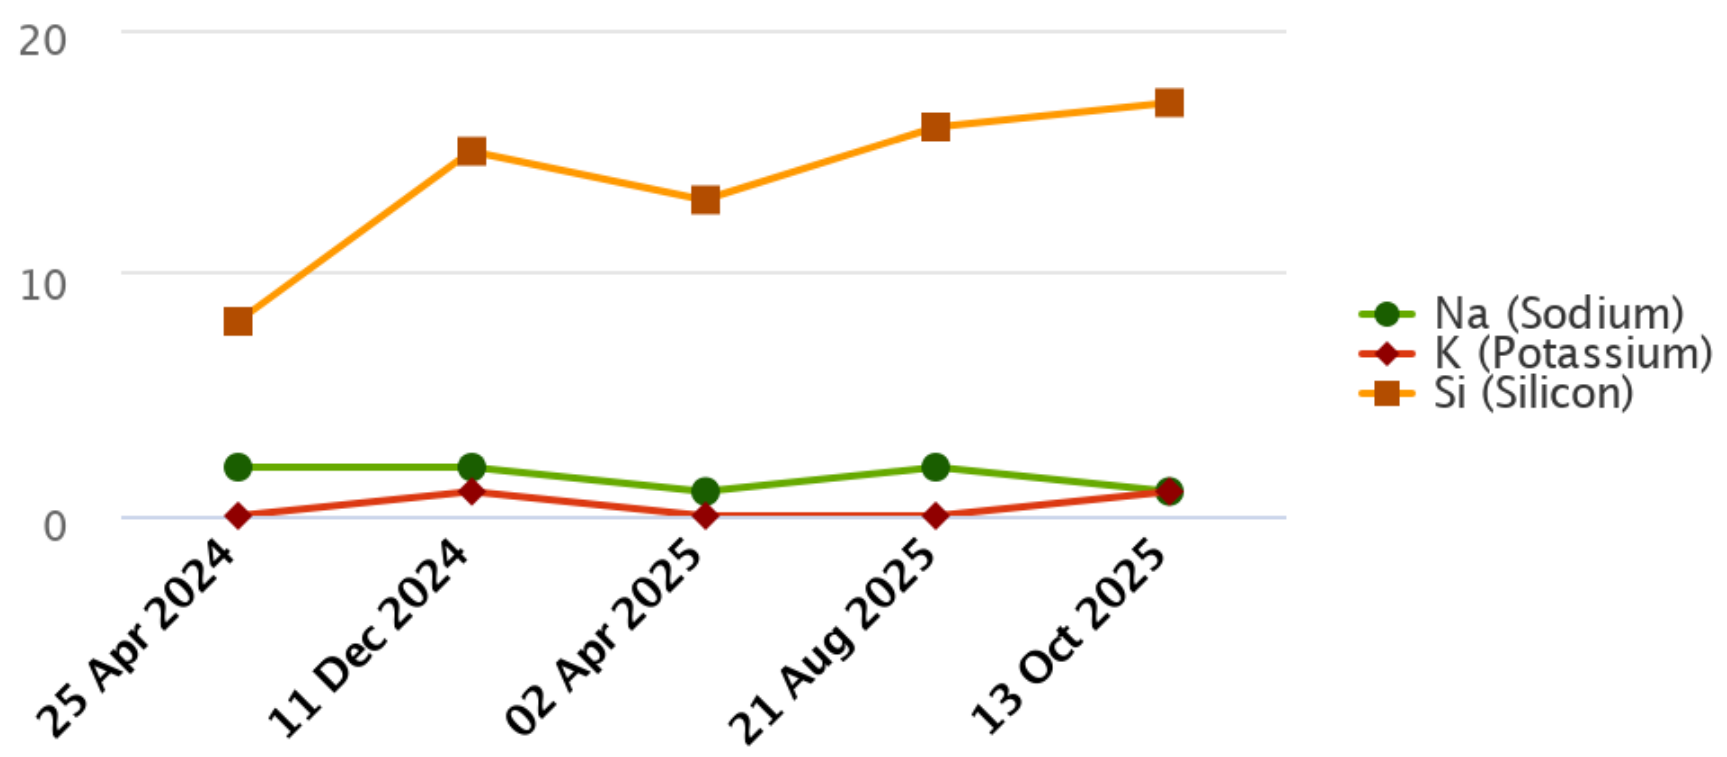
Contaminants

CAUTION - ELEVATED SILICON LEVEL. Determine source of Silicon (Si) and take corrective action. If the silicon level is elevated for the first time with no history of an increasing trend, then resample immediately to confirm condition. If wear metals levels are low, then the silicon likely exists in a non-abrasive form. Possible sources of non-abrasive silicon include: a. Defoamants; b. Sealant compounds. If wear metal levels are elevated, then the silicon likely exists in an abrasive form. Possible sources of abrasive silicon include: a. Abrasive dirt remaining in equipment due to ineffective purification and / or filtration; b. Faulty seals, breather, fill caps; c. Improper sampling techniques that result in dirt contaminating the sample. The oil may be unfit for continued use and should be monitored closely for further condition regressions. Prolonged usage of lubricants with elevated levels of abrasive silicon can cause severe wear and damage to the equipment. Inspect the equipment for signs of excessive wear. Change the oil immediately if the condition escalates. Contact your ExxonMobil representative for further assistance if necessary.
