Alert

Unit ID: 4-RK-2

Description: Kiln 1Drive Primary Gear Box

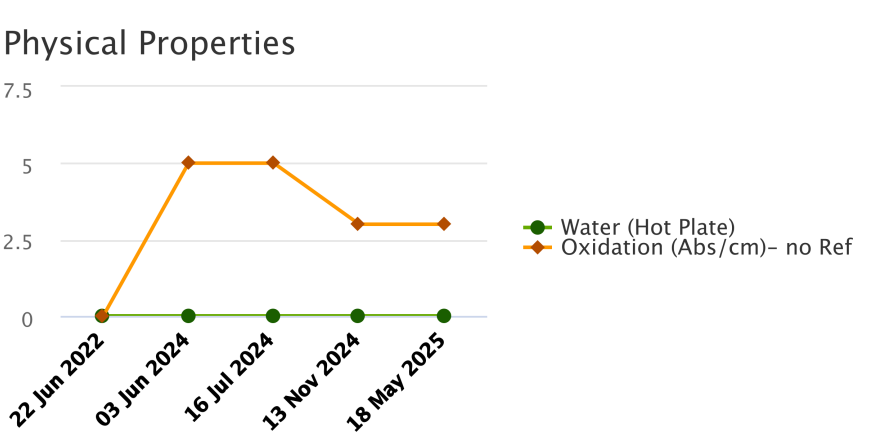
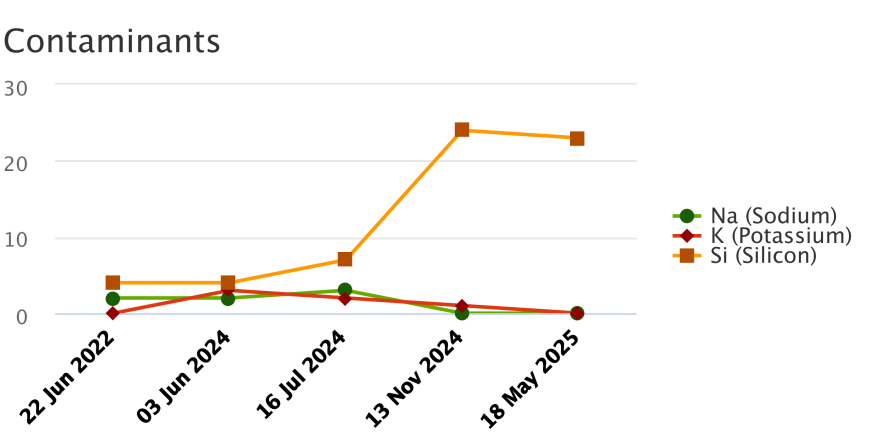
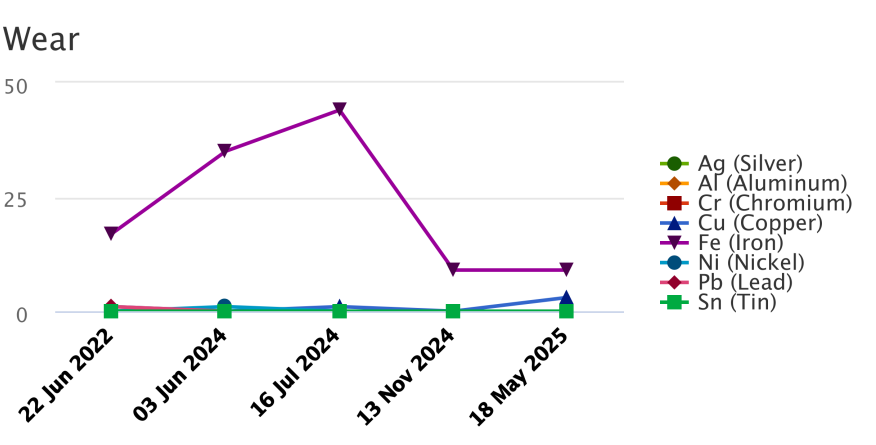
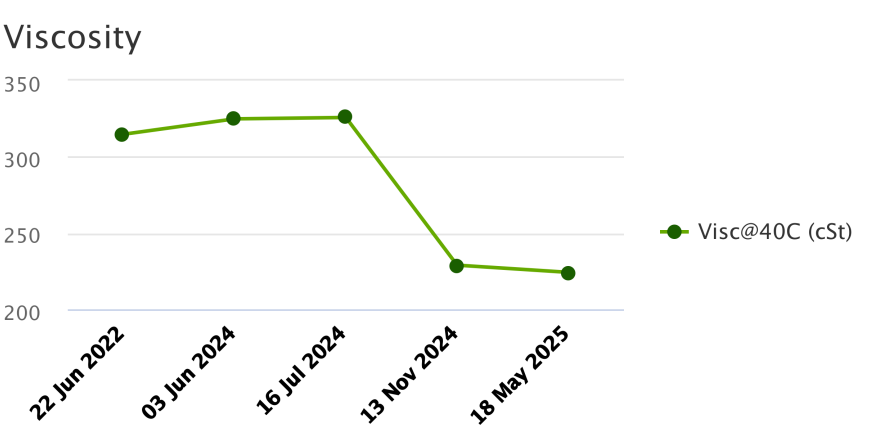
Sample Data & Trends

ACTION REQUIRED - ELEVATED SILICON LEVEL. Determine source of Silicon (Si) and take corrective action. If the silicon level is elevated for the first time with no history of an increasing trend, then resample immediately to confirm condition. If the wear metals levels are low, then the silicon likely exists in a non-abrasive form. Possible sources of non-abrasive silicon include: a. Defoamants; b. Sealant compounds. If wear metals levels are elevated, then the silicon likely exists in an abrasive form. Possible sources of abrasive silicon include: a. Abrasive dirt; b. Contamination from environment during an equipment overhaul or shutdown. Other possible sources of silicon include: a. Inefficient or leaking air intake filters; b. Leaking pipes; c. Clogged oil bath air filter; d. Poor oil filtration; e. Dirty sample containers or improper sampling procedures. In landfill gas applications, silicon can enter the engine as a siloxane. This material is a gas and is not normally abrasive; however, siloxanes can easily mask the presence dirt. The oil may be unfit for continued use and should be monitored closely for further condition regressions. Prolonged usage of lubricants with elevated levels of abrasive silicon can cause severe wear and damage to the equipment. Inspect the equipment for signs of excessive wear and change the oil immediately if damage is detected. Contact your ExxonMobil representative for further assistance if necessary.

ACTION REQUIRED - REDUCED OIL VISCOSITY. Determine cause of reduced oil viscosity and take corrective action. Oil contamination with fuel is the most frequent cause of reduced oil viscosity. If fuel is not detected in the oil or if the system is not an engine, possible causes of reduced viscosity include: a. Contact with oil that has a lower viscosity; b. Contamination with a hydraulic fluid or automatic transmission oil; c. Incorrectly labeled sample. Inspect the system for signs of fuel or coolant ingress. Resample the oil after corrective actions have been implemented. If the condition continues or escalates, recharge the system with new oil. Contact your ExxonMobil representative for further assistance if necessary.

ACTION REQUIRED - UNSATISFACTORY OIL CONDITION. Test results indicate that the condition of this oil sample is unsatisfactory. The oil may be unfit for continued use and should be closely monitored further condition regressions. Contact your ExxonMobil representative for further assistance if necessary.
