Mobil<sup>TM</sup>

Unit ID: 5-BM-1

Description: Kiln 2 Ball Mil Discharge End Bearing

Alert

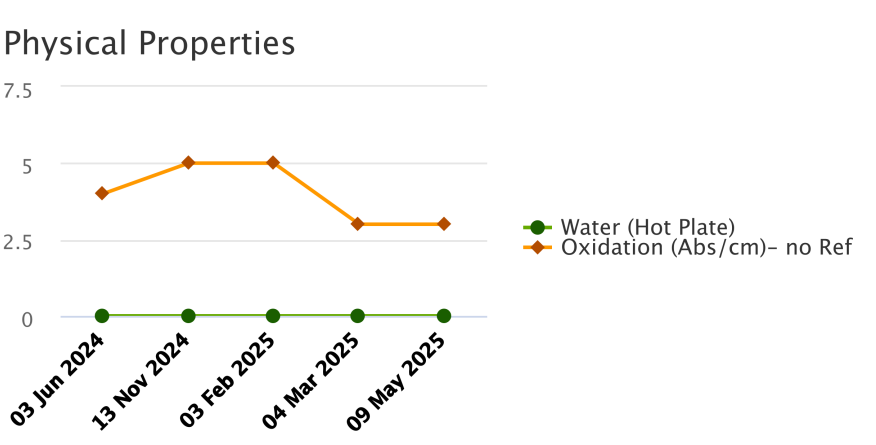
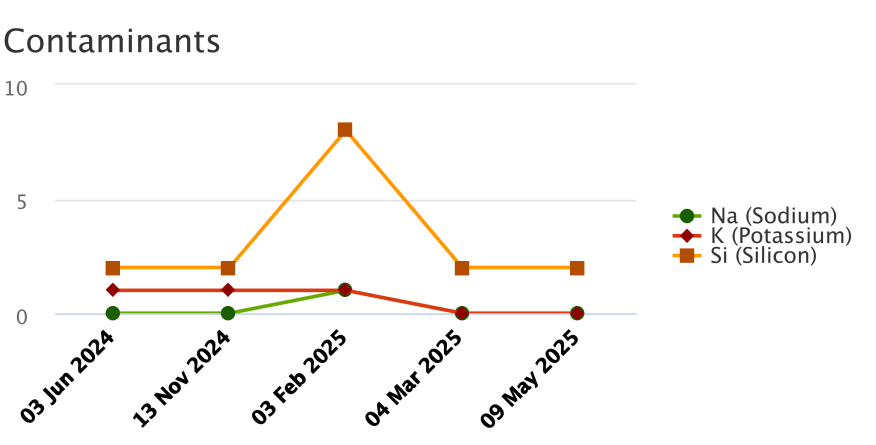
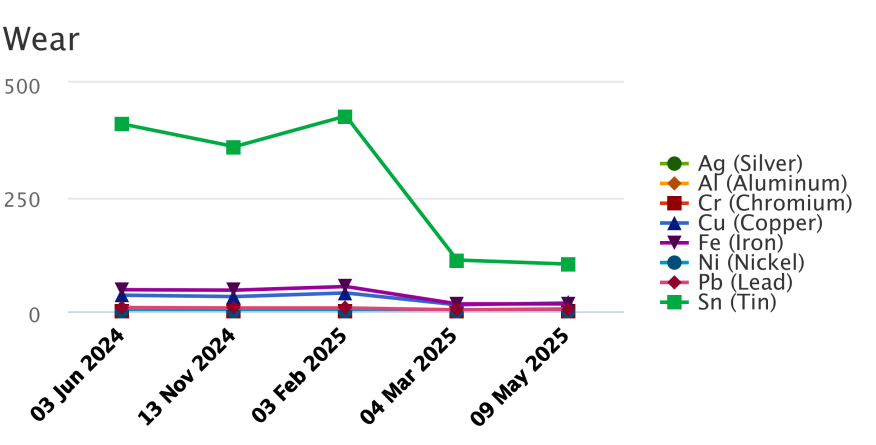
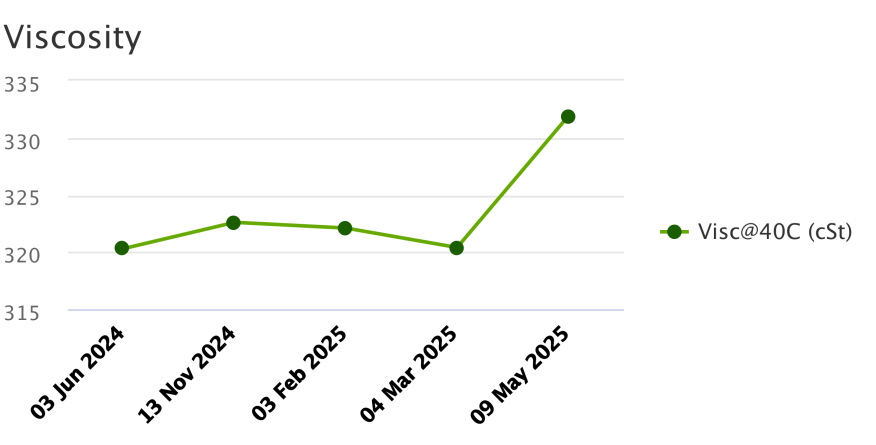
| | Cu (Copper) | 35 | 32 | 40 | 14 | 18 |
| | Fe (Iron) | 47 | 46 | 54 | 16 | 16 |
| | Sn (Tin) | 409 | 360 | 427 | 112 | 103 |

ACTION REQUIRED - EXCESSIVE WEAR METALS LEVELS. Determine cause of excessive wear metals levels and take corrective action. Possible causes of excessive wear metals levels include: a. Excessively worn bearings, gears, and / or shafts; b. Equipment fatigue; c. Abrasive dirt. The components suffering from excessive wear are unfit for continued use and should be inspected immediately. Change the oil immediately after corrective actions have been implemented. Contact your ExxonMobil representative for further assistance if necessary.

ACTION REQUIRED - UNSATISFACTORY OIL CONDITION. Test results indicate that the condition of this oil sample is unsatisfactory. The oil may be unfit for continued use and should be closely monitored further condition regressions. Contact your ExxonMobil representative for further assistance if necessary.
