| | Unit ID: 2-vs-1 lower | Asset ID: 50090471 |
| | Description: 2-vs-1 lower | |
| ID: 402009<br>Name: Greer Lime<br>Address: 1088 Germany Valley Limestone Road, Riverton, WV 26814-0000 US<br>Parent Account: MATTHEWS LUBRICANTS, INC. | Sample ID: 25154217074<br>Service Level: Essential<br>Bottle ID: a003624013<br>Tested Lubricant: MOBIL DTE BB | Asset Class: Circulating System<br>Manufacturer:<br>Model:<br>Lubricant: MOBIL DTE BB |

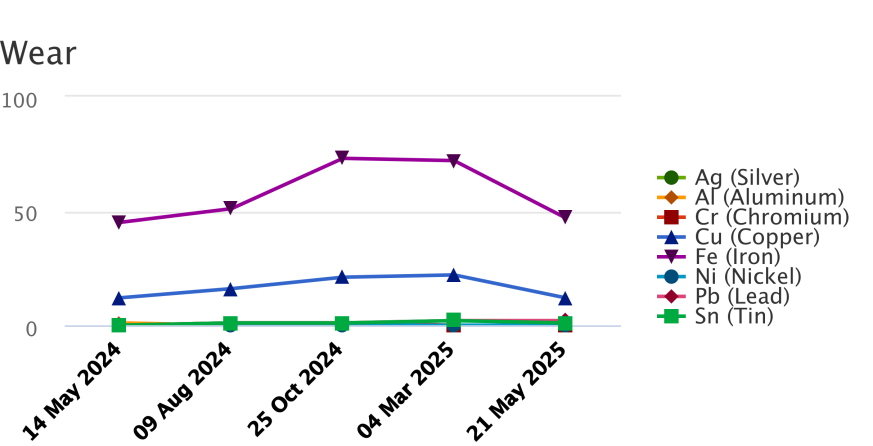
**Wear**

ACTION REQUIRED - ELEVATED IRON LEVEL. Determine source of Iron (Fe) and take corrective action. If the iron level is elevated for the first time with no history of an increasing trend, then resample immediately to confirm condition. Possible sources of iron include: a. Machinery component wear; b. Metal-to-metal contact; c. Corrosion; d. Abrasive dirt contamination. The oil may be unfit for continued use and should be closely monitored for further condition regressions. Inspect the equipment for signs of damage. Change the oil after corrective measures have been implemented. Contact your ExxonMobil representative for further assistance if necessary.
