Sample Data & Trends

Alert	
		Unit ID: 1212	Asset ID: 51414379
		Description: rear diff	
Account Information		Sample Information	Equipment Information
ID: 402009		Sample ID: 25296320033	Asset Class: Gear Drive
Name: Greer Lime		Service Level: Essential	Manufacturer: CATERPILLAR
Address: 1088 Germany Valley Limestone Road, Riverton, WV 26814-0000 US		Bottle ID: a037320411	Model:
Parent Account: MATTHEWS LUBRICANTS, INC.		Tested Lubricant: MOBIL DELVAC MODERN OFF-HIGHWAY TRANS FLUID 50	Lubricant: MOBIL DELVAC MODERN OFF-HIGHWAY TRANS FLUID 50
Continued			
Recommendation/Comments

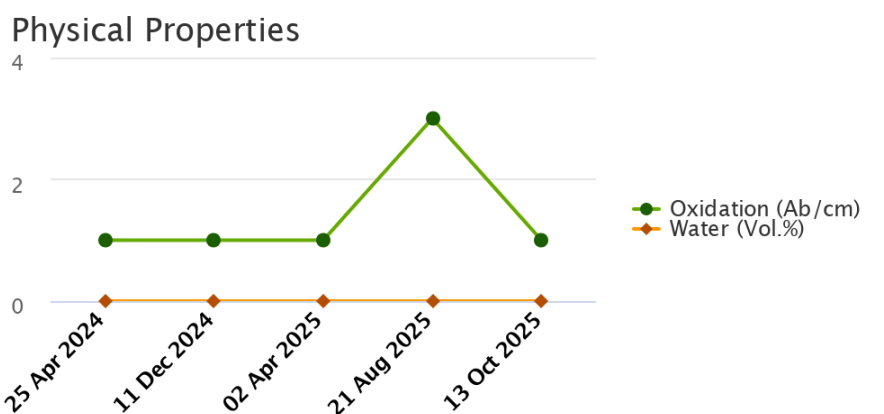
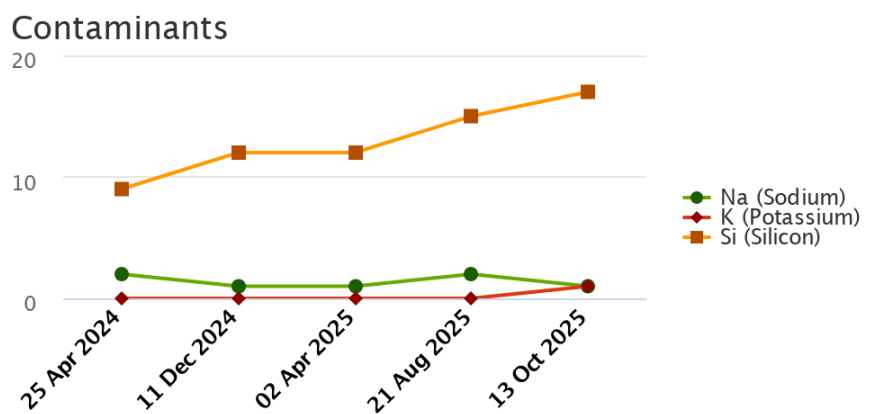
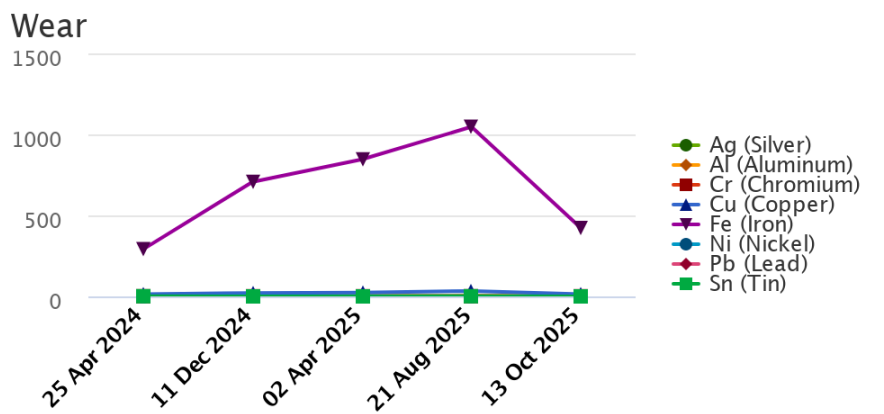
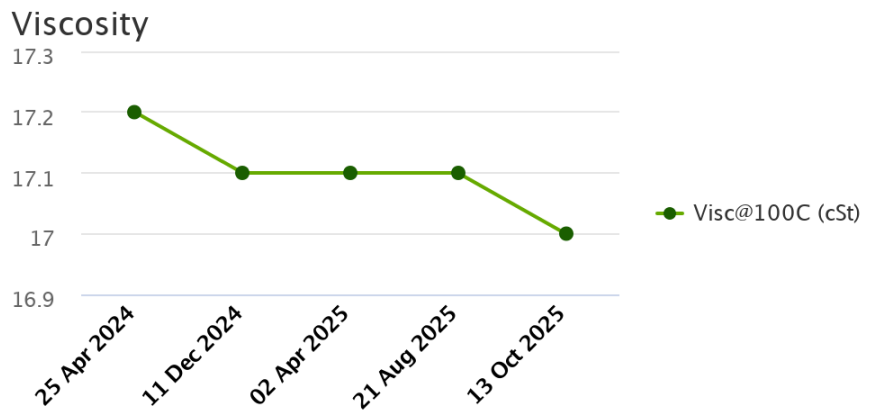
Oxidation (Ab/cm)		1	1	1	3	1
Water (Vol.%)		NotDetected	NotDetected	NotDetected	NotDetected	NotDetected
Wear (ppm)	Ag (Silver)	0	0	0	0	0
	Al (Aluminum)	2	4	4	5	2
	Cr (Chromium)	1	1	1	1	1
	Cu (Copper)	14	21	24	34	14
	Fe (Iron)	291	707	846	1047	422
	Mo (Molybdenum)	0	1	0	1	1
	Ni (Nickel)	0	1	1	1	0
	Pb (Lead)	0	0	0	0	0
	Sn (Tin)	1	0	0	1	0
Contaminant (ppm)	K (Potassium)	0	0	0	0	1
	Na (Sodium)	2	1	1	2	1
	Si (Silicon)	9	12	12	15	17
Additive (ppm)	B (Boron)	1	1	1	2	2
	Ba (Barium)	1	0	0	0	0
	Ca (Calcium)	2961	3050	2851	3192	3598
	Mg (Magnesium)	11	12	11	12	18
	P (Phosphorus)	816	814	797	950	952
	Zn (Zinc)	857	721	713	808	1051

ACTION REQUIRED - ELEVATED IRON LEVEL. Determine source of Iron (Fe) and take corrective action. If the iron level is elevated for the first time with no history of an increasing trend, then resample immediately to confirm condition. Possible sources of iron include: a. Machinery component wear; b. Metal-to-metal contact; c. Corrosion; d. Abrasive dirt contamination. The oil may be unfit for continued use and should be closely monitored for further condition regressions. Inspect the equipment for signs of damage. Change the oil after corrective measures have been implemented. Contact your ExxonMobil representative for further assistance if necessary.

ACTION REQUIRED - EXCESSIVE IRON LEVEL. Determine source of Iron (Fe) and take corrective action. If the iron level is excessive for the first time with no history of an increasing trend, then resample immediately to confirm condition. The oil and filter are unfit for continued use. Change the filter immediately and either centrifuge or change the oil. Prolonged usage of oil with excessive iron levels can adversely affect product performance and damage the equipment. Contact your ExxonMobil representative for further assistance if necessary.

CAUTION - ELEVATED SILICON LEVEL. Determine source of Silicon (Si) and take corrective action. If the silicon level is elevated for the first time with no history of an increasing trend, then resample immediately to confirm condition. If wear metals levels are low, then the silicon likely exists in a non-abrasive form. Possible sources of non-abrasive silicon include: a. Defoamants; b. Sealant compounds. If wear metal levels are elevated, then the silicon likely exists in an abrasive form. Possible sources of abrasive silicon include: a. Abrasive dirt remaining in equipment due to ineffective purification and / or filtration; b. Faulty seals, breather, fill caps; c. Improper sampling techniques that result in dirt contaminating the sample. The oil may be unfit for continued use and should be monitored closely for further condition regressions. Prolonged usage of lubricants with elevated levels of abrasive silicon can cause severe wear and damage to the equipment. Inspect the equipment for signs of excessive wear. Change the oil immediately if the condition escalates. Contact your ExxonMobil representative for further assistance if necessary.
