Sample Data & Trends

Caution	
	Unit ID: 1212	Asset ID: 51414380
	Description: left front final drive	
Account Information	Sample Information	Equipment Information
ID: 402009 Name: Greer Lime Address: 1088 Germany Valley Limestone Road, Riverton, WV 26814-0000 US Parent Account: MATTHEWS LUBRICANTS, INC.	Sample ID: 25296320035 Service Level: Essential Bottle ID: a037321130 Tested Lubricant: MOBIL DELVAC MODERN OFF-HIGHWAY TRANS FLUID 50	Asset Class: Gear Drive Manufacturer: CATERPILLAR Model: Lubricant: MOBIL DELVAC MODERN OFF-HIGHWAY TRANS FLUID 50
Continued		
Recommendation/Comments

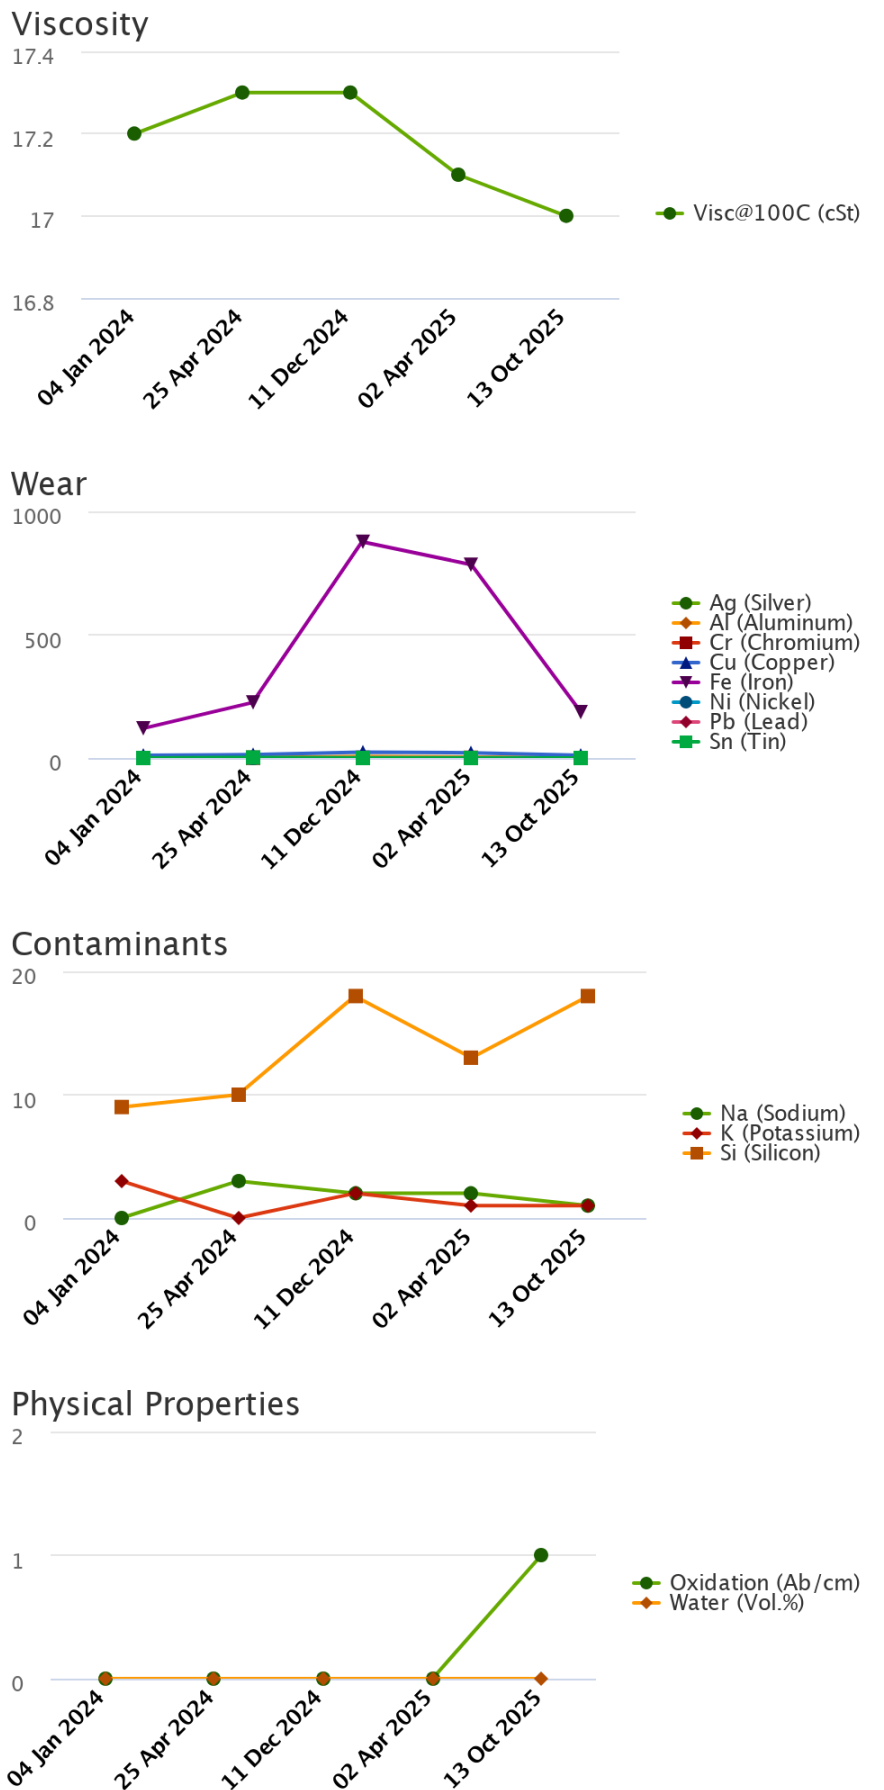
- 13 Oct 2025 3:21 PM UTC - Josh Simmons - In Service Oil Sample Comments: Photo:
