Sample Data & Trends

Normal	
	Unit ID: 1230	Asset ID: 51782506
	Description: 982 m	
Account Information	Sample Information	Equipment Information
ID: 402009 Name: Greer Lime Address: 1088 Germany Valley Limestone Road, Riverton, WV 26814-0000 US Parent Account: MATTHEWS LUBRICANTS, INC.	Sample ID: 25286289073 Service Level: Essential Bottle ID: a037043480 Tested Lubricant: MOBIL DELVAC MODERN OFF-HIGHWAY TRANS FLUID 30	Asset Class: Transmission Manufacturer: CATERPILLAR Model: Lubricant: MOBIL DELVAC MODERN OFF-HIGHWAY TRANS FLUID 30

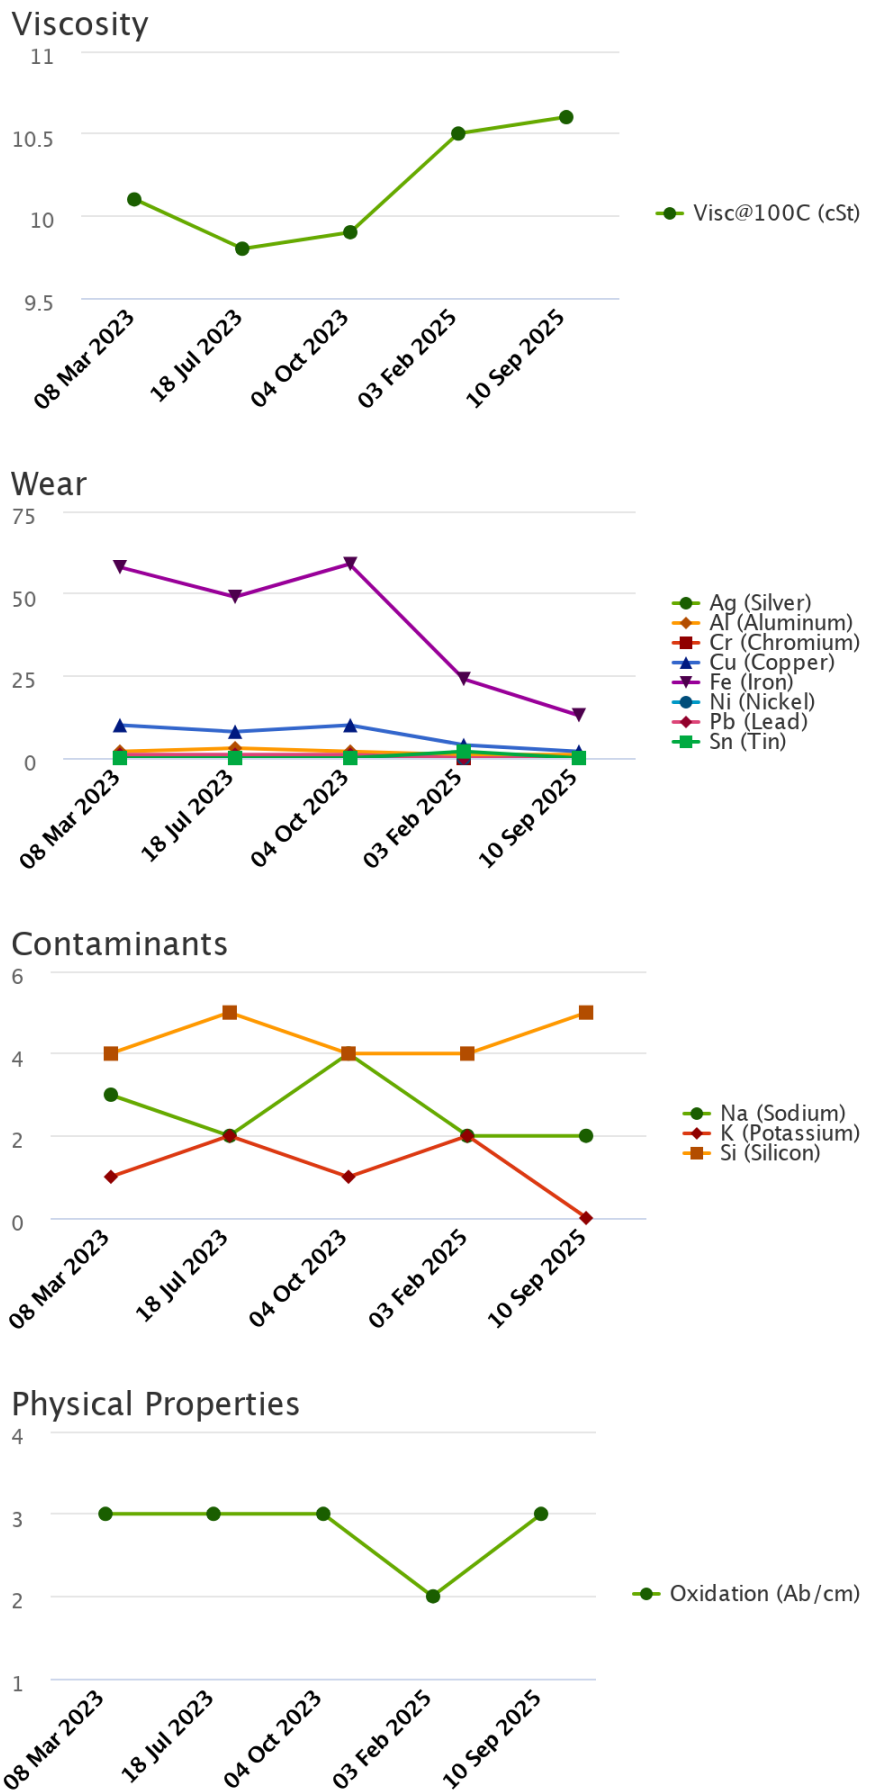
- 10 Sep 2025 3:05 PM UTC - Josh Simmons - In Service Oil Sample Comments: Photo:
