Sample Data & Trends

Caution	
	Unit ID: 1231	Asset ID: 51828010
	Description: roof bolter	
Account Information	Sample Information	Equipment Information
ID: 402009 Name: Greer Lime Address: 1088 Germany Valley Limestone Road, Riverton, WV 26814-0000 US Parent Account: MATTHEWS LUBRICANTS, INC.	Sample ID: 25296320030 Service Level: Essential Bottle ID: a037299915 Tested Lubricant: MOBIL DELVAC MODERN OFF-HIGHWAY TRANS FLUID 30	Asset Class: Transmission Manufacturer: ATLAS COPCO Model: Lubricant: MOBIL DELVAC MODERN OFF-HIGHWAY TRANS FLUID 30
Continued		
Recommendation/Comments

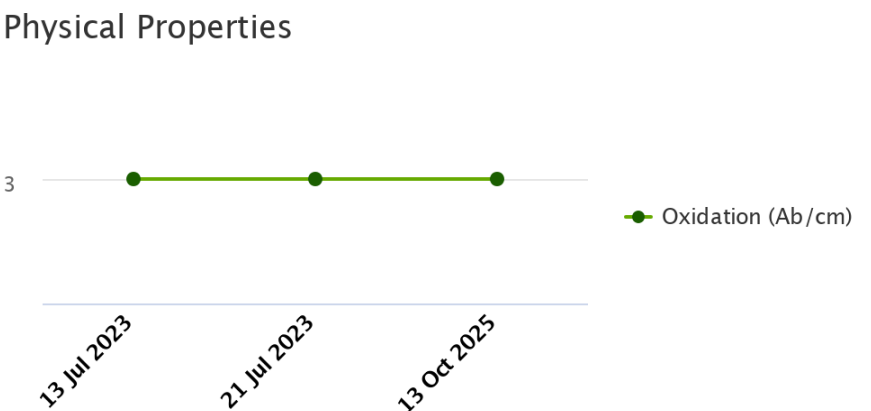
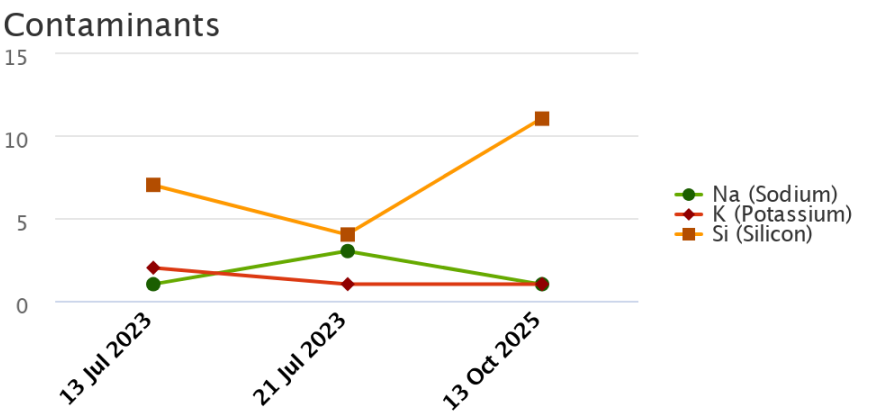
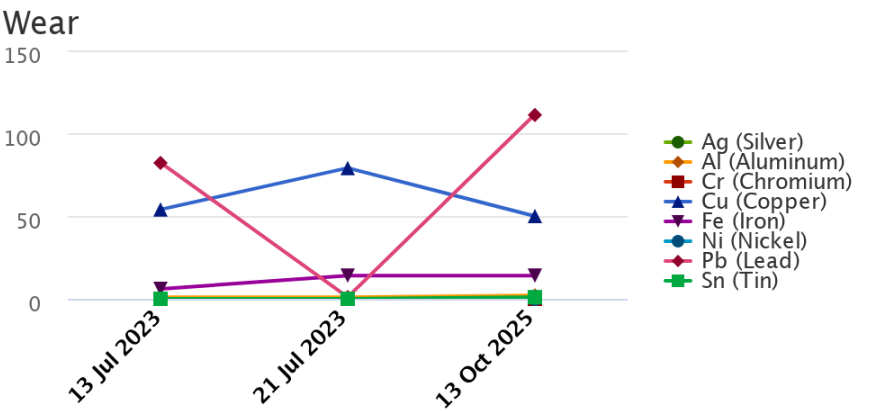
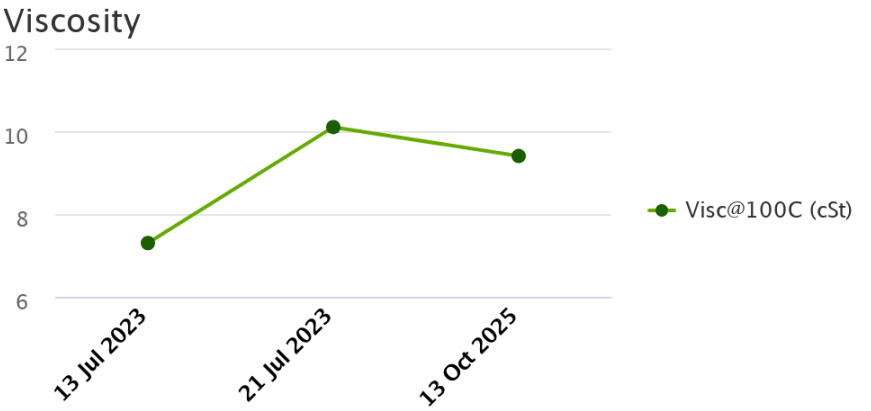
- 13 Oct 2025 3:50 PM UTC - Josh Simmons - In Service Oil Sample Comments: Photo:
