MobilTM

Unit ID: 772

Asset ID: 51852116

Description: 980 g right rear final

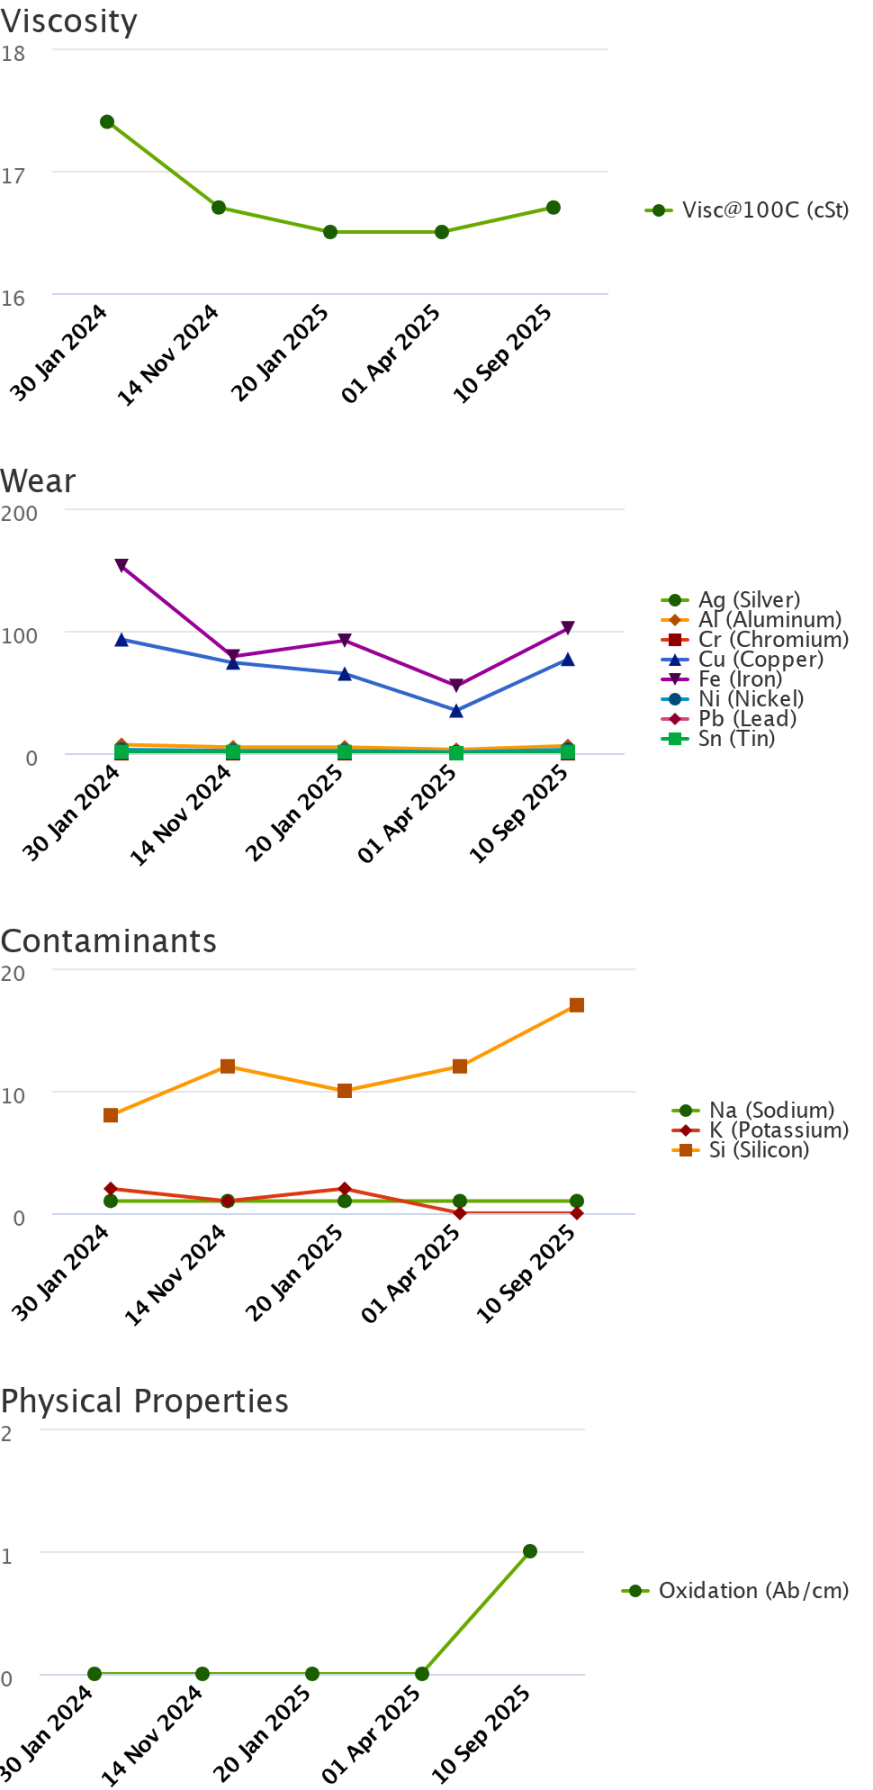
Sample Data & Trends

Sample Info	Report Status	Alert	Alert	Alert	Normal	Alert
	Sample ID	24039222076	24330195068	25059439049	25111107047	25286131002
	Service Level	Essential	Essential	Essential	Essential	Essential
	Bottle ID	a030127636	a033565138	a033595170	A035376824	a037050807
	Tested Lubricant	MOBILTRANS HD 50	MOBILTRANS HD 50	MOBILTRANS HD 50	MOBILTRANS HD 50	MOBIL DELVAC MODERN OFF-HIGHWAY TRANS FLUID 50
	Sampled	30 Jan 2024	14 Nov 2024	20 Jan 2025	01 Apr 2025	10 Sep 2025
	Reported	12 Feb 2024	26 Nov 2024	04 Mar 2025	22 Apr 2025	15 Oct 2025
	Equipment Age	57117	58702	5399	60106	61231
	Equipment UOM	Hours	Hours	Hours	Hours	Hours
	Oil Age					
	Make-up Volume					
	Oil Changed		No	Yes	Yes	Yes
	Filter Changed		No	Yes	No	Yes
Lubricant	Contamination Rating	Normal	Normal	Normal	Normal	Normal
	Equipment Rating	Alert	Alert	Alert	Normal	Alert
	Lubricant Rating	Normal	Normal	Normal	Normal	Normal
	Visc@100C (cSt)	17.4	16.7	16.5	16.5	16.7

Oxidation (Ab/cm)	0	0	0		1
	Water (Vol.%)	NotDetected	NotDetected	NotDetected		NotDetected
Wear (ppm)	Ag (Silver)	0	0	0	0	0
	Al (Aluminum)	7	5	5	3	6
	Cr (Chromium)	0	0	0	0	0
	Cu (Copper)	93	74	65	35	77
	Fe (Iron)	153	79	92	55	102
	Mo (Molybdenum)	1	1	1	0	0
	Ni (Nickel)	3	2	2	1	3
	Pb (Lead)	1	0	0	0	0
	Sn (Tin)	1	1	1	0	1
Contaminant (ppm)	K (Potassium)	2	1	2	0	0
	Na (Sodium)	1	1	1	1	1
	Si (Silicon)	8	12	10	12	17
Additive (ppm)	B (Boron)	2	1	2	2	2
	Ba (Barium)	0	0	0	0	0
	Ca (Calcium)	3221	3399	3291	3094	3532
	Mg (Magnesium)	16	15	14	11	14
	P (Phosphorus)	945	977	930	847	1037
	Zn (Zinc)	1056	1030	1062	950	1071

ACTION REQUIRED - ELEVATED WEAR METALS LEVELS. Determine cause of elevated wear metals levels and take corrective action. If the wear metals levels are elevated for the first time with no history of an increasing trend, then resample immediately to confirm condition. Because silicon levels are not also elevated, abrasive dirt is not the cause of this condition. Possible causes of elevated wear metals include: a. Worn of oil-wetted parts; b. Contamination from previous fill; c. Over-extended oil service life; d. Normal break-in of new equipment. Continue to closely monitor the equipment and oil for signs of further condition regressions. Contact your ExxonMobil representative for further assistance if necessary.
