Alert

Unit ID: 4-RK-1

Description: Kiln 2 Drive Trunion Bearing 1

Sample ID: 25342227013

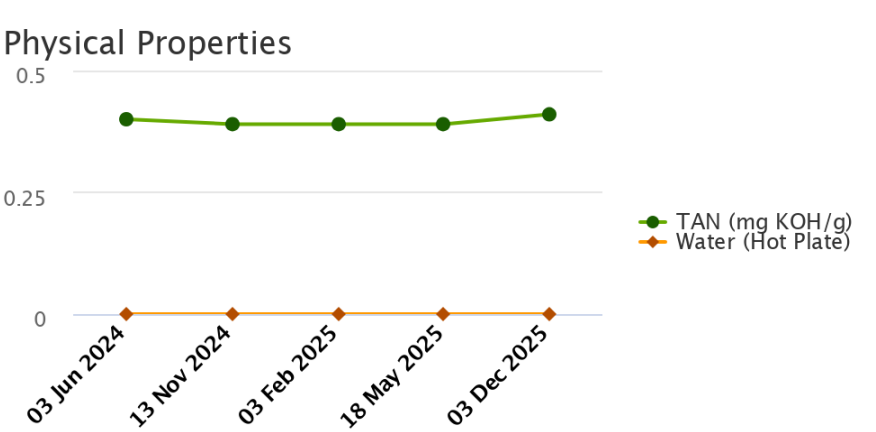
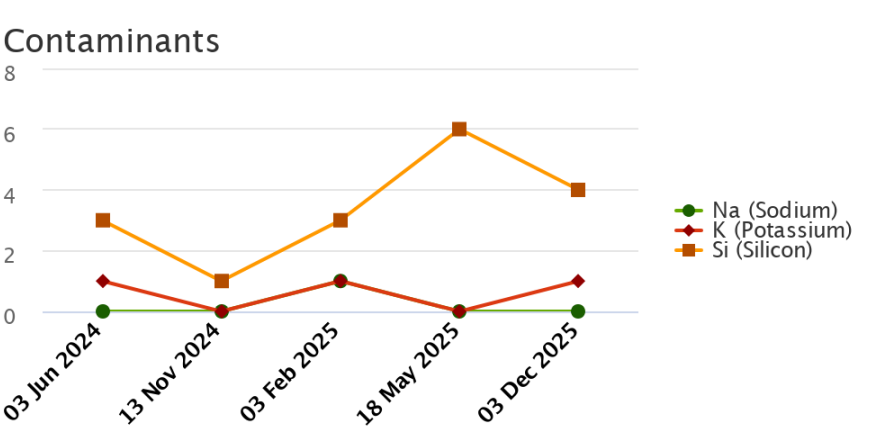
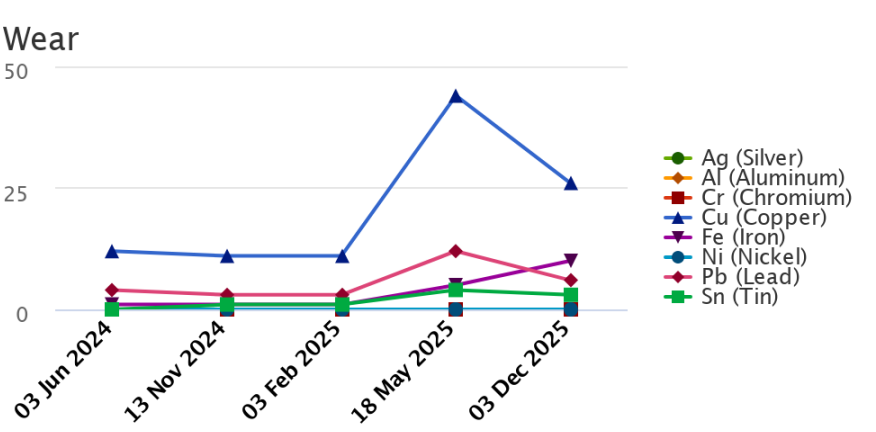
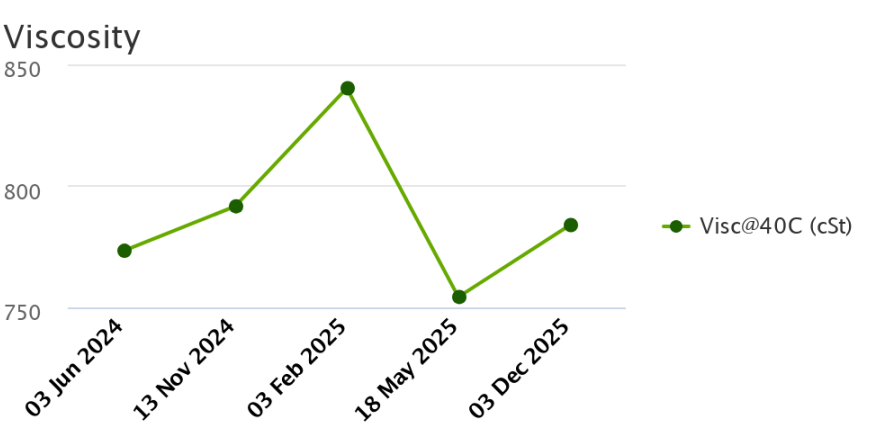
ACTION REQUIRED - ELEVATED OIL VISCOSITY. Determine cause of elevated oil viscosity and take corrective action. Elevated viscosities can interfere with the cooling process of components and restrict oil flow causing oil starvation and component wear. Possible causes of elevated viscosity include: a. Contact with oil that has a higher viscosity; b. High rates of oxidation and oil degradation; c. Excessive sediment; d. Coolant contamination. A partial drain and refill with fresh oil may rejuvenate the oil condition. Change the oil immediately if the condition escalates. Contact your ExxonMobil representative for further assistance if necessary.

ACTION REQUIRED - UNSATISFACTORY OIL CONDITION. Test results indicate that the condition of this oil sample is unsatisfactory. The oil may be unfit for continued use and should be closely monitored further condition regressions. Contact your ExxonMobil representative for further assistance if necessary.
