MobilTM

Unit ID: 5-BM-1

Description: Kiln 2 Ball Mill Feed End Bearing

Alert

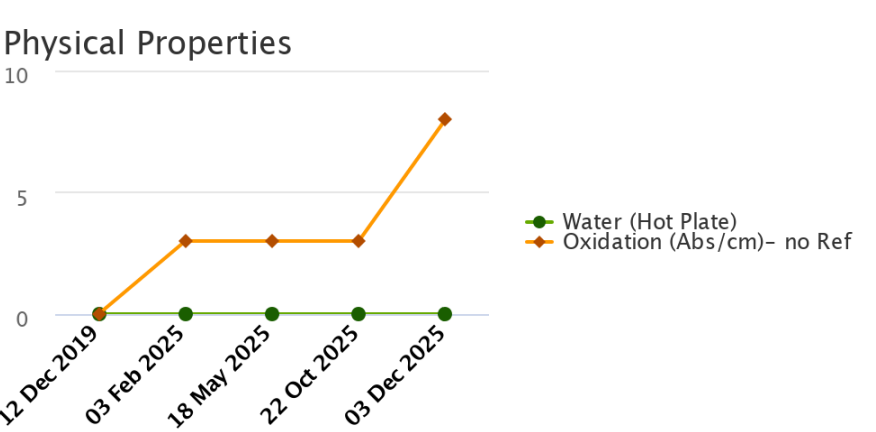
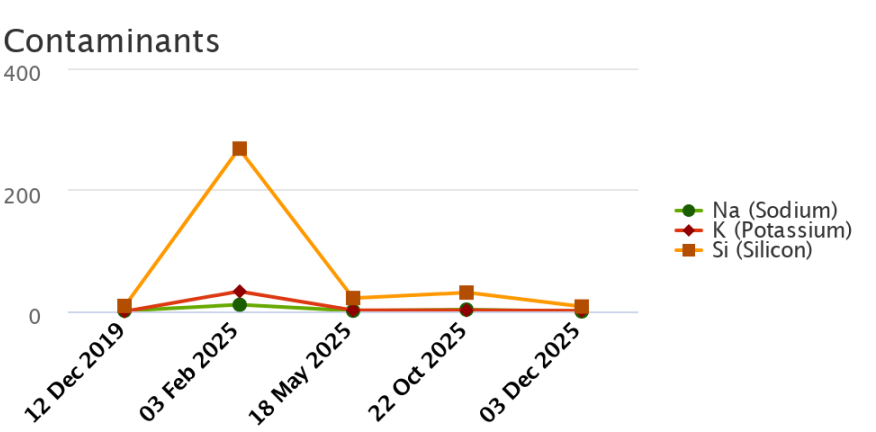
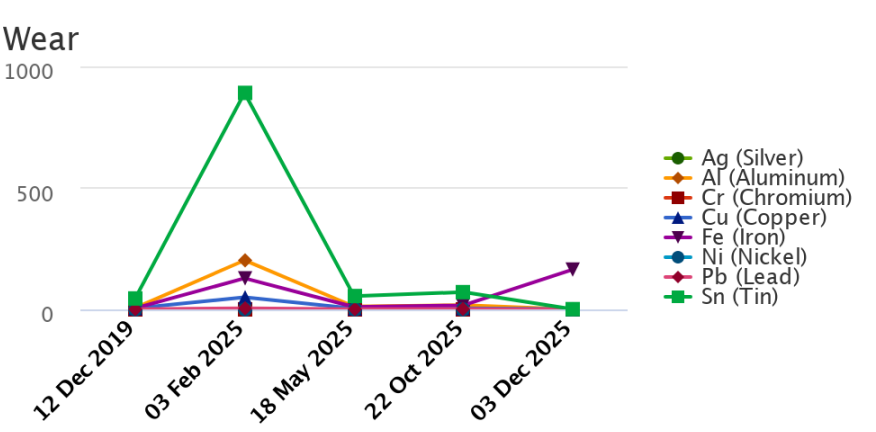
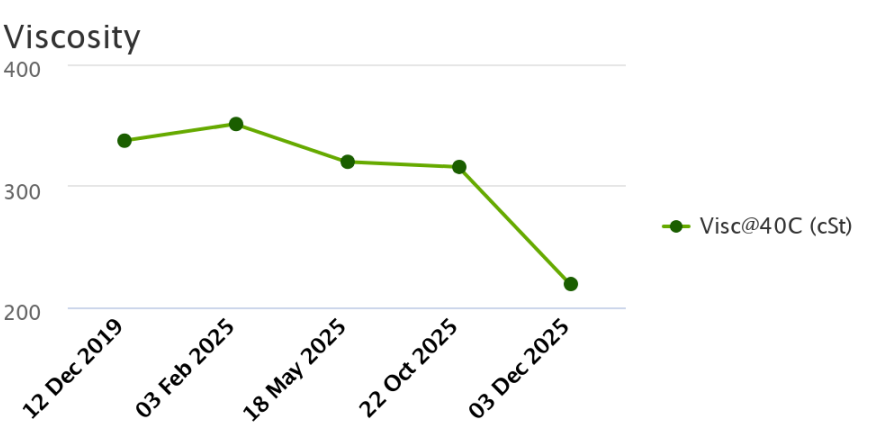
Sample Data & Trends

Sample Info	Report Status	Normal	Alert	Alert	Alert	Alert
	Sample ID	19352475036	25044280017	25147132044	25308280026	25342227014
	Service Level	Essential	Essential	Essential	Essential	Essential
	Bottle ID	a005311802	a033581370	a033684445	a037321143	a003620210
	Tested Lubricant	MOBIL VACUOLINE 537	MOBIL VACUOLINE 537	MOBIL VACUOLINE 537	MOBIL VACUOLINE 537	MOBIL VACUOLINE 537
	Sampled	12 Dec 2019	03 Feb 2025	18 May 2025	22 Oct 2025	03 Dec 2025
	Reported	20 Dec 2019	18 Feb 2025	29 May 2025	06 Nov 2025	10 Dec 2025
	Equipment Age					
	Oil Age					
	Make-up Volume					
	Oil Changed					
	Filter Changed					
Lubricant	Contamination Rating	Normal	Alert	Alert	Alert	Alert
	Equipment Rating	Normal	Alert	Alert	Alert	Alert
	Lubricant Rating	Normal	Normal	Normal	Normal	Alert
	Visc@40C (cSt)	337.2	350.9	319.8	315.6	219.2
	Oxidation (Ab/cm)	0				
	Oxidation (Abs/cm) D7414		3	3	3	8
	Water (Hot Plate)	NotDetected	NotDetected	NotDetected	NotDetected	Detected

Wear (ppm)	Ag (Silver)		0	0	0	0
	Al (Aluminum)	6	202	12	18	0
	Cr (Chromium)	0	0	0	0	0
	Cu (Copper)	5	50	4	5	1
	Fe (Iron)	5	128	10	17	164
	Mo (Molybdenum)	0	0	0	0	0
	Ni (Nickel)	0	0	0	0	0
	Pb (Lead)	1	5	1	2	0
	Sn (Tin)	45	891	55	71	1
Contaminant (ppm)	K (Potassium)	0	33	2	2	1
	Na (Sodium)	1	11	1	3	0
	Si (Silicon)	9	268	22	31	8
Additive (ppm)	B (Boron)	0	11	0	3	0
	Ba (Barium)	0	2	0	0	0
	Ca (Calcium)	218	595	193	249	11
	Mg (Magnesium)	1	17	2	3	2
	P (Phosphorus)	377	254	442	421	223
	Zn (Zinc)	441	3	502	523	2

ACTION REQUIRED - EXCESSIVE IRON LEVEL. Determine source of Iron (Fe) and take corrective action. If the iron level is excessive for the first time with no history of an increasing trend, then resample immediately to confirm condition. The oil and filter are unfit for continued use. Change the filter immediately and either centrifuge or change the oil. Prolonged usage of oil with excessive iron levels can adversely affect product performance and damage the equipment. Contact your ExxonMobil representative for further assistance if necessary.

CAUTION - ELEVATED OXIDATION. Oil oxidation is the chemical degradation of a lubricant at high temperatures and can contribute to the formation of dark varnish deposits on equipment. Determine cause of elevated oxidation and take corrective action. Potential causes of elevated oxidation include: a. High oil temperatures; b. Over-extended oil service life; c. Localized hot spots; d. Low oil level in reservoir; e. Poor oil circulation; f. Mixed lubricants of different formulations. The oil may be unfit for continued use and should be monitored closely for further condition regressions. A partial drain and refill with fresh oil may rejuvenate the oil condition. Change the oil immediately if the condition escalates. Contact your ExxonMobil representative for further assistance if necessary.

ACTION REQUIRED - REDUCED OIL VISCOSITY. Determine cause of reduced oil viscosity and take corrective action. Reduced viscosities can impair the lubricant's ability to protect the equipment. Possible causes of reduced viscosity include: a. Initial fill or contact with oil that has a lower viscosity; b. Contamination with a fuel or solvent; c. Incorrectly labeled sampled. Inspect the system for signs of fuel or coolant ingress. Resample the oil after corrective actions have been implemented. If the condition continues or escalates, recharge the system with new oil. Contact your ExxonMobil representative for further assistance if necessary.

ACTION REQUIRED - UNSATISFACTORY OIL CONDITION. Test results indicate that the condition of this oil sample is unsatisfactory. The oil may be unfit for continued use and should be closely monitored further condition regressions. Contact your ExxonMobil representative for further assistance if necessary.

ACTION REQUIRED - EXCESSIVE WATER CONTAMINATION. Determine source of water and take corrective action. Analyze the oil with an on-site water test if accessible. Possible sources of water include: a. Leaking seals; b. Condensation resulting from low operating temperatures or prolonged shutdowns; c. Compromised oil cooler; d. Direct exposure to atmosphere as a result of compromises to system components (i.e. improperly sealed tank fill access point). Remove water from oil using centrifuges or dehydration units, or drain the oil and recharge the system with new oil. Resample the system after corrective measures have been implemented. Contact your ExxonMobil representative for further assistance if necessary.
