HSE FLASH – Learning From Incident

DESERT STAR ENERGY

Reversing truck struck a parked light vehicle			
Ifadah#	45821	**Date**	18-Aug-2026
Time	07:45	**Risk Category**	Driving / Vehicle Safety
Injury/Asset Damaged	Asset damage – rear door of light vehicle	**Activity**	Material delivery to laydown yard
Actual Severity	Minor (Level 1)	**Potential Severity**	Major (Level 4)
Location	Laydown yard, Desert Star Energy Field Camp 3

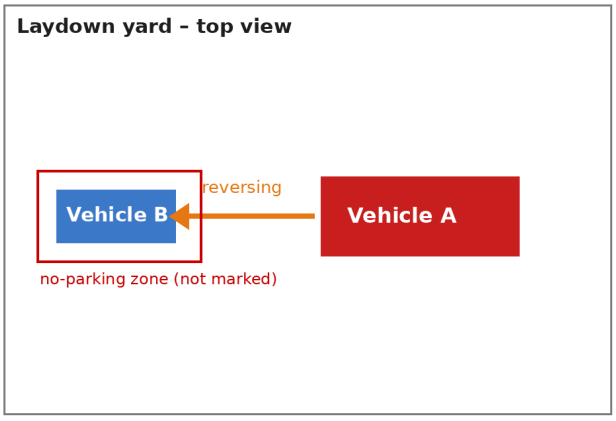
During a material delivery by Falcon Logistics LLC, a 10-tonne flatbed truck reversed into the laydown yard without a banksman. The driver, Rami Haddad, could not see a light vehicle parked behind the truck and struck its rear door at low speed. Nobody was inside the light vehicle and no one was injured.

- No banksman was assigned for the reversing manoeuvre.
- The truck's reversing camera was not working and had not been reported.
- The light vehicle was parked inside the truck manoeuvring area, which was not marked as a no-parking zone.
- The delivery was not covered in the morning toolbox talk (Permit WP-2209 listed offloading only).

- Assign a trained banksman for every reversing manoeuvre.
- Add reversing camera and alarm checks to the daily vehicle pre-use inspection.
- Mark and enforce no-parking zones in truck manoeuvring areas.
- Brief all delivery drivers at the gate on site traffic rules.
