Persistence, and a Read Defect That Looked Like the Wrong Thing

UM-NATOS-018

DOCUMENT	REVISION	STATUS	CLASSIFICATION
UM-NATOS-018	1.0 · 2026-08-15	**Complete, verified on hardware**	Internal

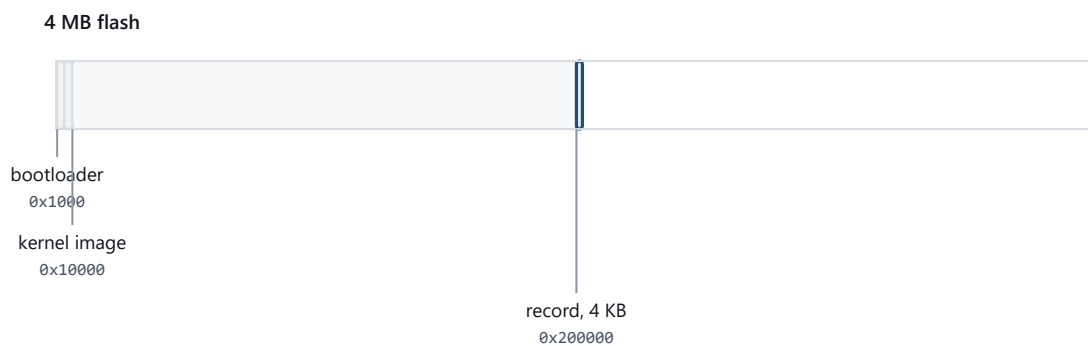
The mechanism is small. The report is mostly about the defect that sat in front of it for the whole of the work: **every flash read returned the true value shifted right by one bit**, consistently, on every transaction. The chip ID read `0x34200B` where the part reports `0x684016`, which is exactly that value shifted once.

The cause was the SPI clock divider — inherited from the bootloader rather than set. Three properties of the defect made it point somewhere else, and this report records them because each is a general trap, not a flash-specific one:

- a *timing* fault that is perfectly consistent presents as a *framing* fault
- two hypotheses were tested against a board that had never been reflashed, so a working theory and a broken one produced identical evidence
- the fix that eventually worked had already been tried, and discarded, on the strength of one of those untested runs
