RUNOFF STATION - GRASSLAND, SOIL AND WATER RESEARCH LABORATORY (GSWRL)

RUNOFF STATION

W6

REPAIRS

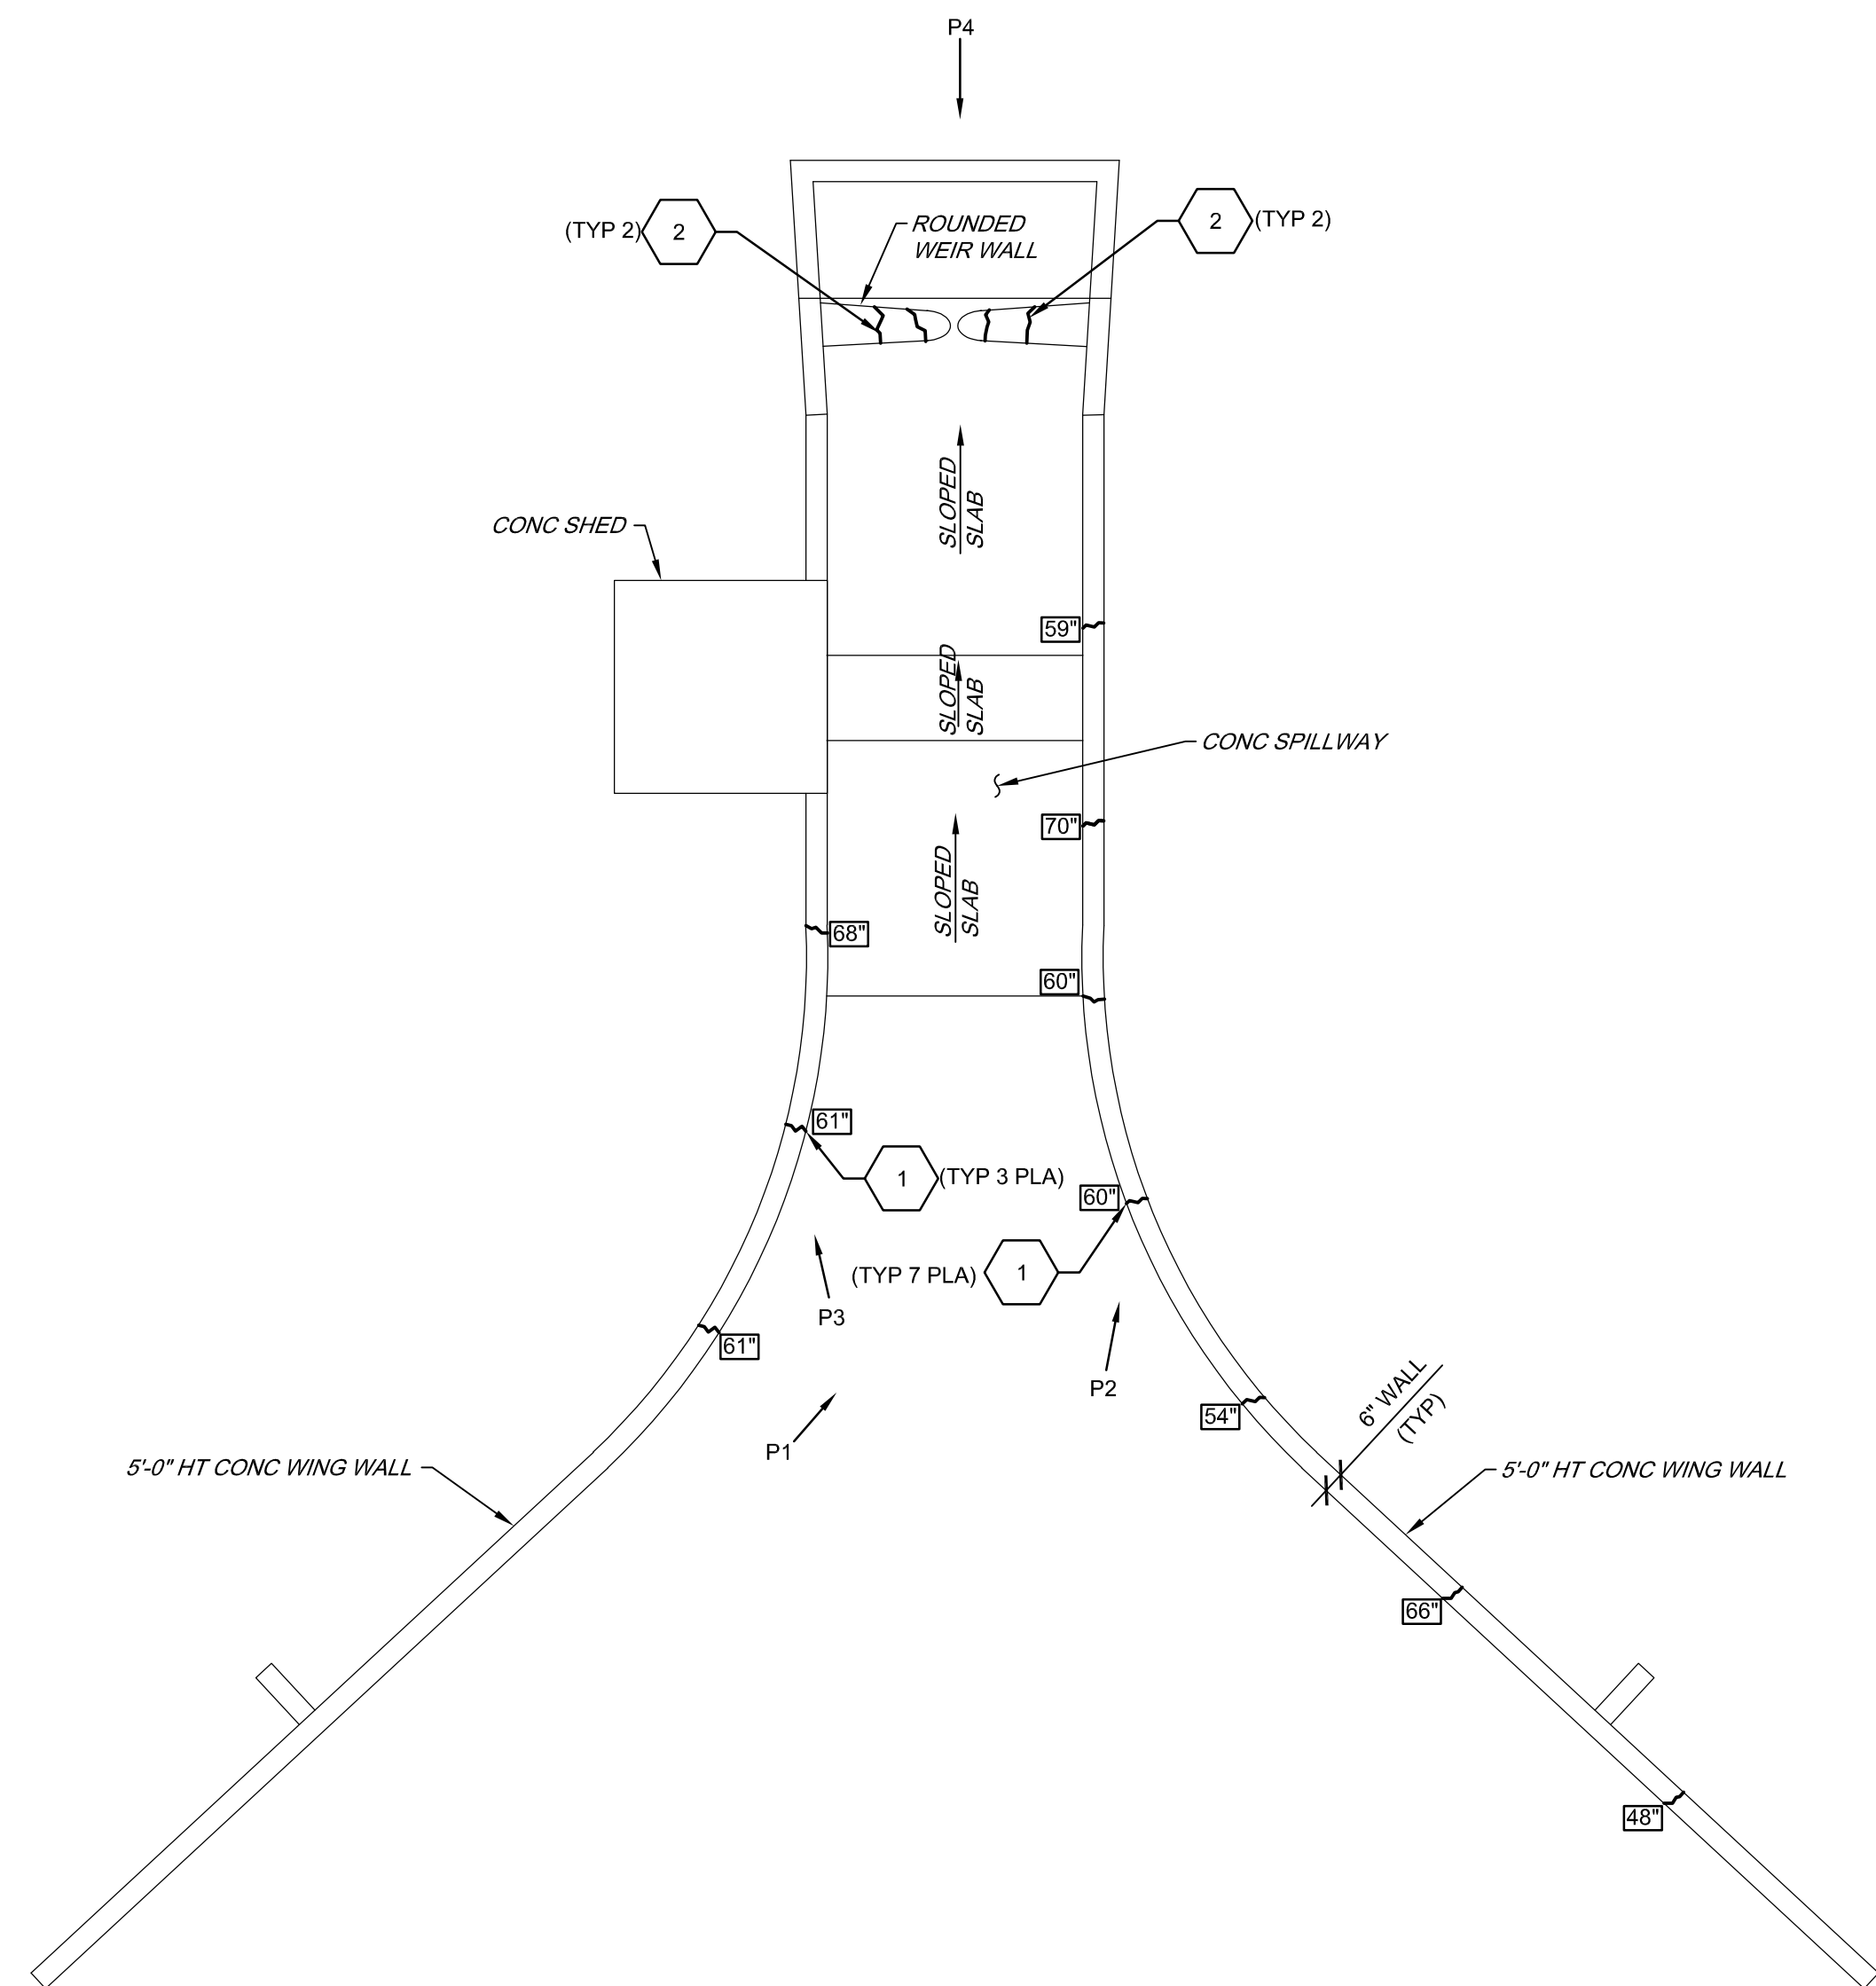
**RUNOFF STATION W6 NEW WORK PLAN**
1/4"=1'-0" 0 2' 4' 8'

1. FOR GENERAL STRUCTURAL NOTES, LEGEND, AND STRUCTURAL TECHNICAL TERMS SEE DRAWING S-001.
2. FOR RUNOFF STATION LOCATION PLAN SEE DRAWING S-003.
3. CRACK WIDTH $\frac{1}{8}$ " UNO

1. ROUT CRACKS TO 3/8-INCH DEPTH, EA FACE. PREP SURFACES AND PRESSURE INJECT EPOXY FILL IN CRACKS IN WING WALLS. FOLLOW EPOXY MANUFACTURERS PREP AND INSTALLATION REQUIREMENTS.
2. ROUT CRACKS IN WEIR, PREP SURFACES AND PRESSURE INJECT EPOXY FILL IN CRACKS. INSTALL BITUTHENE LIQUID MEMBRANE, AS MANUFACTURED BY GRACE CONSTRUCTION PRODUCTS, OR APPROVED EQUAL, AT ALL JOINTS.

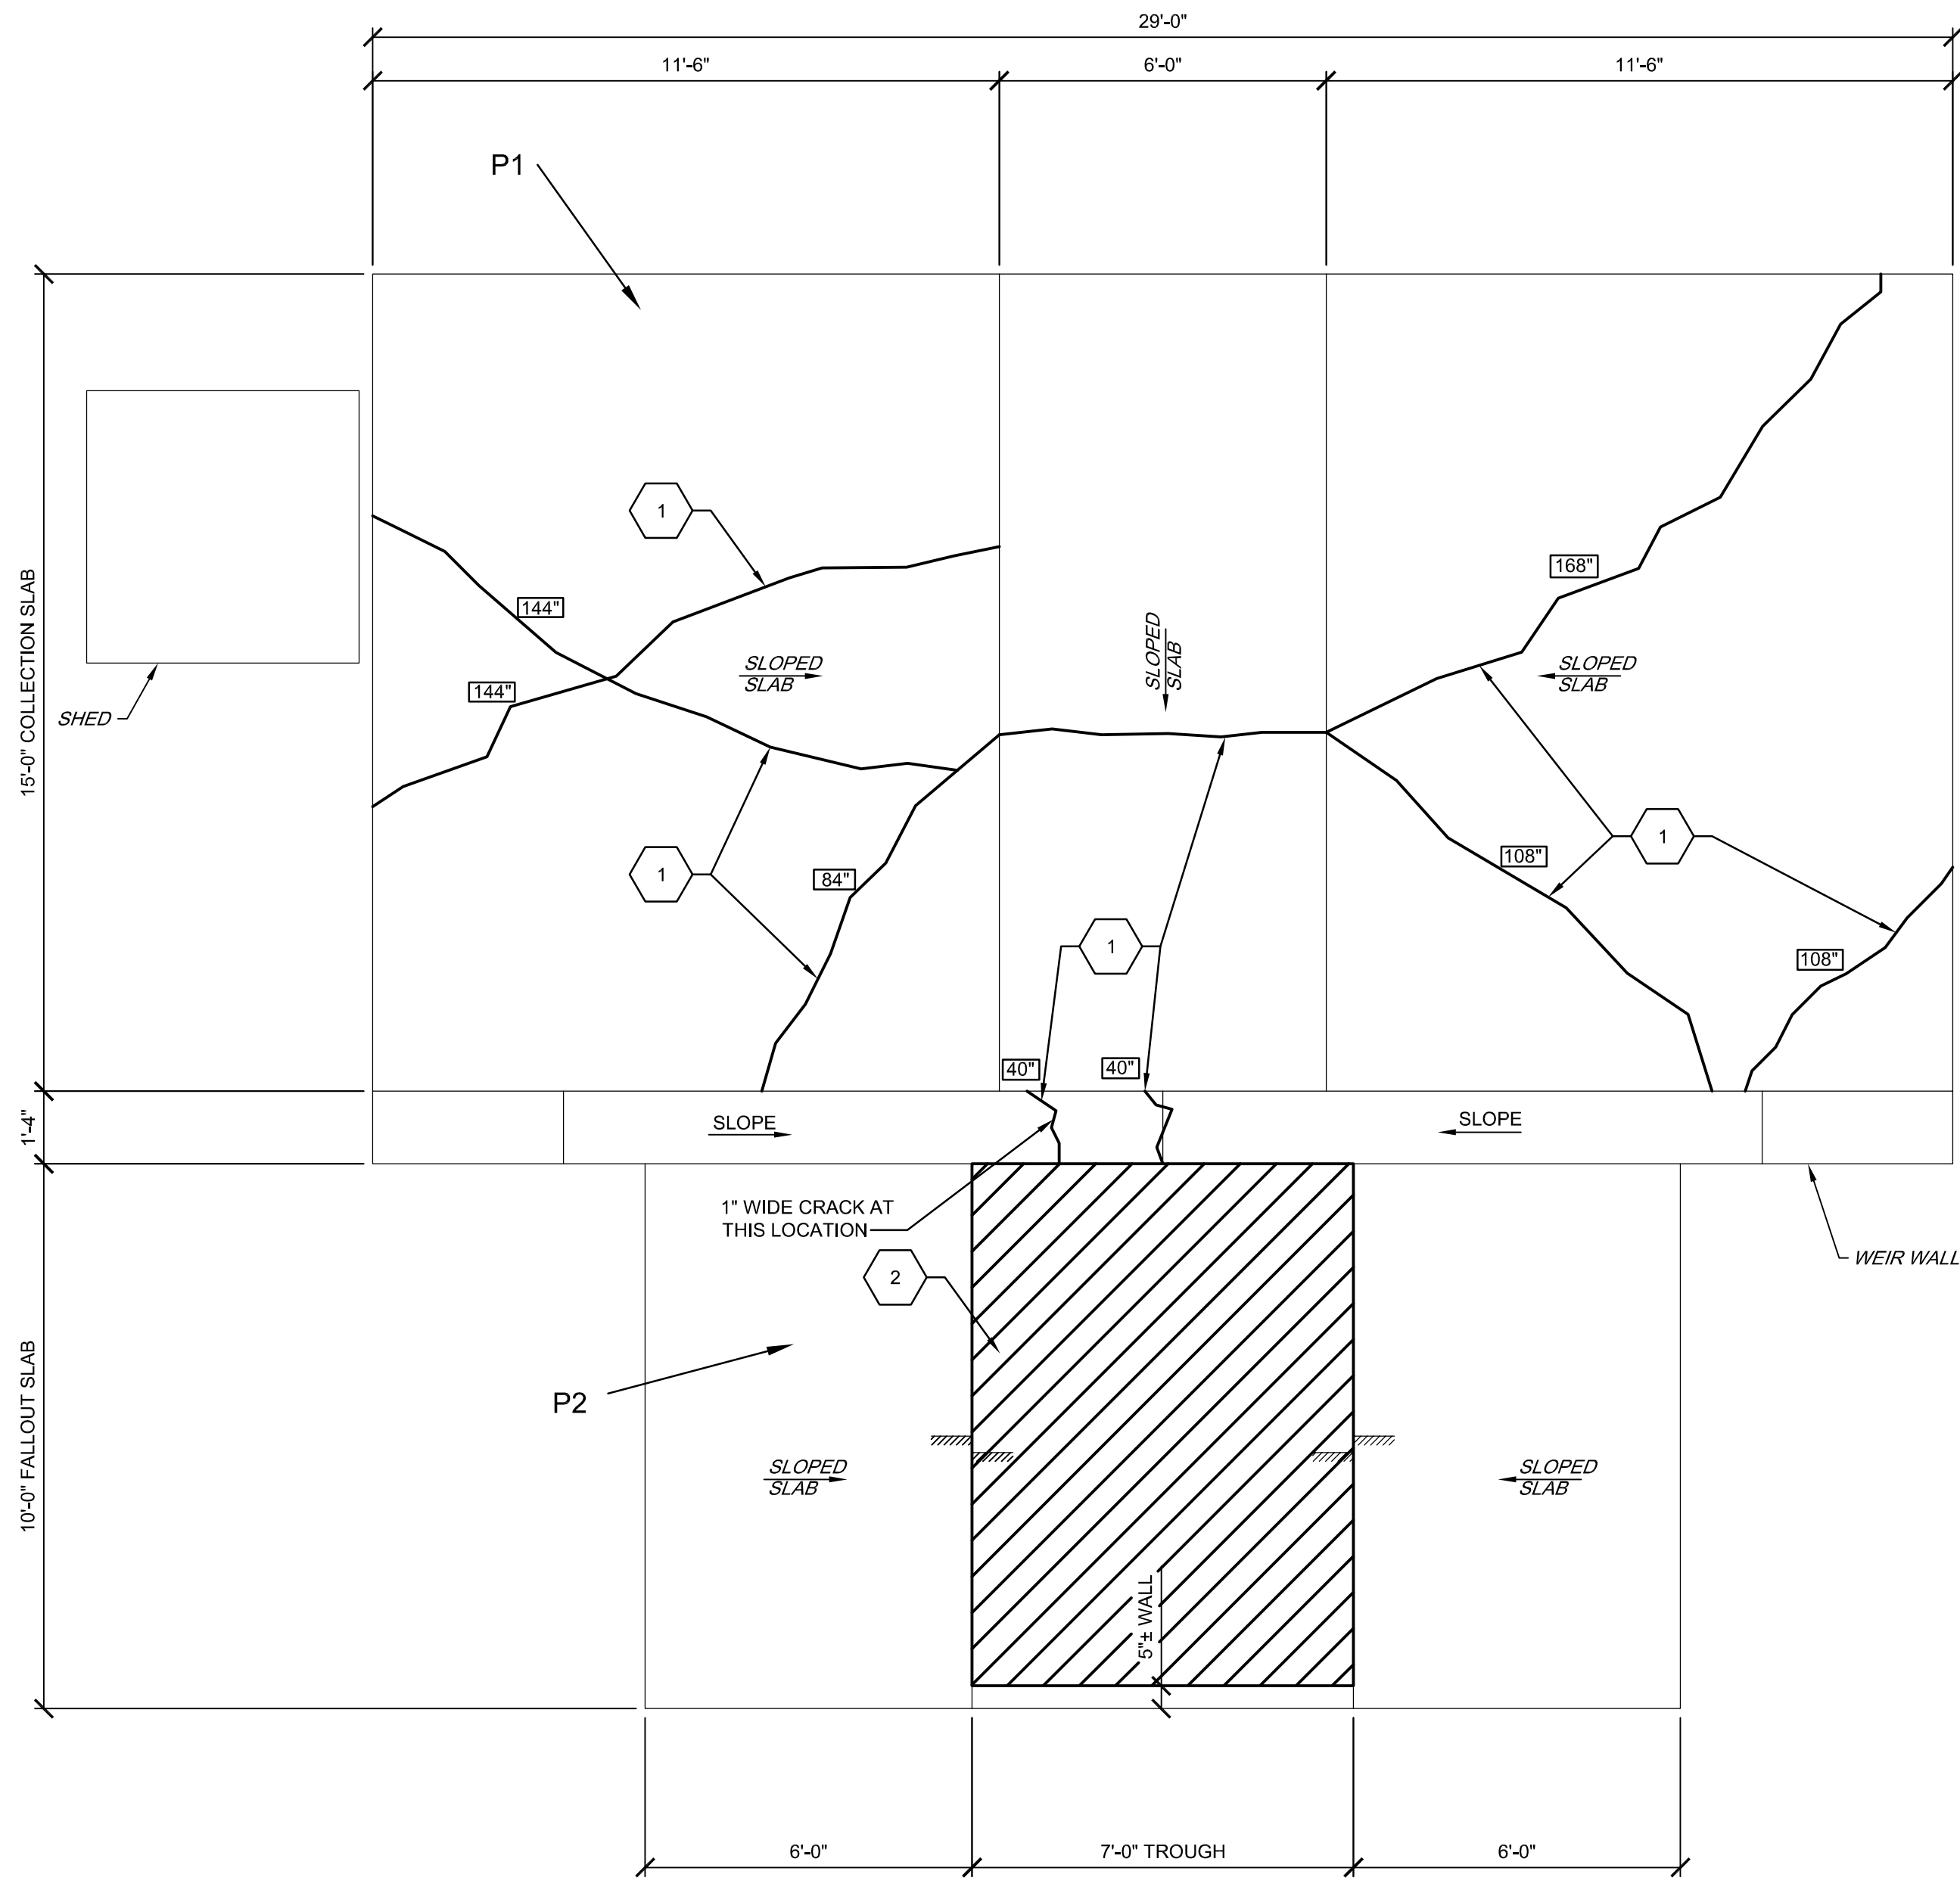
**RUNOFF STATION W13 NEW WORK PLAN**
3/8"=1'-0" 0 2' 4' 6'

- FOR GENERAL STRUCTURAL NOTES, LEGEND, AND STRUCTURAL TECHNICAL TERMS SEE DRAWING S-001.
- FOR RUNOFF STATION LOCATION PLAN SEE DRAWING S-003.
- CRACK WIDTH" = 1/8 UN.

- ROUT CRACKS IN SLAB AND WEIR TO 3/8-INCH DEPTH. PREP SURFACES AND PRESSURE INJECT EPOXY FILL IN CRACKS. FOLLOW EPOXY MANUFACTURERS PREP AND INSTALLATION REQUIREMENTS. AFTER ROUT AND EPOXY, INSTALL BITUTHENE LIQUID MEMBRANE, AS MANUFACTURED BY GRACE CONSTRUCTION PRODUCTS, OR APPROVED EQUAL, AT ALL WEIR JOINTS.
- REMOVE EXISTING SLAB TO 1" DEPTH. PREPARE SURFACE AND INSTALL POLYMER MODIFIED TOPPING SLAB TO RE-ESTABLISH SLAB SURFACE AND ELEVATION. FOLLOW TOPPING SLAB MANUFACTURERS REQUIREMENTS FOR SURFACE PREP AND TOPPING INSTALLATION.
