Jie Zhang

Monitoring of Lubricant Film Failure in a Ball Bearing Using Ultrasound

Keywords: bearing failure, lubricant film, condition monitoring, ultrasound

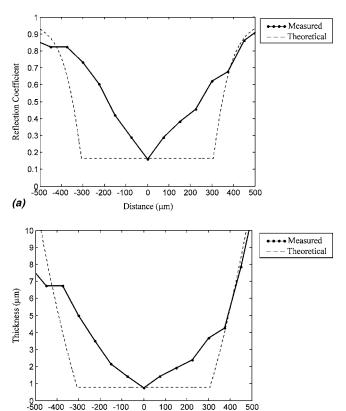
Figure 4(a) shows an experimentally measured reflection coefficient profile for a shaft speed of 506 rpm and a bearing radial load of 15 kN before any contaminant materials were added to the lubricant. Reflected signals were recorded at a rate of 20 kHz as the ball passed the transducer location. It can be seen that the reflection coefficient falls to a minimum at the center of the lubricated contact region and then rises again. This minimum reflection coefficient corresponds to an oil film thickness of 0.75 μ m. Also shown in Fig. 4(a) is the theoretical reflection coefficient distribution (using Eq. (8) to obtain thickness, then Eq. (1) to calculate the reflection coefficient). Note that for the theoretical line, the central film thickness has been assumed to occur across the whole of the contact (i.e., the minimum film thickness at the exit constriction of the contact is not modelled). Figure 4(b) shows an experimentally measured thickness profile and theoretical thickness profile corresponding to the reflection coefficient profile shown in Fig. 4(a). Comparing the two curves in Fig. 4(a) and the two curves in Fig. 4(b), it can be seen that there is a good quantitative agreement at

Fig. 4 Shaft speed of 506 rpm and a radial load of 15 kN. (a) Measured reflection compared with a theoretical prediction based on a predicted oil film thickness. (b) Measured lubricant thickness compared with a theoretical thickness.

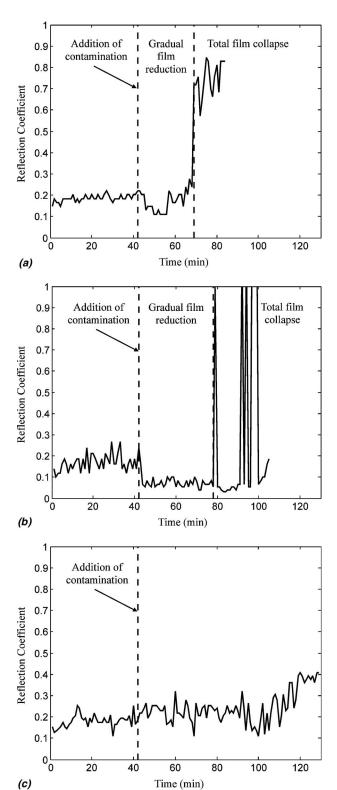
When acetone was added to the lubricant, it can be seen from Fig. 5(a) that the reflection coefficient first decreases (from an average of 0.18 to 0.14 shown as gradual film reduction regime) and then steeply increases after 69 min (shown as total film col-

Fig. 5 Reflection coefficient versus time for failure by the addition of (a) acetone, (b) water, and (c) sand

lapse regime). The bearing seized after 84 min, which was the shortest of the three contaminant cases. The failure scenario is as follows. First, the acetone dissolves the lubricant, which lowers its viscosity and hence reduces the lubricant film thickness resulting in an immediate decrease in the reflection coefficient. Second, over the next 12 min it is thought that the acetone and lubricant evaporate, causing a lack of lubrication of the bearing to occur.

When water was added to the lubricant, it can be seen from Fig. 5(b) that, as in the acetone case, the reflection coefficient initially decreases, followed by a series of sharp reflection coefficient peaks, starting after 42 min. The initial reduction in reflection coefficient is slightly more marked than for acetone (average reflection coefficient falling from 0.17 to 0.07 shown as gradual film reduction regime). It is likely that the water (since it is not piezoviscous) will not enter the contact. However, some will dissolve in the oil, reducing its viscosity, and the water may also act to displace lubricating oil from the contact inlet. Both these effects would cause a reduction in the film thickness and hence a reduction in the reflection coefficient. The reflection coefficient remains at this reduced value for 78 min (until the point marked as total film collapse). With time the surfaces of the raceway and ball oxidize, leading to increased wear and damage (increased surface roughness). This oxidation can be seen in Fig. 6(c). The presence of oxidation products and the increased surface roughness acting together then cause the observed dramatic increases in the reflection coefficient.

Figure 5(c) shows the effect of the addition of sand particles to the lubricant. This causes a gradual increase in the reflection coefficient over the 125 min duration of the test. The sand particles roughen the contacting surfaces; the roughness changes from Ra =0.02 μ m to Ra=0.14 μ m. Figure 6(d) shows a photograph of the bearing surface after the addition of sand to the bearing. It appears that this roughening of the surface has led to a slight increase in the measured film thickness. The reflection coefficient is sensitive to the separation of the mean lines of the two rough surfaces. With the increased roughness and the possibility of micro-elastohydrodynamic lubrication at the asperity contacts, the measured film thickness and hence reflection coefficient increases marginally. The sand abrasion also caused an increase in the radii of the contact elements and hence a decrease in the contact pressure (Eq. (5)). The film thickness therefore increases slightly, and the reflection coefficient also increases.

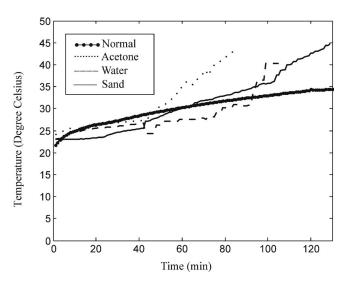
Fig. 7 Temperature versus time for a ball bearing under normal operation (labelled "normal") and various failure cases

Figs. 5(a)–5(c) with more conventional condition monitoring approaches of temperature and vibration sensing. Figure 7 shows the variation in temperature as a function of time for the same three failure cases. It can be seen that the temperature increases gradually for all contaminant cases and for normal operation. The most marked change is for the addition of acetone and that can be seen to result in a significant change in the gradient of temperature increase. This is in agreement with the hypothesis that the evaporation of the acetone caused the bearing to be starved of lubricant and hence significant heating though solid-solid contact resulted. The acetone also resulted in the most rapid seizure of the bearing. The addition of water causes a small initial effect (a reduction in temperature) followed by a similar gradient to that seen before its addition. However, after 92 min the temperature starts to increase more rapidly. This coincides with the observed dramatic increase in reflection coefficient seen in Fig. 5(b). From Fig. 7 it can be seen that the addition of sand caused a small increase in the gradient of temperature increase. It can also be seen that the gradient further increases after 90 min, presumably due to an increased rate of wear prior to failure.

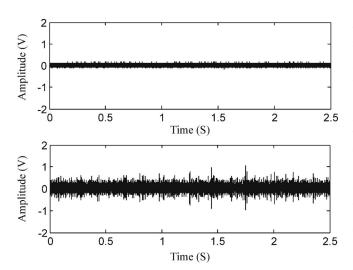
Figure 8 shows typical vibration signals before and after the addition of sand to the lubricant from which a significant increase in vibration amplitude is clear. Figure 9 shows the vibration mea-

Fig. 8 Vibration signals before and after failure for sand case
