GENERAL SERVICE REPORT

Customer:	Lite and Easy	**Date:**	02/05/2025
Site Address:	8-10 Naweena Road Regency Park	**Site Contact:**	Peter
		Phone:	0417782039
Customer PO #:		**Internal Job #:**	5395

Subject: Replace PT100 on lunch tool (12497.61) it is overheating and fix thread insert for knife

Equipment Type:	Serial Number:	Customer Line # (if applicable):
Trave 340		Line 1

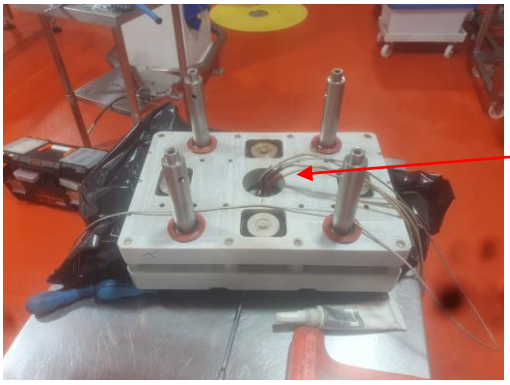
Lot of moisture in the vacuum gauge on the tool showing that the tool is getting exposed to water during the cleaning.

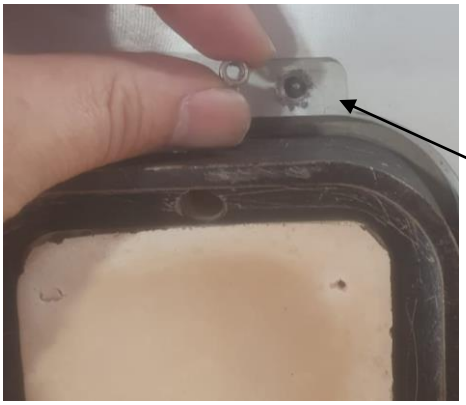
Stripped tool and replaced PT 100
