GENERAL SERVICE REPORT

Customer:	Coles ROAA	**Date:**	10.08.22 – 11.08.22
Site Address:	54 Templar Rd, Erskine Park NSW 2759	**Site Contact:**	Trent Cleminson
		Phone:	0438287226
Customer PO #:		**Internal Job #:**	2383

Subject: Check platformer 9x8 VSP tool

Equipment Type:	Serial Number:	Customer Line # (if applicable):	Area
Platformer	A17A-11614	Line 4	Meat processing room

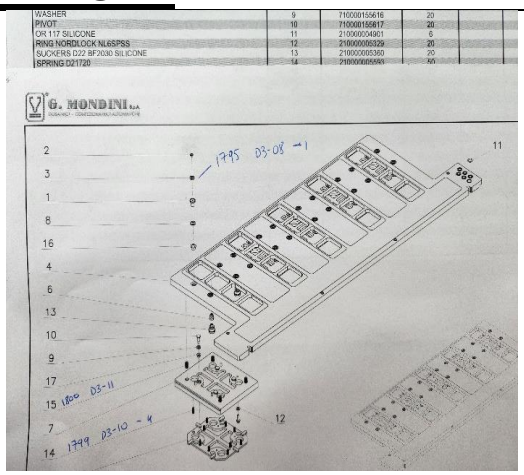
Undo plate from folding plate and found not enough springs only 6 but according to the drawing it should be 10 in each so totally 50 pcs. Put extra springs (use customer stock).

Replaced worn dampers (Use customer stock)
Replaced worn springs (use customer stock)
Cleaned all bushes
Installed all folding plates back to the frame and level up.
Inspect bottom tool
Replaced t-seal and found worn moulding.
