SelectEquip
Flexible Innovative Packaging Systems

GENERAL SERVICE REPORT

Subject: XT500 film trial Platformer

Equipment Type:	Serial Number:	Customer Line # (if applicable):
Trave 590	A17A-11614	Line 4
Platformer	A17A-11614	Line 4

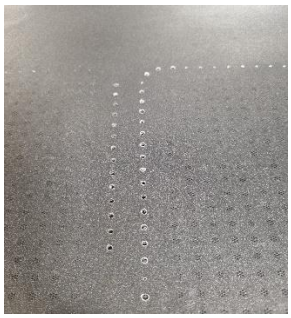
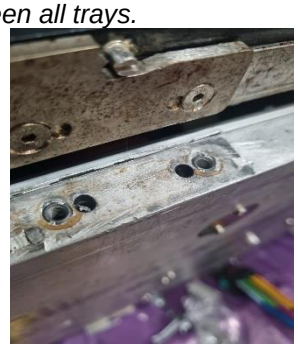
- *The two diffuser sent away for recoating were damaged by opened the holes too big of which we had to try clean up to use for our trials.*
- *We started testing the film with low temperature and noticed the vacuum switches off when the diffuser turns at 90 degrees and then back on causing the film to slip off.*

- *Normally we only need to pulse the vacuum to hold the film in place but with this film we need to hold the vacuum on for the full cycle, due to the film lifting on the corners loosing vacuum.*

- *We had to drill and install threaded inserts on heater plate no4 to install bracket clips for Diffuser.*
- *Two of the Diffuser arrived from recoating but the holes needed to be opened so maintenance started working on opening the holes.*

- *The parameter 47 "vacuum pulse time for maintain film" had to be set at "0" to keep the vacuum on through the turning cycle.*
- *So we manage the run all four diffuser and back plate at a low temperature which ran okay*

- *The distance belt was adjusted to try get a good balance between all trays.*
