GENERAL SERVICE REPORT

Subject: Film Break issue Large tool

Equipment Type:	**Serial Number:**	**Customer Line # (if applicable):**
Trave 590 XL	A/21/A-12629	Line 2
Equipment condition:	Good

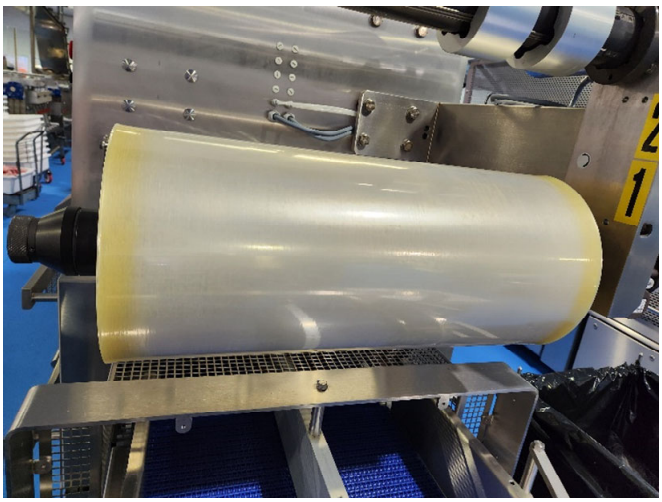
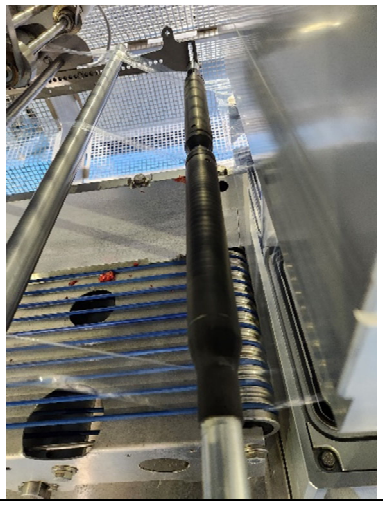
- Arrived on site line running small tool no film issues
- Waited for large tool change over 10am
- Film is curling badly and is old and water loged

- Exit film roller lowered to separate film from tool better
- Aligned and reset cone and spacers as film due to curl was rolling up in gaps and causing film to break or fold and cut badly
- After

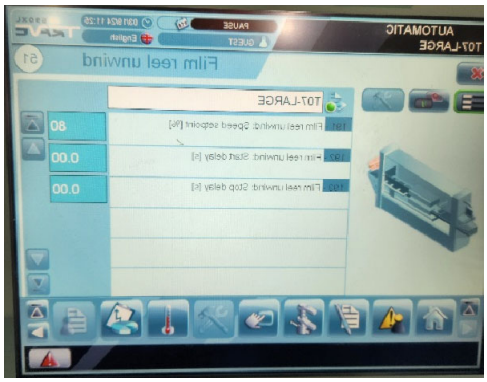
- after slowing down film unroll film settled down and worked correctly
- Left site as film and been running for 20minuites well

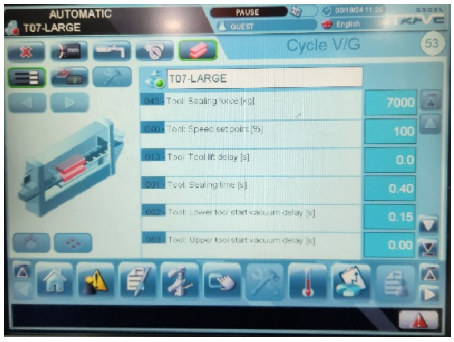
- Returned to site as film was now breaking in the centre of tool during cycle
- Film was removed due to also being corrogated

- To get film working I had to lower the gas set point from 1080 to 1040 causing tray bubble to lower
- We have to compenstate for the fact that meat is at least 5 mm hihger than tray
- Adjusted lower tool vacuum delay from .15 to .05 to allow film to hold to top tool
- Adjusted top air pressure to accommodate lower gas pressure to even out gas in tray and allow an even bubble

5 mm ocord needs to be replaced as soon as it is ordered and received
