GENERAL SERVICE REPORT

Customer:	Coles ROAA	**Date:**	20th September
Site Address:	54 Templar Rd, Erskine Park NSW 2759	**Site Contact:**	Alan Villa
		Phone:	0410 556 153
Customer PO #:		**Internal Job #:**	1349

Equipment Type:	Serial Number:	Customer Line # (if applicable):
Trave 590	A17A-11614	Line 4
Platformer	A17A-11614	Line 4

Service forming pick and place 9x8 Platformer tooling

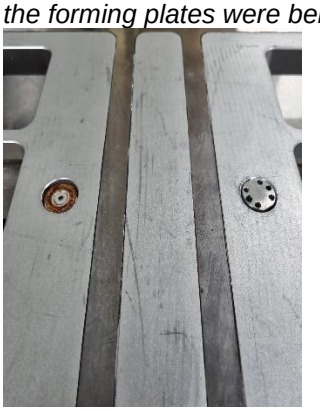
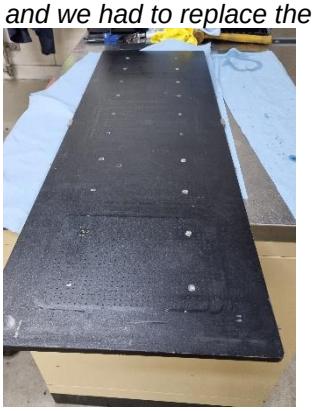
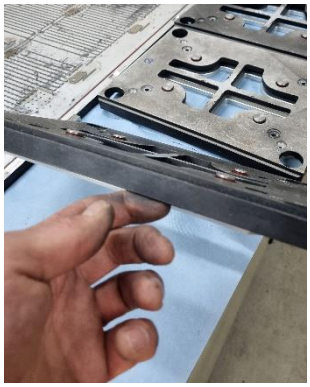
- *Started to pull apart all the forming plates for the pick and place*
- *All the dampers needed to be removed and replaced*
- *All the forming plates were bent and we had to replace the lot.*

- *Replaced all the bushings in the forming plate*
- *Inspect the suction cups and all okay*
- *The diffuser were inspected which are damaged, this is caused by damage dampers and can be prevented.*
- *Cleaned all contamination from diffusers.*
- *The changeover troller needs some work as the back stoppers are bend and need to be welded.*
