GENERAL SERVICE REPORT

Customer:	Coles ROAA	**Date:**	25th and 26th Sep
Site Address:	54 Templar Rd, Erskine Park NSW 2759	**Site Contact:**	Trent Cleminson
		Phone:	0438 287 226
Customer PO #:		**Internal Job #:**	
Subject: Full service

Equipment Type:	Serial Number:	Customer Line # (if applicable):
Trave 590	A17A-11614	Line 4
Platformer	A17A-11614	Line 4

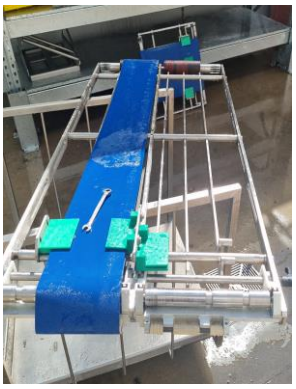
- Tooling was removed and shuttle from machine
- The infeed and spacer belts had to be removed for inspection and cleaned

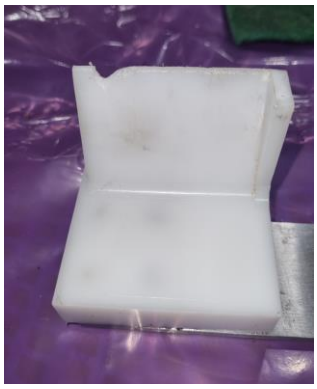
- Removed the belts so we could clean and inspect bearings.
- The nylon gears were removed to replace all bearings

- Phasers and guides were removed for full inspection and found the inlet phasers need replacing
- Inspect the cylinders and guide shafts.
- Inspect the outfeed cords and lubricated the drum motors.
- Replaced damaged circlip off one of the film rollers

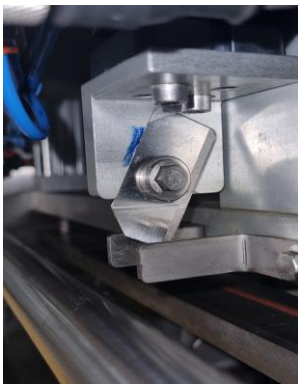
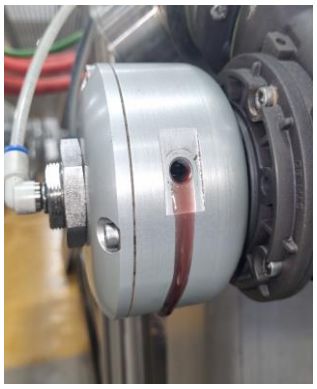
- Removed the centre knife, and replaced back 180 degree and will need replacing.
- Inspect the scrap rewind clutch oil which still good
- Inspect all film air locks and still okay

- Inspect the pusher arms and found the bushing need replacing, the operator side polish shaft needs replacing.
- Manually lubricated the pusher arm bushings to try free up old grease.

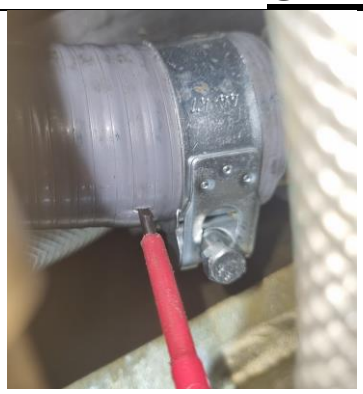
- Cleaned and inspected the opening and closing of pusher arms.
- Replaced one of the missing mounting screws
- Inspect the vacuum hoses and found on both sides of the machine with holes in the hoses that would have caused vacuum leakage.

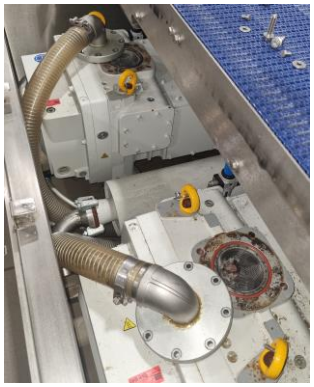
- Inspect the vacuum pump filters and cleaned out.
