UptimeEquip
Innovative Maintenance Support Program

GENERAL SERVICE REPORT

Customer:	Hilton	**Date:**	02/12/2025
Site Address:	22 Seena Place, Heathwood	**Site Contact:**	Kane Burnet
		Phone:	
Customer PO #:		**Internal Job #:**	5863

Subject: **Production Support various lines**

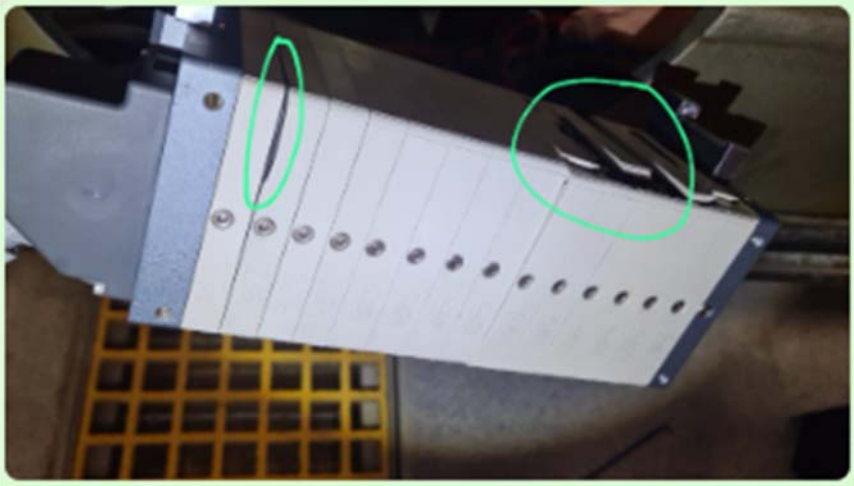
- Martina called me and said the pacers don't seem to work. I checked and found the valve bank in the bottom cabinet of the machine totally wrecked. I handed over to night shift.

Line 9 valve bank a little bad in a bad state

Back parts are broken and leaking air out. Hope there is spare parts for this
