GENERAL SERVICE REPORT

Customer:	Hilton	**Date:**	04/12/2025
Site Address:	22 Seena Place, Heathwood	**Site Contact:**	Kane Burnet
		Phone:	
Customer PO #:		**Internal Job #:**	5863

Subject: **Production Support various lines**

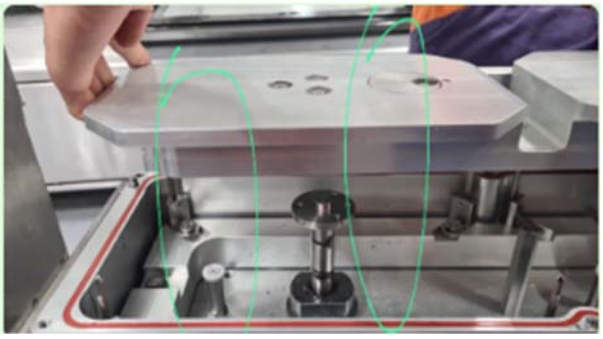
Line 9.

- Line 9 one side is sealing good other side deformation of trays badly. See the tray depth different for the 2 sides

- The stopper counter plates was wrong orientation.

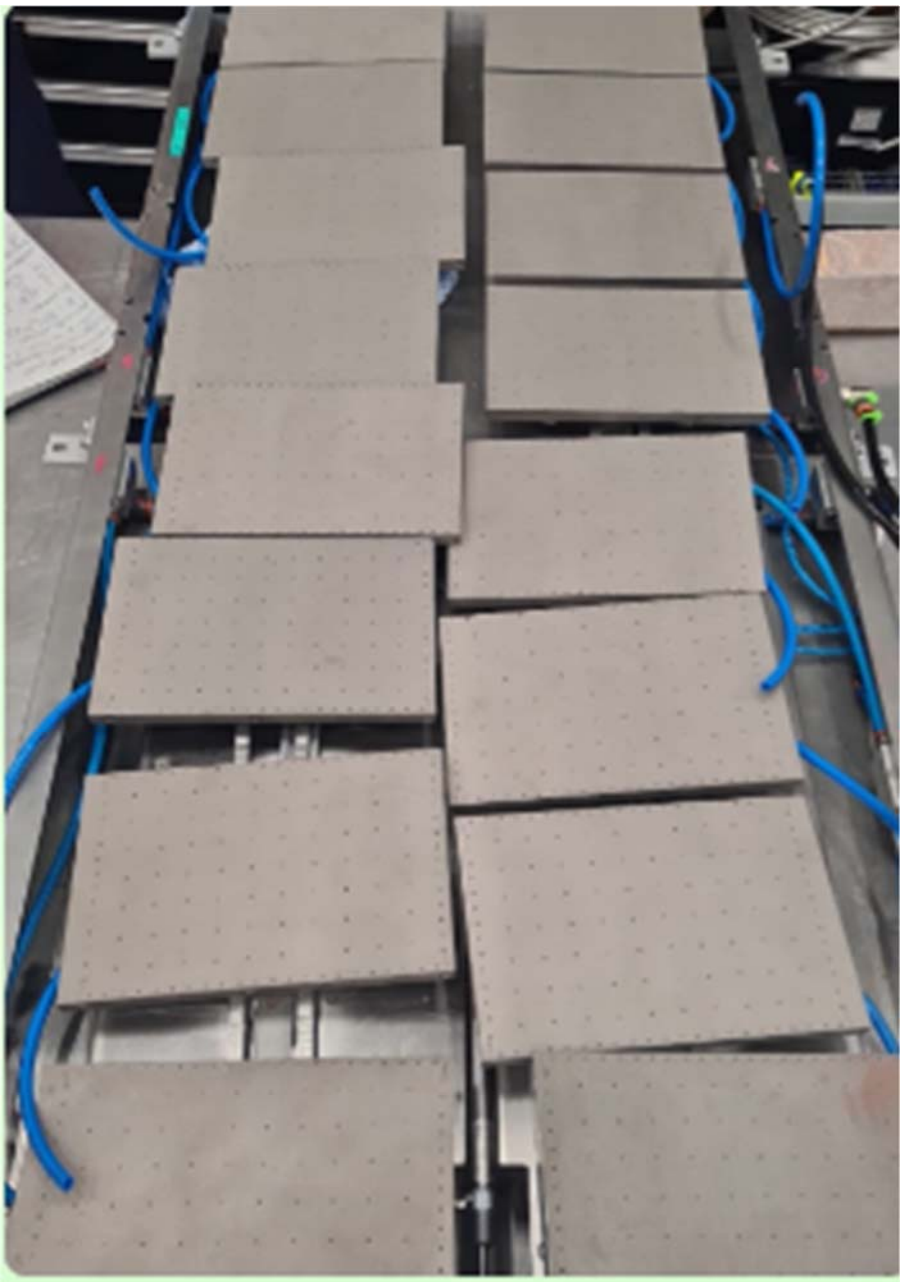
- Checked the shuttle that is still lying in pieces and see all the shuttle plates are in bad condition and needs to be sent for recoating.
- Went upstairs and found some recoated plates upstairs. Started to put the plates together with other parts with help from the tool team.

Found some recoted plates for the small skin shuttle of line 1. Hea 1057
