GENERAL SERVICE REPORT

Customer:	Coles ROAA	**Date:**	5/10/2022
Site Address:	54 Templar Rd, Erskine Park NSW 2759	**Site Contact:**	Trent Cleminson
		Phone:	0438 287 226
Customer PO #:		**Internal Job #:**	3696

Subject: New film trial

Equipment Type:	Serial Number:	Customer Line # (if applicable):
Trave 590	A17A-11614	Line 4
Platformer	A17A-11614	Line 4

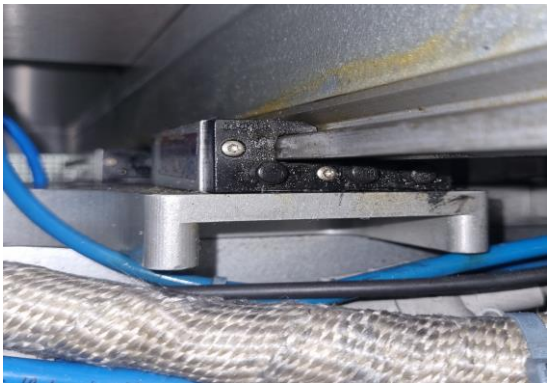
- The Platfomer was running but trays are not in the best condition and can be due to the following problems, which need looking into as follows
  1. The pick and place foam needs replacing, this plays an important part of the cycle to lay the sheets even.

2. The pick and place linear bearings need replacing, this plays an important part for correct positioning of film sheets.
  3. The Preheater plates damaged due to worn dampers on the pick and unload plates, this could have been prevented with regular services
  4. The Preheater plates have blocked vacuum ports due to melted film and contamination; this plays an important part of the forming trays

RECOMMENDATIONS
Comments:
The mondini tools need service and machine

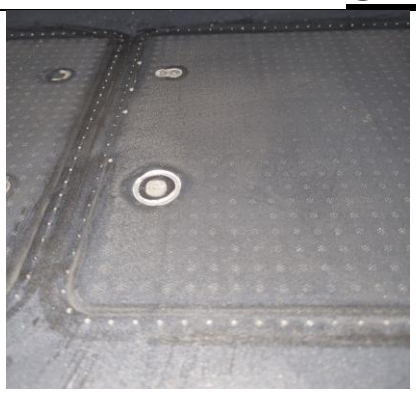
5. Lower mould tool has bad score markings that can affect sealing process for forming.
6. The pick and unload plates are all uneven indicating damage springs or bend.
7. The complete frame for pick and unloading needs replacing which has been taped-up due to vacuum leaks.

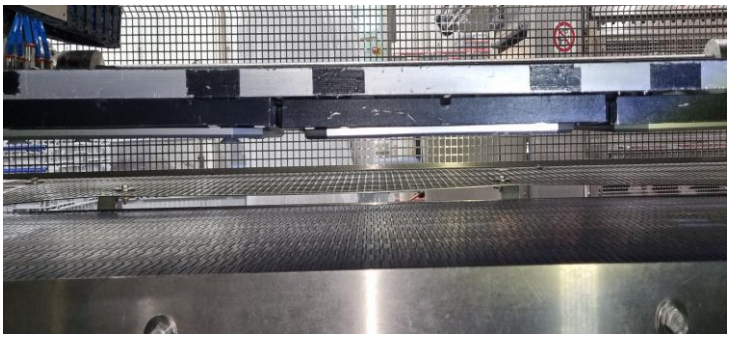
Please Note all above play an important part for forming trays.
