Audit done by: Marc Ashford **Date:** 6/03/2022

RROA Coles

Mondini line A17A-11614

Platformer

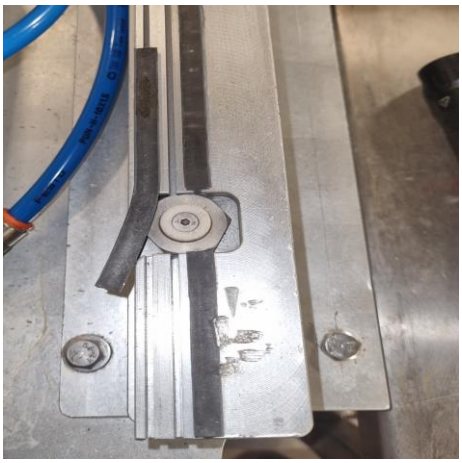
- *The lower moulding tool needs major service with missing end rubbers and Gaskets will need replacing as all springs.*

- *Lower moulding tool will need a full wash down.*
- *The upper pre-heater plates need replacing or send away for Teflon coating.*
- *The upper pre-heaters have bad score markings and missing studs.*
- *Shuttle pick and place after moulding needs major work with damaged springs' bend forming plates and dampers.*

- *This tool needs a complete check over to determine what parts need replacing.*

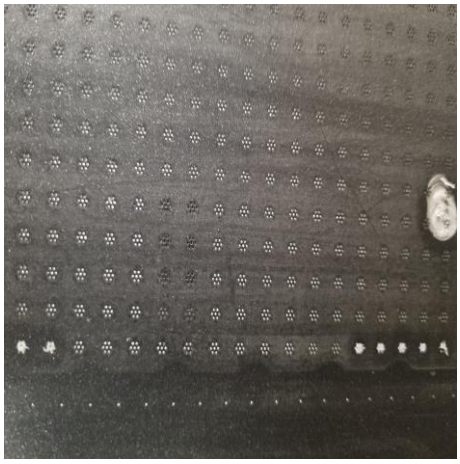
- *The upper pre-heater Teflon is worn and some vacuum hole blocked.*

- *Shuttle pick and place after moulding is damaged and bend.*

- *Shuttle pre-heater tool needs major service to determine what needs replacing or repaired.*

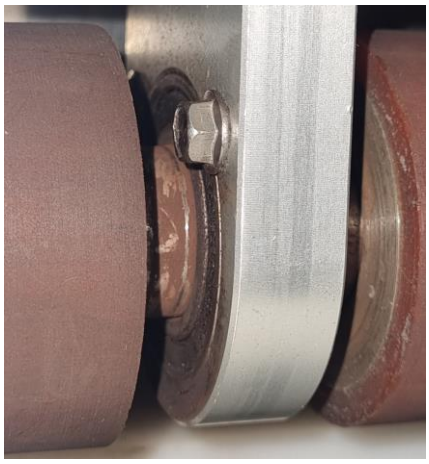
- *The pick and unload insulation foam needs replacing*

- *The film roller bearings need replacing*

- *White nylon block under distance belt needs replacing, this part in important for the correct position of sheets.*

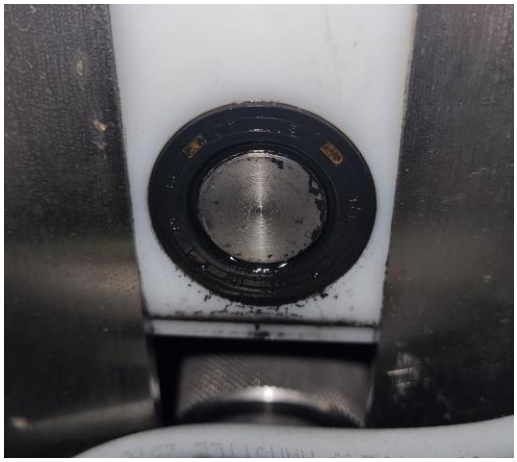
- *Main air switch needs inspecting which should dump when safety doors open, not working.*
- *Full inspection will be needed on the Trave 590XL*
- *Gummy roller gasket needs replacing*

- *Gummy rollers and drive roller need wash down and starting to flatten out*

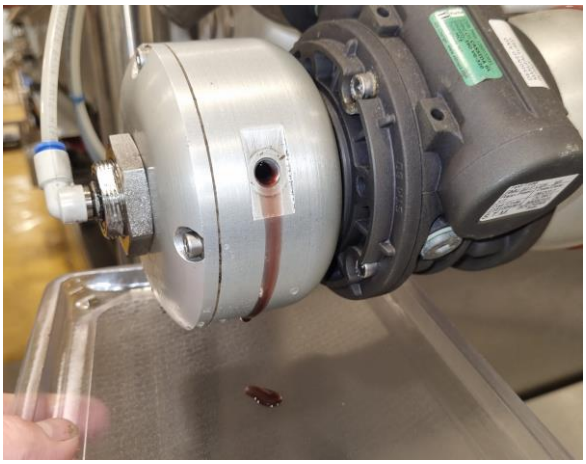
- *Scrap rewind gearbox oil needs replacing.*

- *Vacuum pump filter was inspected and cleaned out*

- *Film roller circlip missing which can affect tracking.*

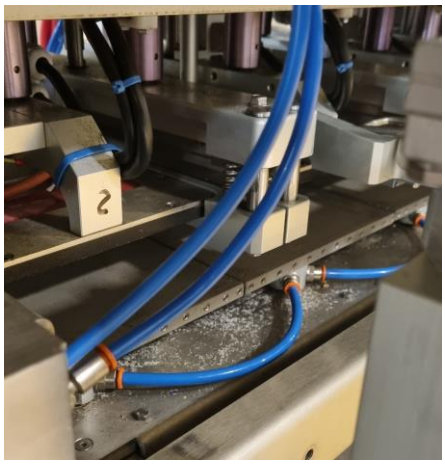
- *Top head needs a full inspection*

- *Top head vacuum hoses need inspecting*
- *Top head needs lubrication*
- *Top head seal bars need full clean and Teflon coating*
- *Shuttle system need a major service where all vacuum ports need to be cleaned out.*
- *Shuttle plates need cleaning*
- *Shuttle plate pneumatics need inspecting*
