GENERAL SERVICE REPORT

Customer:	Coles	**Date:**	22/03/2023
Site Address:	72 Templar Road Erskine Park NSW	**Site Contact:**	Trent Cleminson
		Phone:	
Customer PO #:		**Internal Job #:**	3820

Subject: Shuttle 9x8 clamp issue

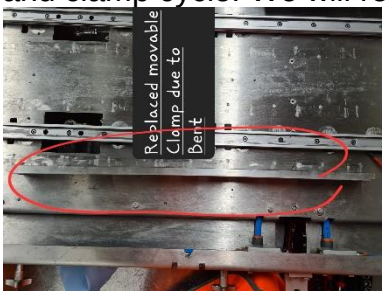
- Call out for shuttle 9x8 issue. Fixed clamp failed to clamp the film in place
  Team said, problem rectified when lid shuttle release position was setting 2mm longer, but next problem happened because lid won't be center to dome.
- Tested fixed and mobile clamp cylinder function, they are working properly
- Checked red o-cords on clamps, they are all in place and proper condition.
- Mobile plate was already identified bending from last service, it may affecting the transfer and clamp cycle. We will resend the quote for this item

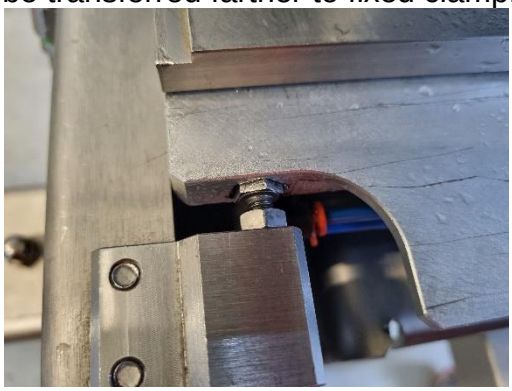
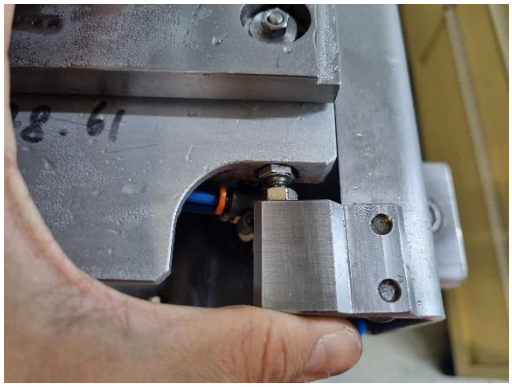
- Found base plate for mobile clamp was worn out on left and right stopper. Need to be replaced.

- Adjusted the mechanical stopper of mobile clamp cylinder about 3mm longer such film will be transferred farther to fixed clamp.

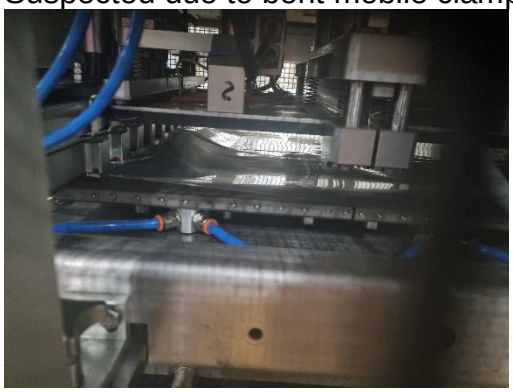
- Tested shuttle on machine, the clamps was good on both side but not on the middle. Suspected due to bent mobile clamp.

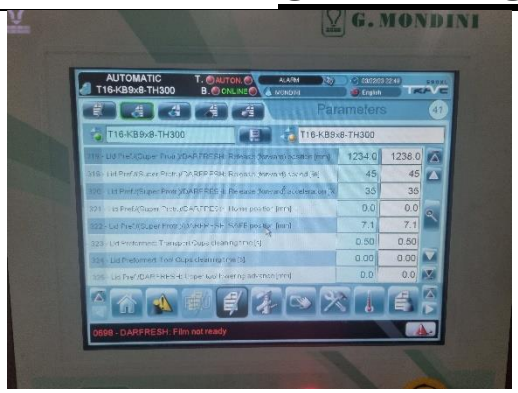
- Shuttle issue was temporary fixed, film could cycling properly. Parameter #318 :Lid shuttle release position was set 1238mm instead of 1245mm. But another issue happened on tool, film was popping during dome forming on all cavity

- Tried to redo heating cycle of shuttle but film still popping.
- Increasing dome vacuum valve #2 delay from 3.5 to 4.5s, only half of the cavity was popping now. Teflon coating on domes weren't in best condition, they need to be replaced.

- Confirming the issue is due to film too cold, production decided not to run the production since it was already 1030pm
- Marc will be onsite in the next morning to rectify film popping issue.
