GENERAL SERVICE REPORT

Customer:	Coles ROAA	**Date:**	10.08.22 – 11.08.22
Site Address:	54 Templar Rd, Erskine Park NSW 2759	**Site Contact:**	Trent Cleminson
		Phone:	0438287226
Customer PO #:		**Internal Job #:**	2383

Subject: Check platformer 9x8 VSP tool

Equipment Type:	Serial Number:	Customer Line # (if applicable):	Area
Platformer	A17A-11614	Line 4	Meat processing room

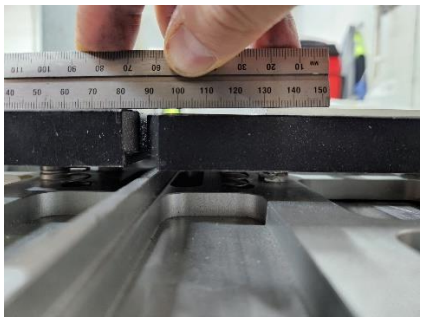
Attend the site.
Inspect the top tool found no level between plates.

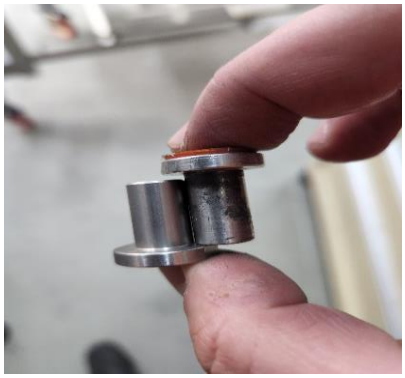
Undo folding plate and found that columns were different lengths.
Tried compensating level by washes so it needs to order the whole set plus spare

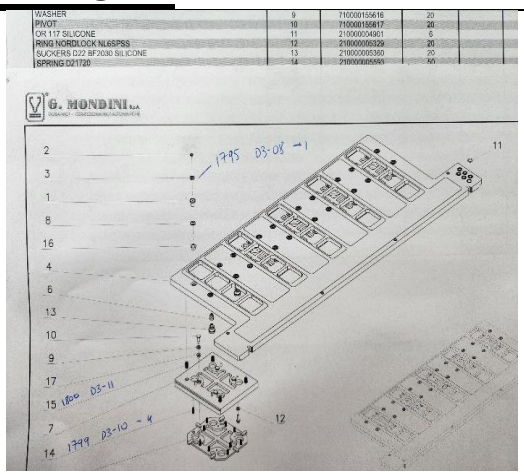
Undo plate from folding plate and found not enough springs only 6 but according to the drawing it should be 10 in each so totally 50 pcs. Put extra springs (use customer stock).

Replaced worn dampers (Use customer stock)
Replaced worn springs (use customer stock)
Cleaned all bushes
Installed all folding plates back to the frame and level up.
Inspect bottom tool
Replaced t-seal and found worn moulding.
