GENERAL SERVICE REPORT

Customer:	Coles	**Date:**	22/05/2021
Site Address:	72 Templar Road Erskine Park NSW	**Site Contact:**	Rahul Sugumaran
		Phone:	
Customer PO #:		**Internal Job #:**	3220

Subject: Service Platformer

Equipment Type:	Serial Number:	Customer Line # (if applicable):
Platformer	A/17/A-11614

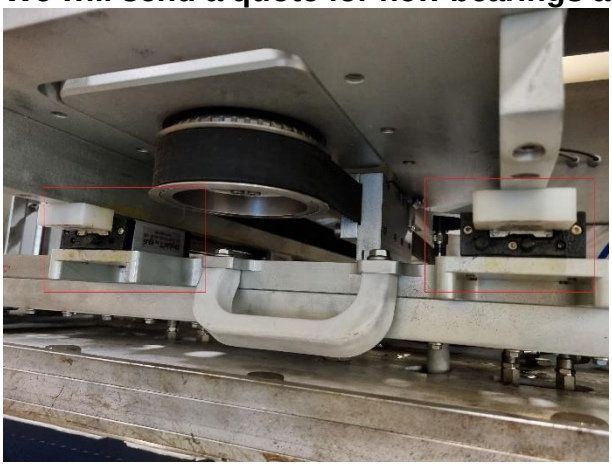
- Suction cups has uneven height and need to be replaced asap.
  We have send email chaser to spare part as quote has been requested on May 11th.
- Linier bearings were slightly worn.
  We will send a quote for new bearings and rail

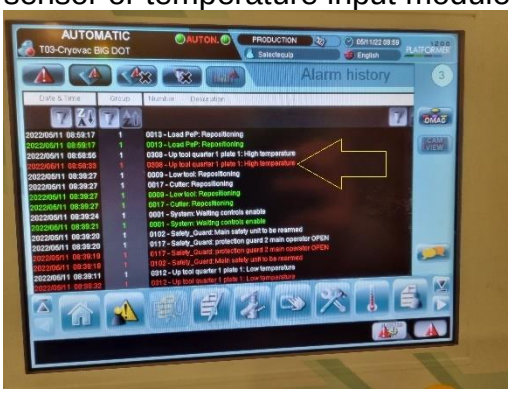
- There was intermittent Alarm 0308 “Up tool quarter 1 plate1 : High Temperature” and other time “Up tool quarter 1 plate 1 : Low Temperature”. Alarm could be reset and machine restart again.
  We have checked thermocouple wires and plug, heater and slip rings. There is nothing ackward, need to observe further onsite when alarm happened. It could be sensor or temperature input module fault.
