GENERAL SERVICE REPORT

Customer:	Coles	**Date:**	23/07/2021
Site Address:	72 Templar Road Erskine Park NSW	**Site Contact:**	Tom Darwen
		Phone:	
Customer PO #:		**Internal Job #:**	3618

Subject: Upper and Lower tool time out - Platformer

Equipment Type:	Serial Number:	Customer Line # (if applicable):
Platformer	A/17/A-11614

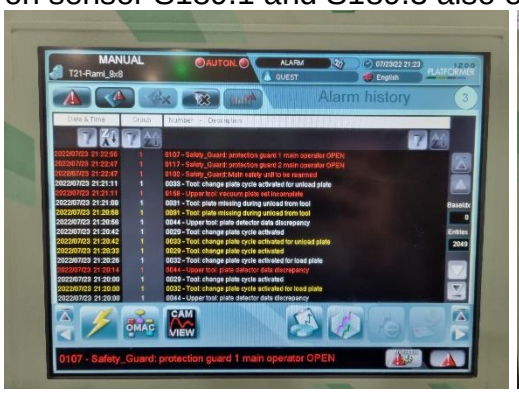
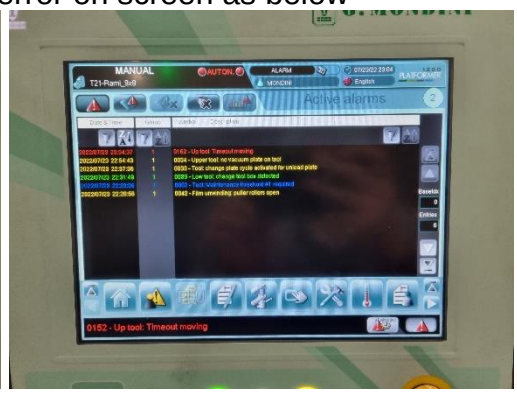
- Was informed that machine stopped with lower tool timeout and no error on the screen.
- When arrived onsite, maintenance team was in process of top vacuum plate changeover but they couldn't complete the changeover cycle.
- Noticed S189.3 sensor was giving inconsistent input to PLC module.
  This is analog current sensor, we were suspecting the sensor is defective. We swapped this sensor with S189.2.
- Noticed all vacuum plates were not locked properly, which causing inconsistent detection on sensor S189.1 and S189.3 also error on screen as below

- Checking the rootcause why plates were not locking and found the stopper for locking cylinder stroke has its counter nut loose and a way to long. Adjusted the stopper and lock it properly.
