GENERAL SERVICE REPORT

Customer:	Coles	**Date:**	23/08/2022
Site Address:	72 Templar Road Erskine Park NSW	**Site Contact:**	Trent Cleminson
		Phone:	
Customer PO #:		**Internal Job #:**	3653

Serviced bottom tool 11x9

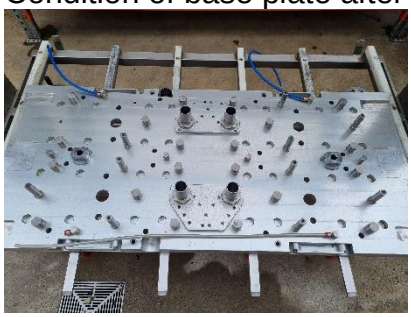
- Replaced 6x springs for shaft
- Replaced new blue springs
- Condition of base plate after cleaning
