GENERAL SERVICE REPORT

Customer:	Coles	**Date:**	28/08/2022
Site Address:	72 Templar Road Erskine Park NSW	**Site Contact:**	Trent Cleminson
		Phone:	
Customer PO #:		**Internal Job #:**	3655

Subject: Service Platformer

Equipment Type:	Serial Number:	Customer Line # (if applicable):
Platformer	11614

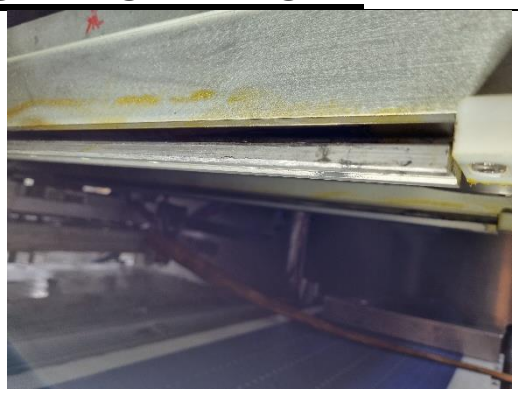
- Checked PT-100 reading. OK
- Checked condition of drive belts and drive coupling.OK
- Checked servomotor connection. OK
- Guide rails and linier bearing were worn out. **To be quoted.**

- To quote new unload P&P for VSP 11x9
- To quote foam, new rails and linear bearings for loading P&P
- To quote analog sensor for vacuum plate detection

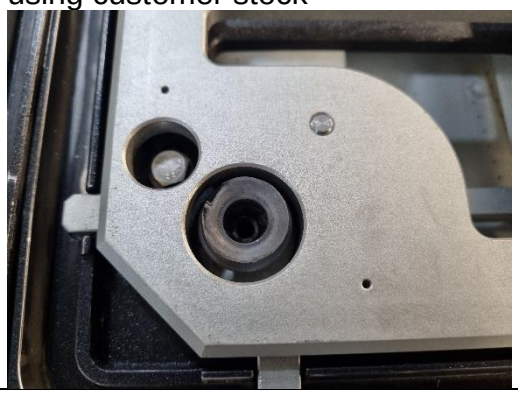
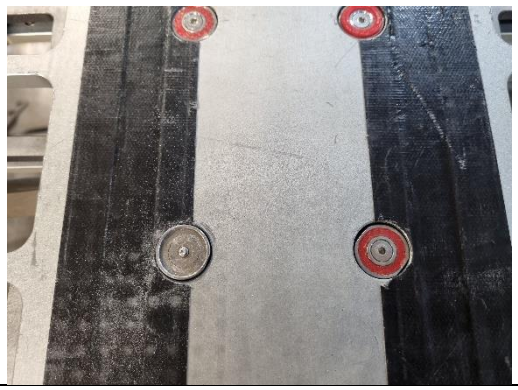
- Checked drive belts and couplings. OK
- 1x suction cups was broken and 1x column+damper was damage on 11x9 VSP. Replaced using customer stock

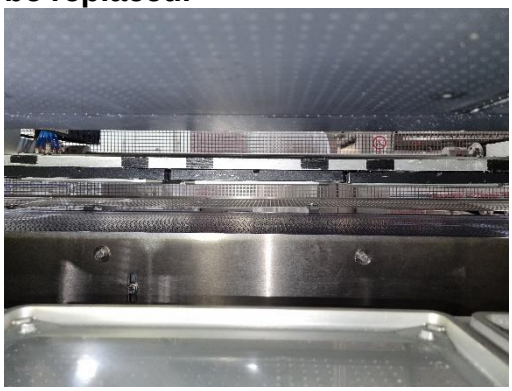
- Noticed base plate for 11x9 VSP was bit bending, all plates have different height as well, and vacuum channel has been repaired and taped. **Recommended complete shuttle to be replaced.**

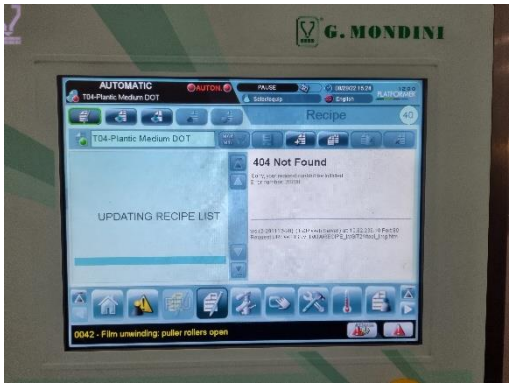
- Checked for any loose or discoloured connection. OK
- Checked all switches and E-stops. OK
- Checked HMI, sometimes there was issue on recipe loading as per below photo.
  For the meantime the only way to fix the issue is to power cycle the machine. Issue has been forwarded to Mondini for further advise.
